Locations along Barberry Creek (upstream to downstream)

Selected Problem Conditions

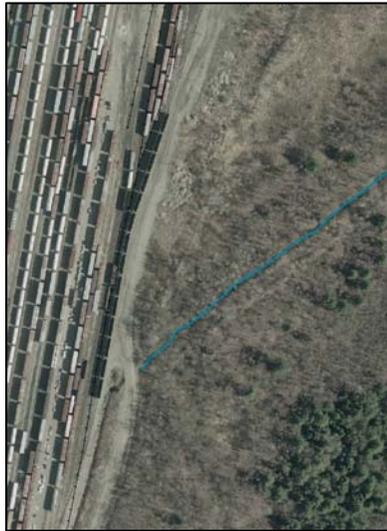
Fig. 8. Railway influence above upstream wetland

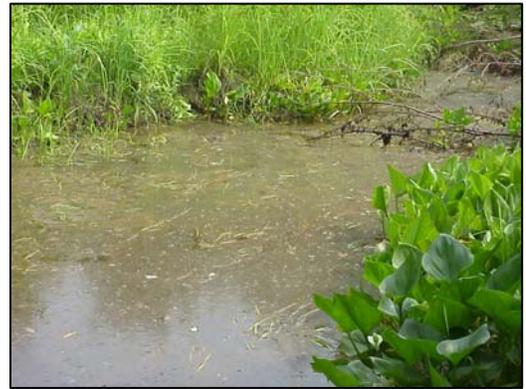
Fig. 9. Impaired water quality at outflow of upstream wetland (7/2003)

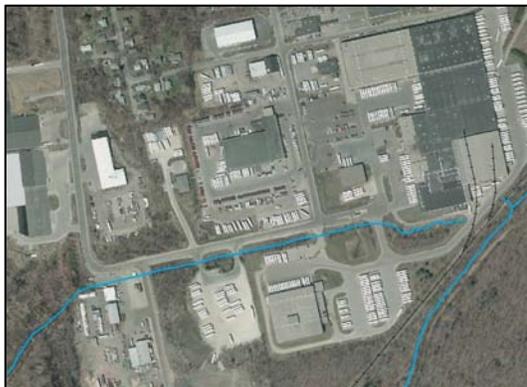
Fig. 10. Impervious surfaces near stream

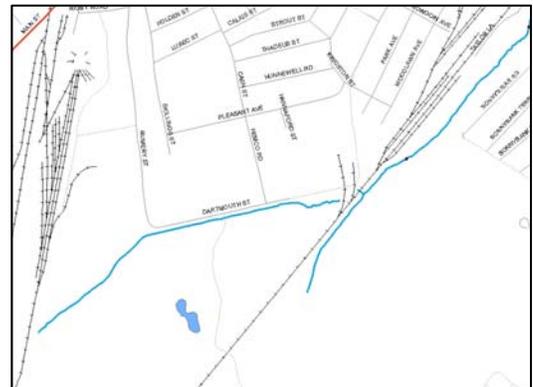
Fig. 11. Extensive channelization

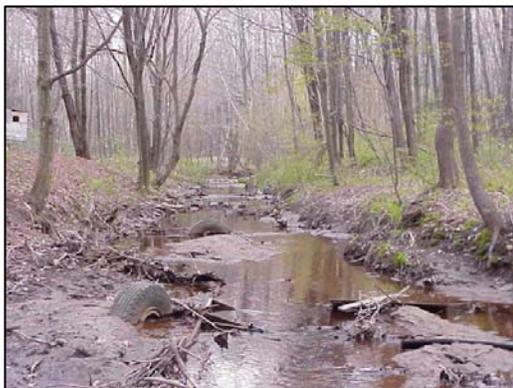
Fig. 12. Sedimentation at S672, 5/2004

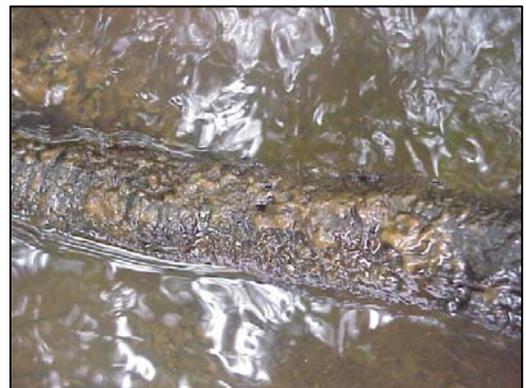
Fig. 13. Log with growth (bacteria, algae, fungi) at S672, 7/2004
