PHOTOSIMULATION 13: MOXIE POND - North, East Moxie Twp

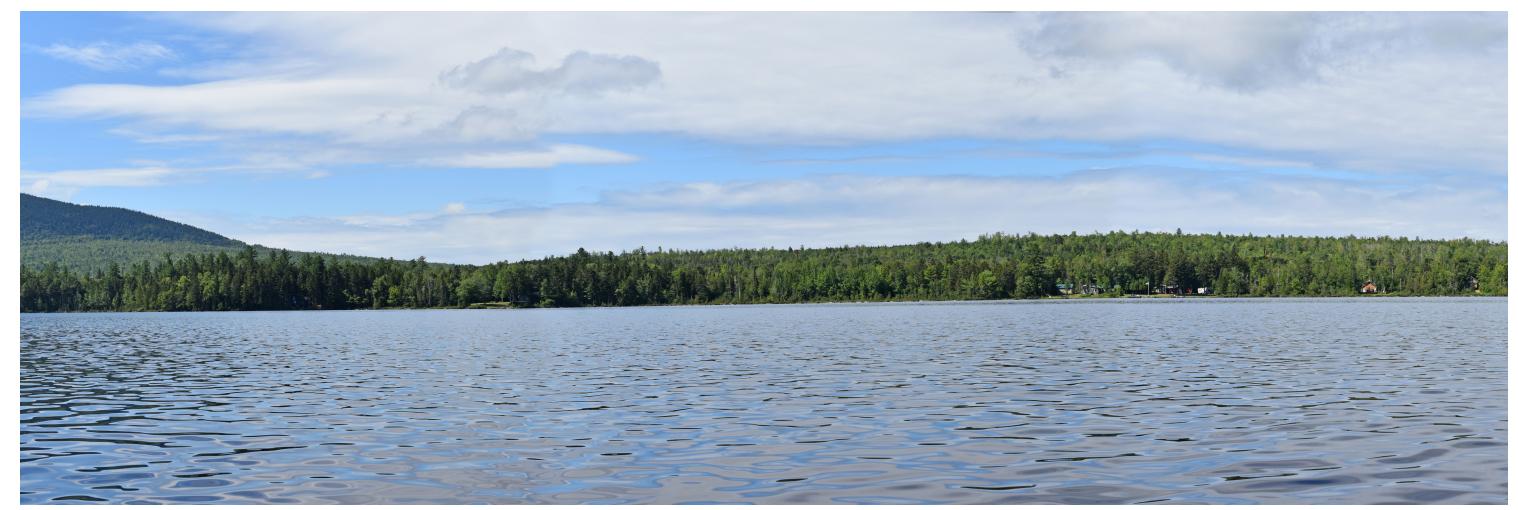
Proposed Conditions: Panoramic view looking southwest to west from the northern end of Moxie Pond toward the proposed co-located HVDC transmission line. The existing 150' wide corridor clearing will be widened by 75' on the western side to accommodate the new transmission line. Three structures and conductors will be visible at distances of 2,400 to 2,900 feet from this viewpoint. Moxie Pond is a designated scenic resource with a 'Outstanding' rating in the Maine Wildlands Lake Assessment. See Appendix B: Study Area Photographs for images.

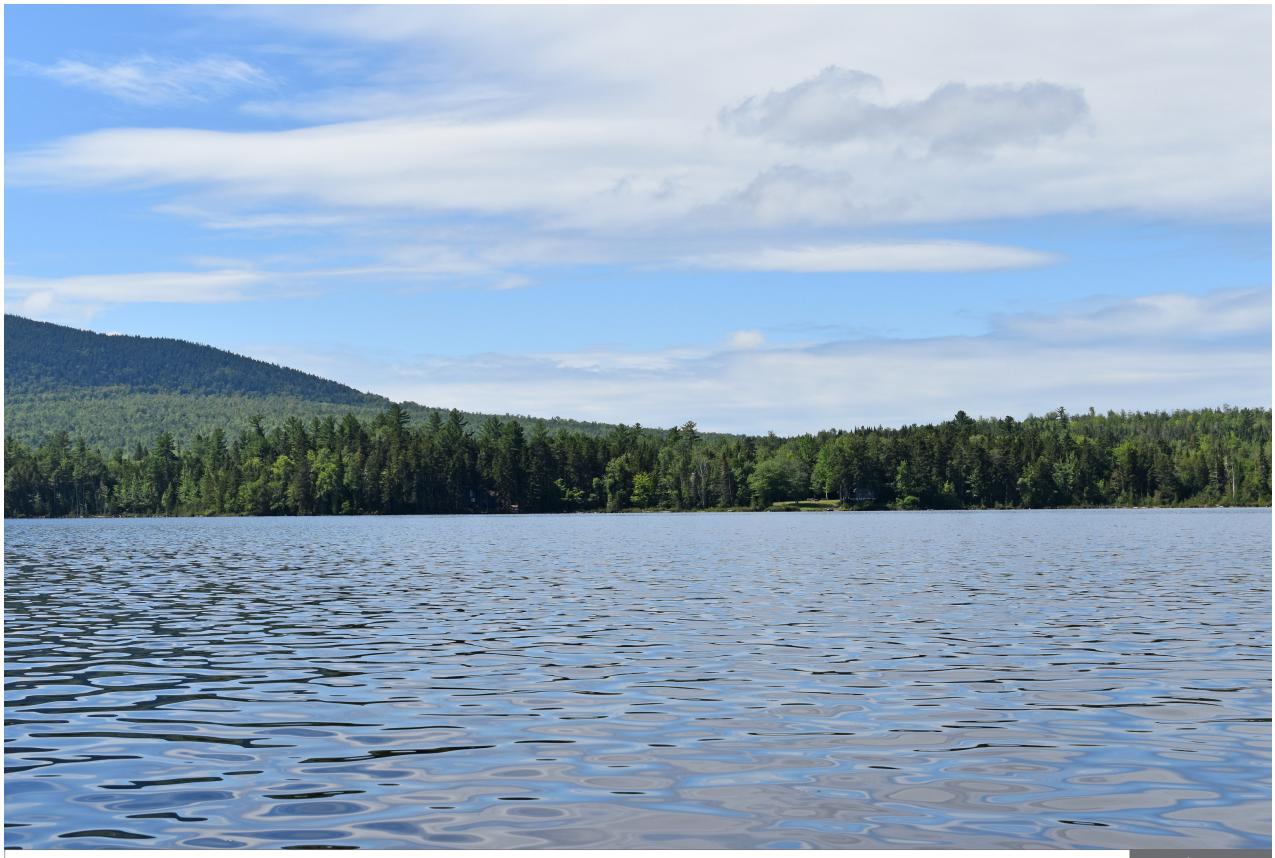
PHOTOSIMULATION 13A: MOXIE POND - North, East Moxie Twp

Existing Conditions: Normal view looking southwest from the northern area of Moxie Pond toward existing 115 kV transmission line. Mosquito Mountain is visible on the left side of the image.

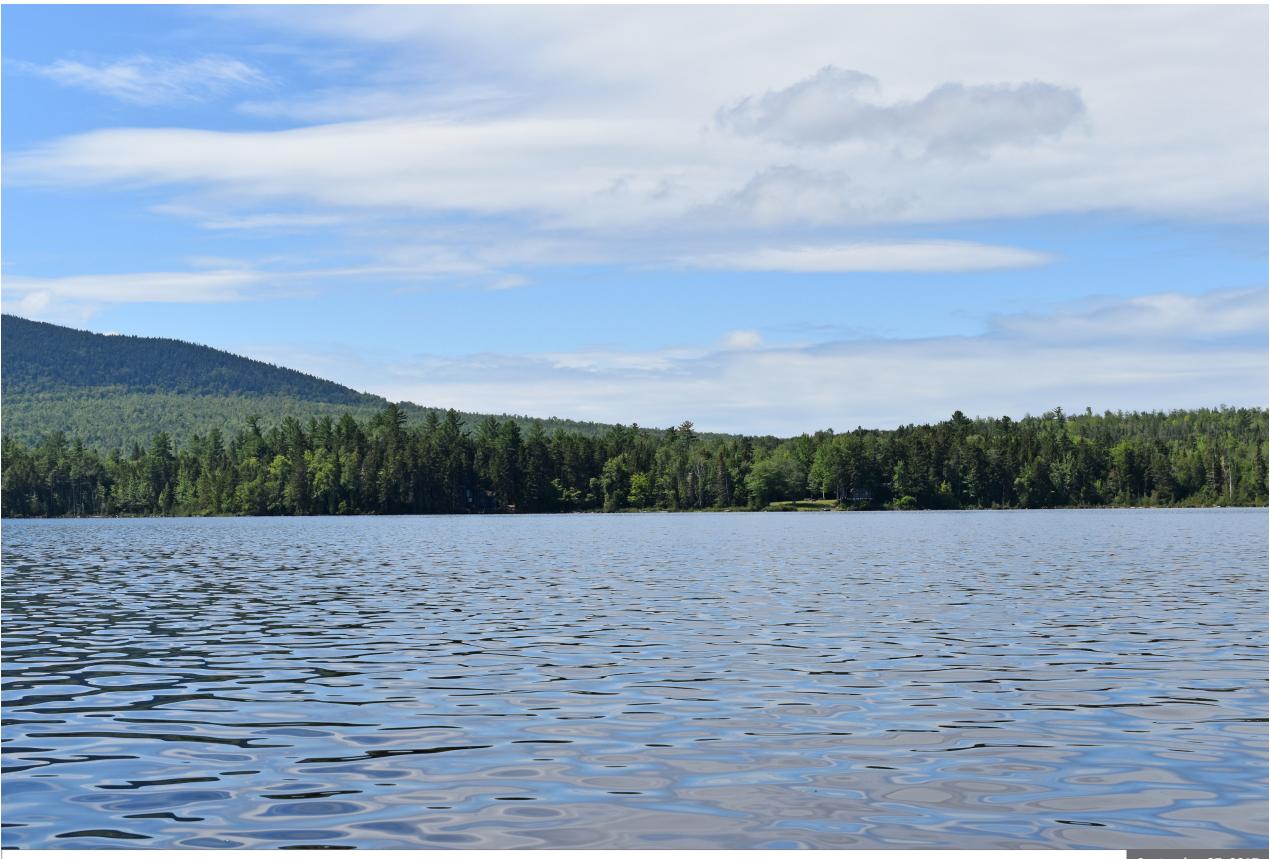
PHOTOSIMULATION 13A: MOXIE POND - North, East Moxie Twp

Proposed Conditions: Normal view looking southwest from the northern area of Moxie Pond toward the proposed co-located HVDC transmission line. One structure and conductors will be visible from this viewpoint at a distance of 2,900 feet. The existing 150' wide corridor clearing will be widened by 75' on the western side to accommodate the new transmission line.

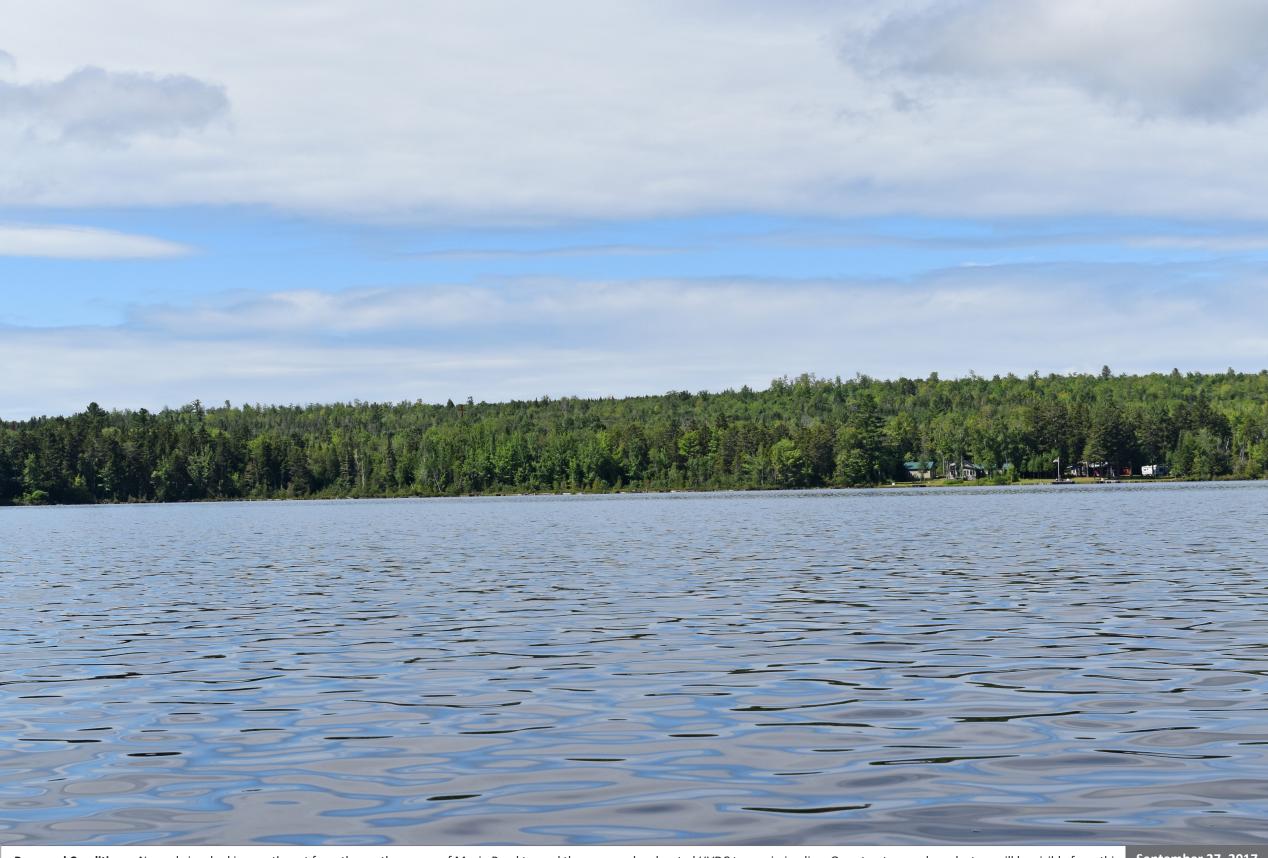
PHOTOSIMULATION 13B: MOXIE POND - North, East Moxie Twp

Proposed Conditions: Normal view looking southwest from the northern area of Moxie Pond toward the proposed co-located HVDC transmission line. One structure and conductors will be visible from this viewpoint at a distance of 2,400 feet. The existing 150' wide corridor clearing will be widened by 75' on the western side to accommodate the new transmission line.

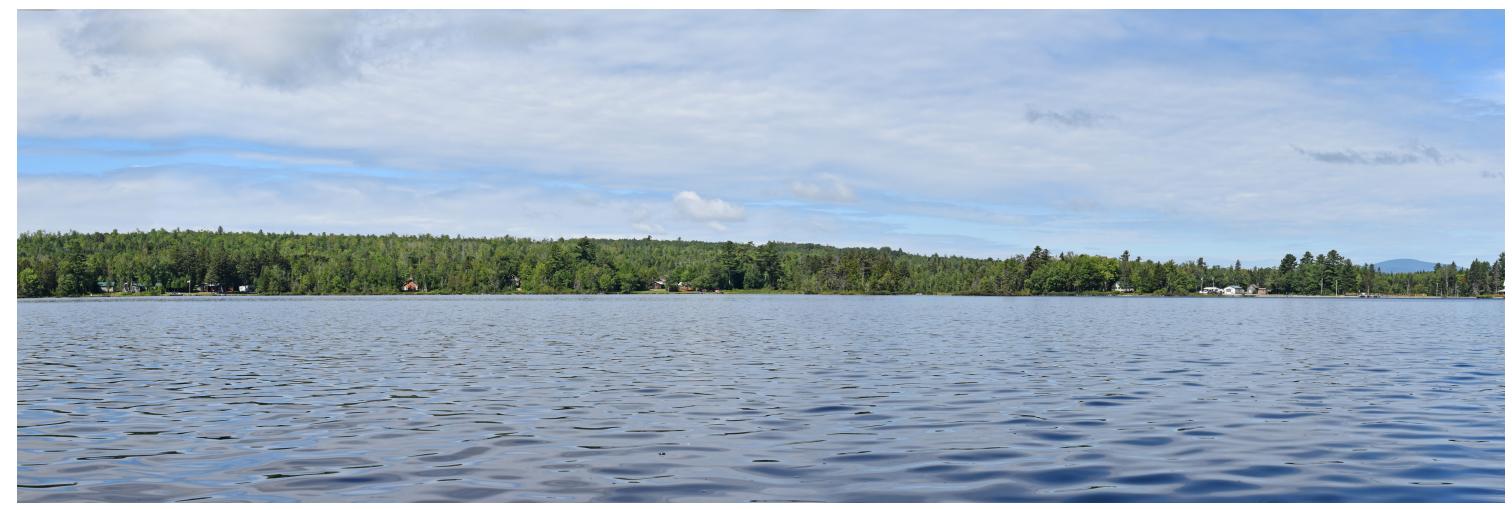
PHOTOSIMULATION 14: MOXIE POND - North, East Moxie Twp

Proposed Conditions: Panoramic view looking west to northwest from the northern end of Moxie Pond toward the proposed co-located HVDC transmission line. The existing 150' wide corridor clearing will be widened by 75' on the western side to accommodate the new transmission line. Three structures and conductors will be visible at distances of 2,400 to 4,200 feet from this viewpoint. Moxie Pond is a designated scenic resource with a 'Outstanding' rating in the Maine Wildlands Lake Assessment.

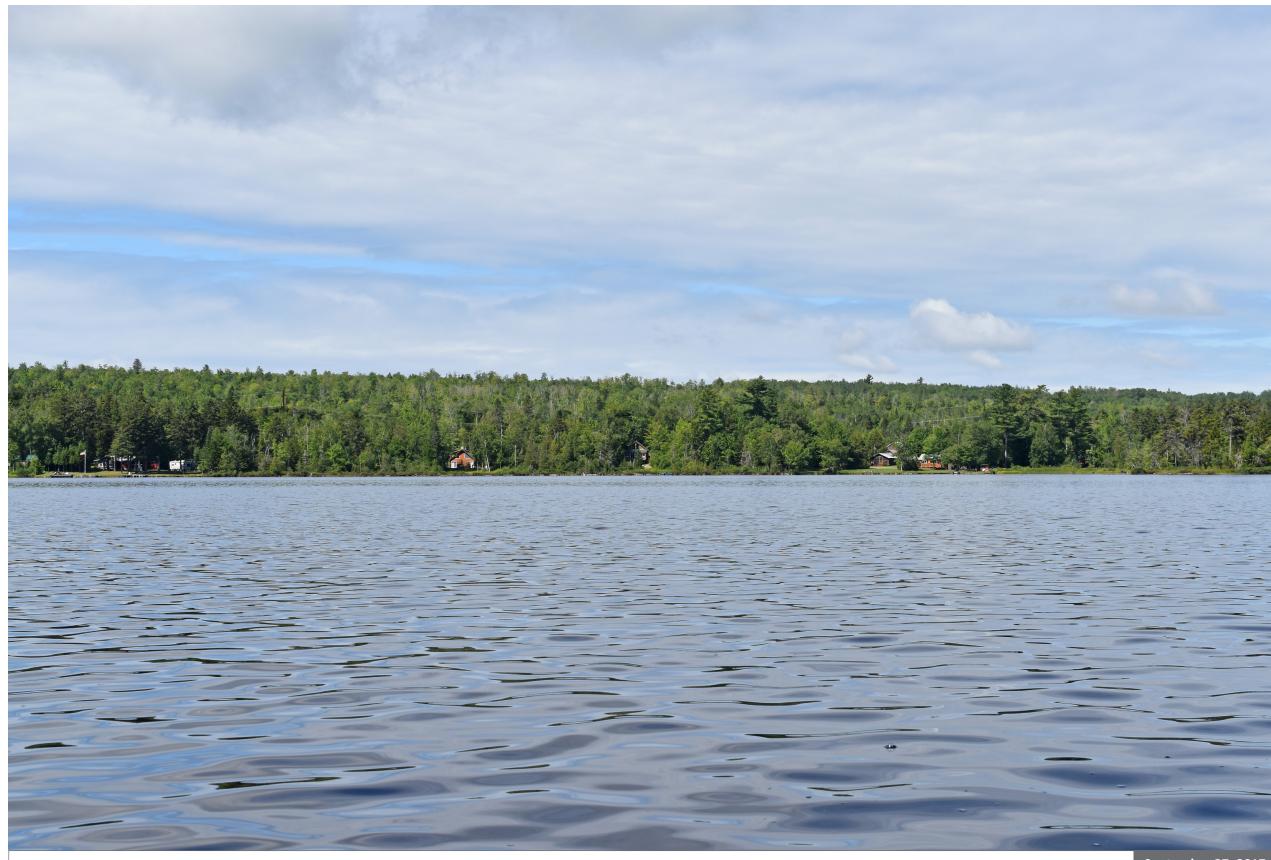
PHOTOSIMULATION 14A: MOXIE POND - North, East Moxie Twp

Proposed Conditions: Normal view looking west from the northern area of Moxie Pond toward the proposed co-located HVDC transmission line. Two structures and conductors will be visible from this viewpoint at a distance of 2,400 feet. The existing 150' wide corridor clearing will be widened by 75' on the western side to accommodate the new transmission line.

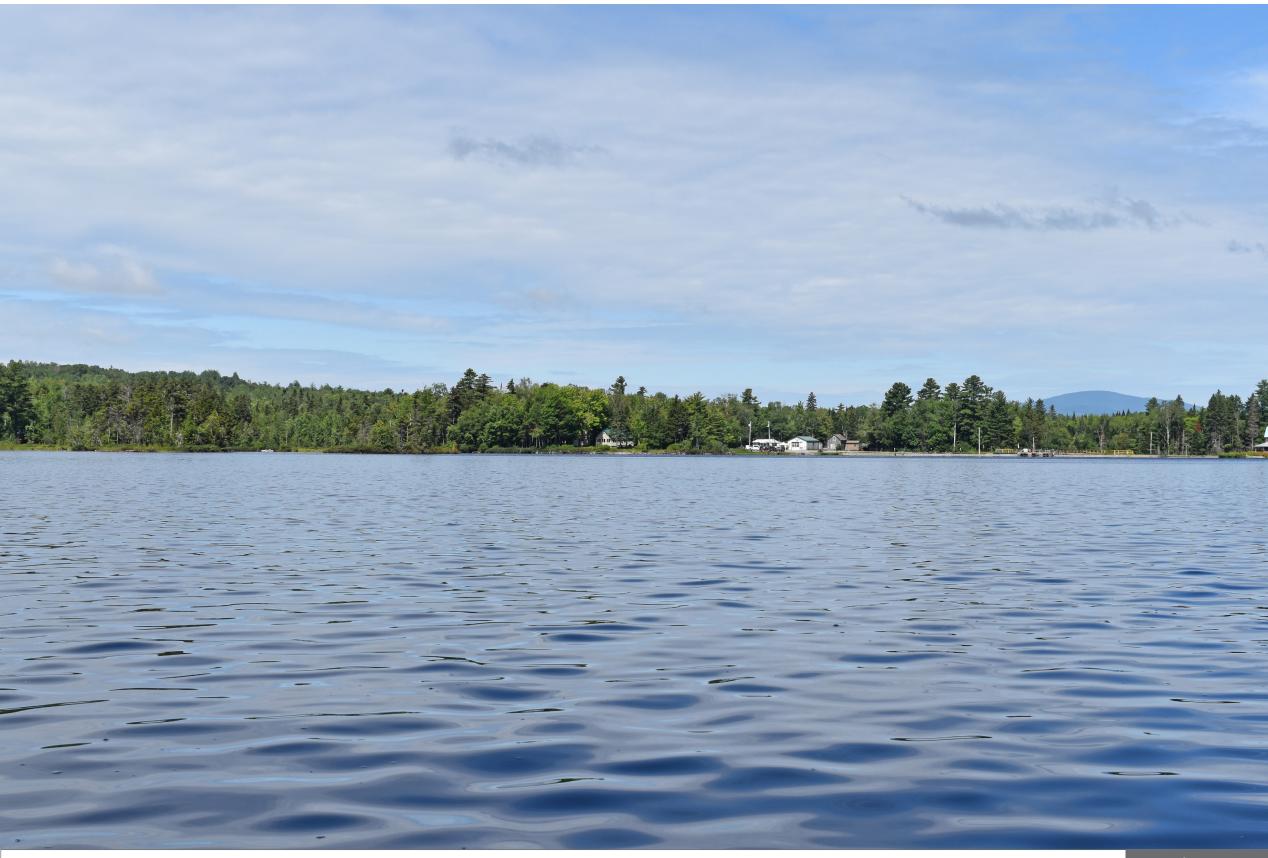
PHOTOSIMULATION 14B: MOXIE POND - North, East Moxie Twp

Existing Conditions: Normal view looking northwest from the northern area of Moxie Pond toward existing 115 kV transmission line. The boat launch at the north end of Moxie Pond and Coburn Mountain are visible on the right side of the image.

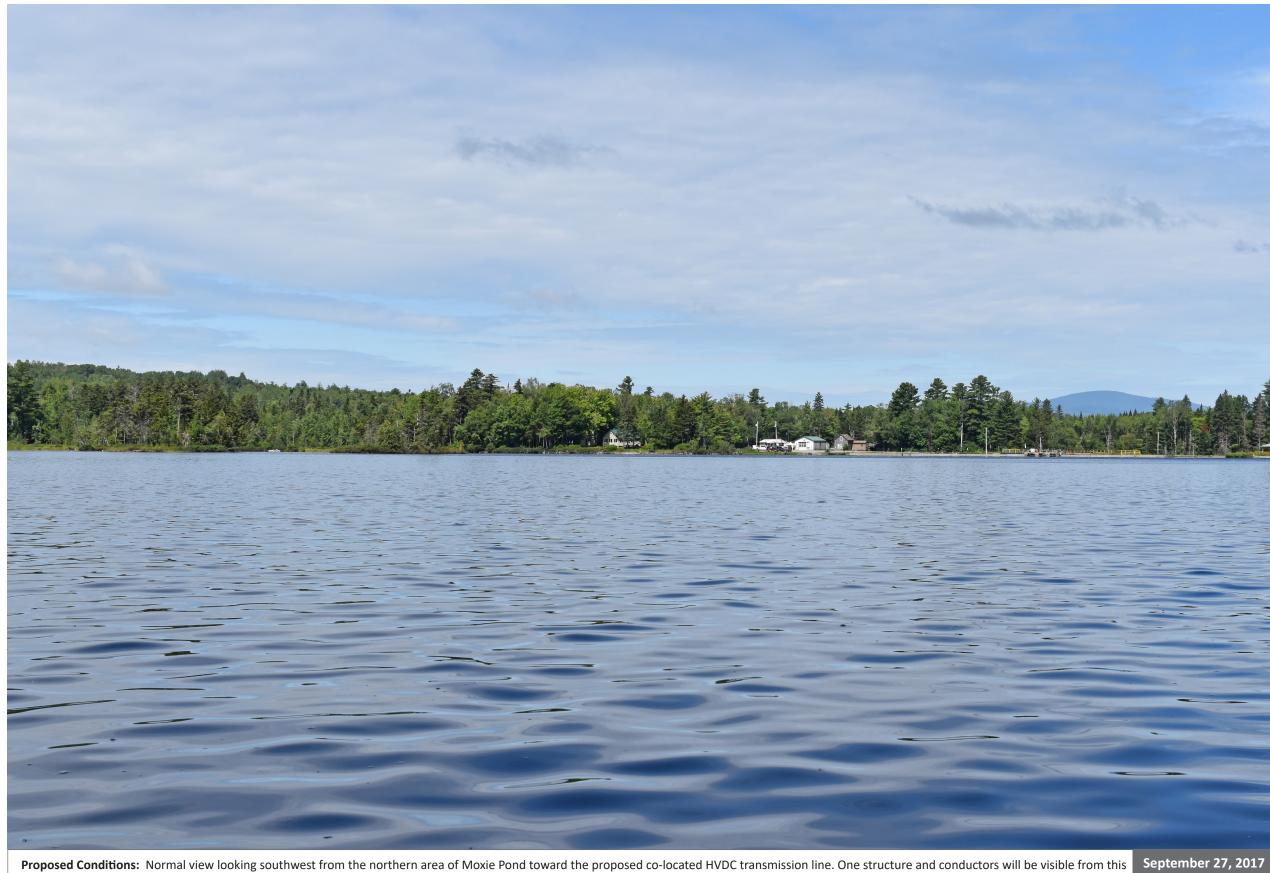
PHOTOSIMULATION 14B: MOXIE POND - North, East Moxie Twp

Proposed Conditions: Normal view looking southwest from the northern area of Moxie Pond toward the proposed co-located HVDC transmission line. One structure and conductors will be visible from this viewpoint at a distance of 4,200'. The existing 150' wide corridor clearing will be widened by 75' on the western side to accommodate the new transmission line.

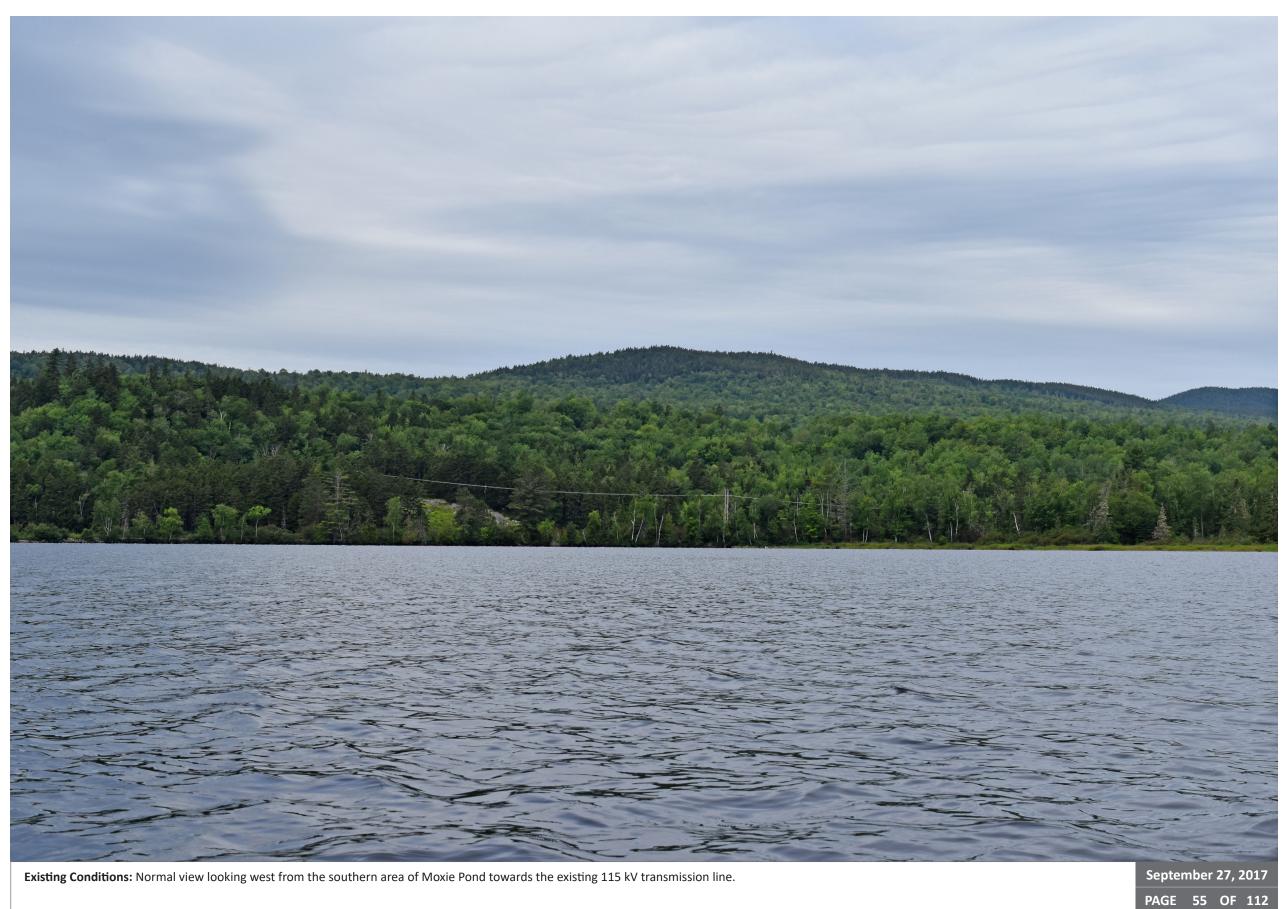
PHOTOSIMULATION 15A: MOXIE POND - South, Bald Mountain Twp T2 R3

Proposed Conditions: Normal view looking west from the southern area of Moxie Pond toward the proposed co-located HVDC transmission line. The clearing will be widened by 75' on the western side of the existing 150' wide 115 kv transmission line corridor to accommodate the new HVDC transmission line. The top portion of three structures and the conductors will be visible above the existing transmission line structures & conductors.

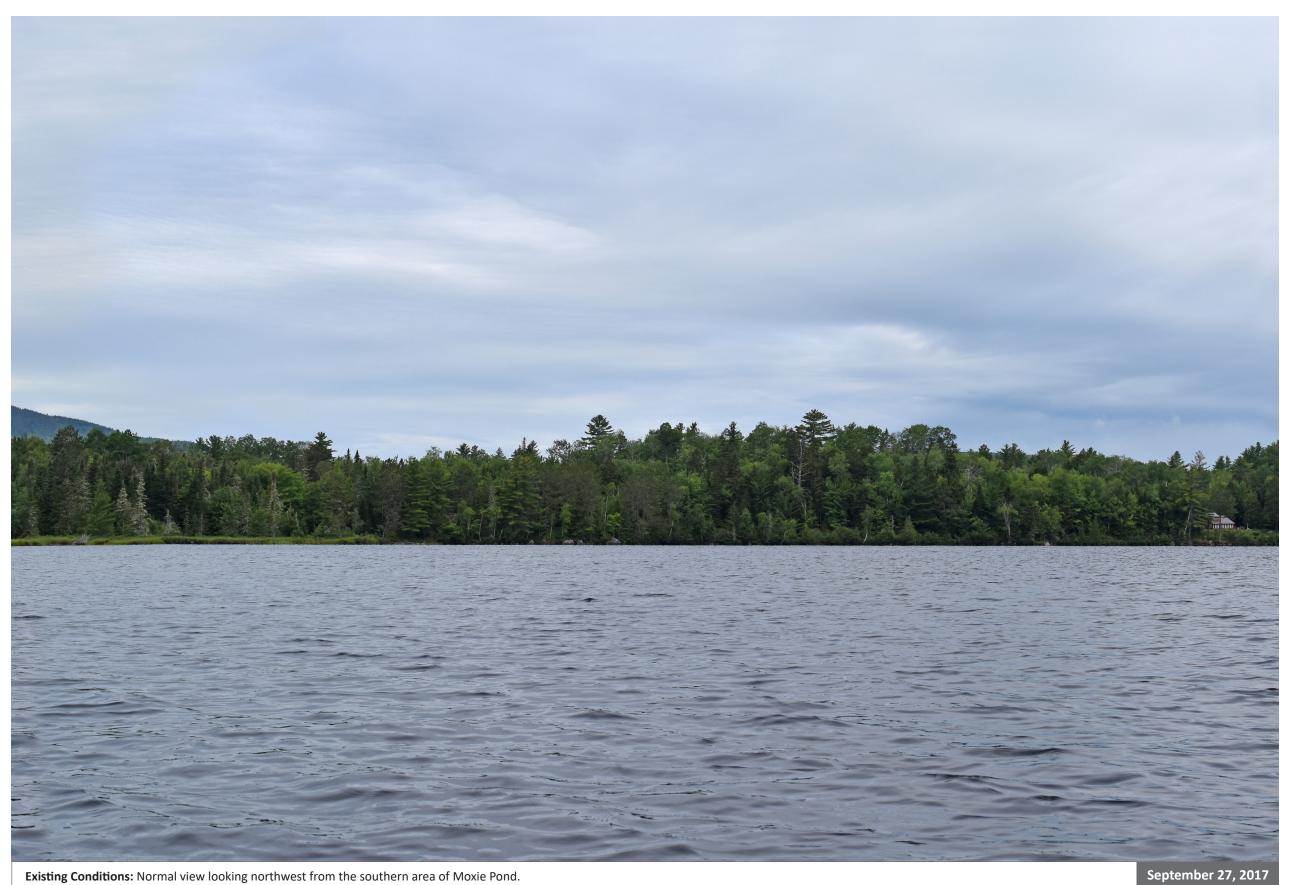
PHOTOSIMULATION 15B: MOXIE POND - South, Bald Mountain Twp T2 R3

Proposed Conditions: Normal view looking northwest from the southern area of Moxie Pond toward the proposed co-located transmission line. The change in vegetation due to the widening of the cleared corridor will not be noticeable looking in this direction. One structure and portions of conductors will be visible, but mostly screened by vegetation.

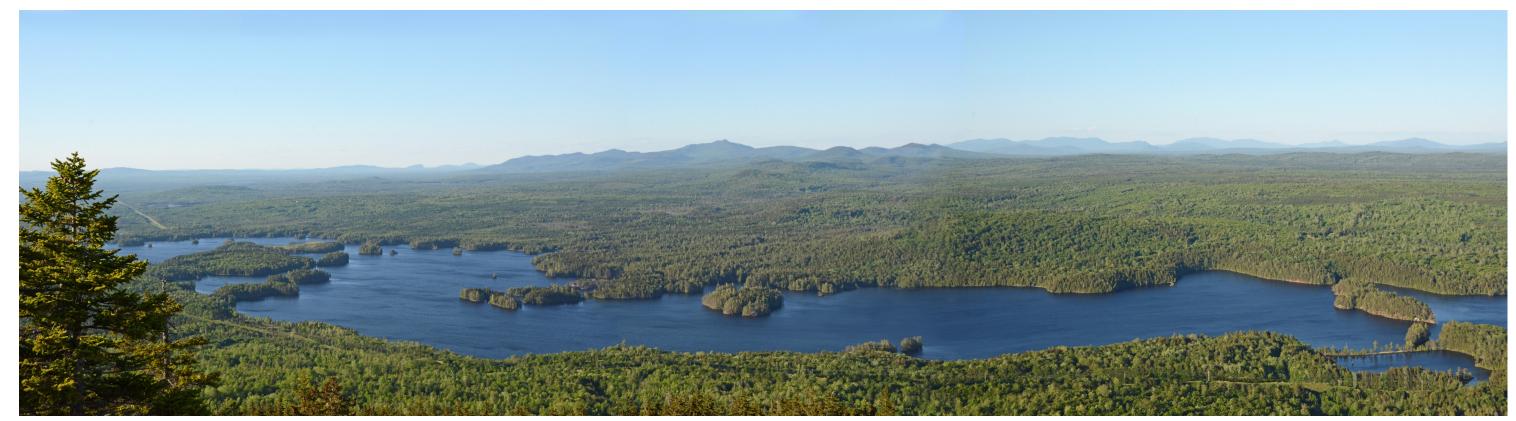
PHOTOSIMULATION 16: MOSQUITO MOUNTAIN - Overlook Looking Northeast, The Forks PLT

Proposed Conditions: Panoramic view looking north to east from the eastern overlook on Mosquito Mountain toward the proposed co-located HVDC transmission line. The existing 150' wide transmission line corridor clearing will be widened by 75' on the western side to accommodate the proposed HVDC transmission line. Seven structures and conductors will be visible within three miles of this viewpoint. Big Moose Mountain is visible in the center of the image with Black Narrows on the right side of the image. Moxie Pond is visible across the entire image. See Appendix B: Study Area Photographs for additional images.

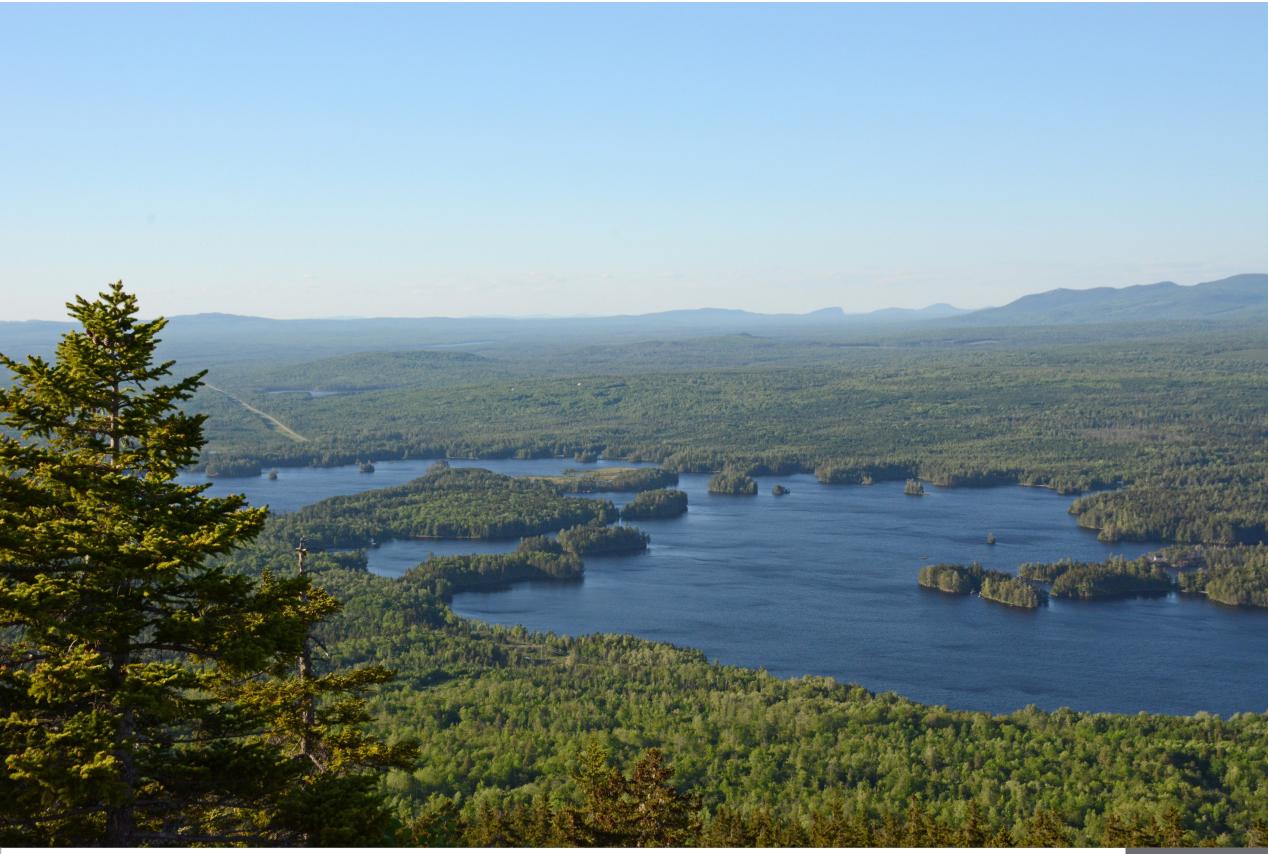
PHOTOSIMULATION 16A: MOSQUITO MOUNTAIN - Overlook Looking Northeast, The Forks PLT

Existing Conditions: Normal view looking north from Mosquito Mountain towards the existing 115 kV transmission line and the northern end of Moxie Pond. The existing transmission line corridor and Indian Pond Road to Harris Dam are visible on the left side of the image, north of Moxie Pond.

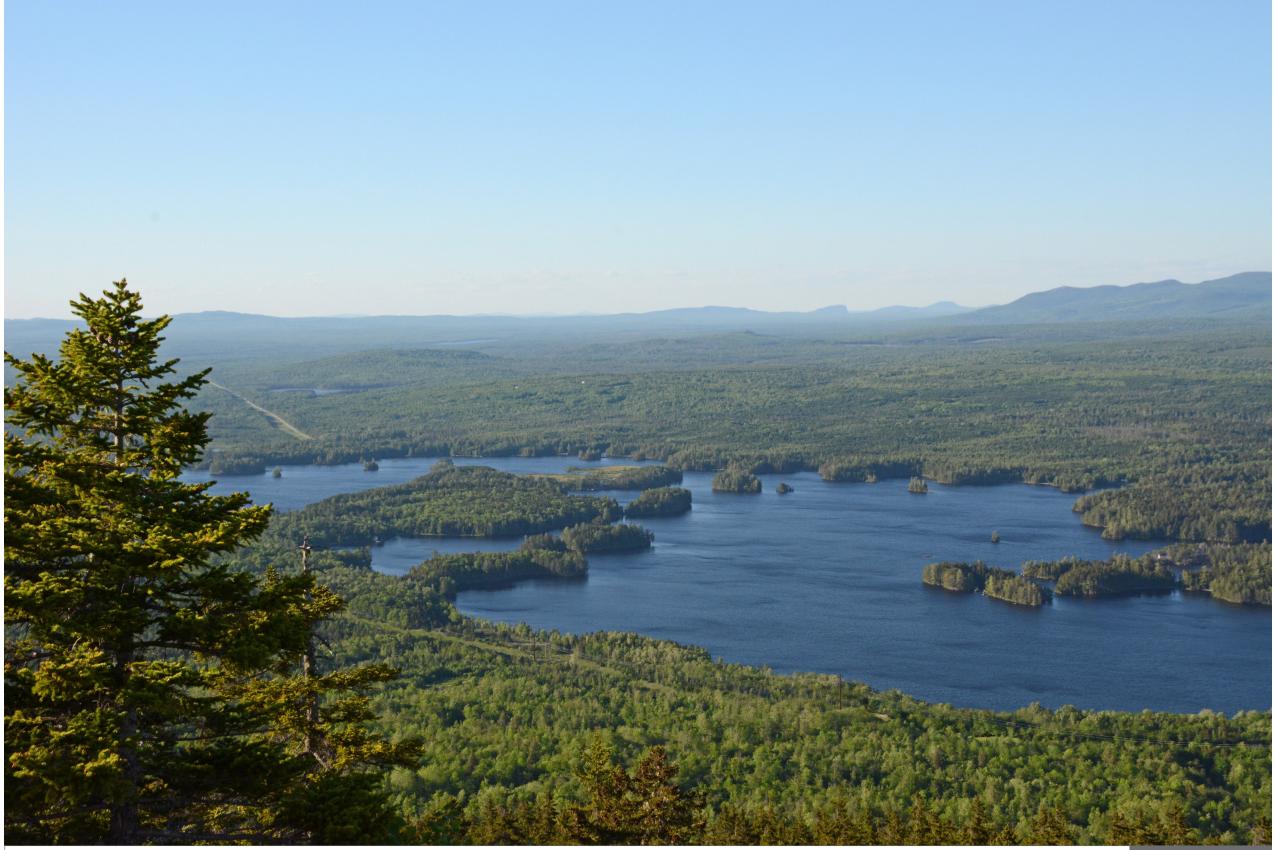
PHOTOSIMULATION 16A: MOSQUITO MOUNTAIN - Overlook Looking Northeast, The Forks PLT

Proposed Conditions: Normal view looking north from Mosquito Mountain toward the proposed co-located HVDC transmission line. The existing 150' wide transmission line corridor clearing will be widened by 75' on the western side to accommodate the proposed co-located HVDC transmission line. Three structures and conductors will be visible from this viewpoint at distances of 0.9 to 1.3 miles.

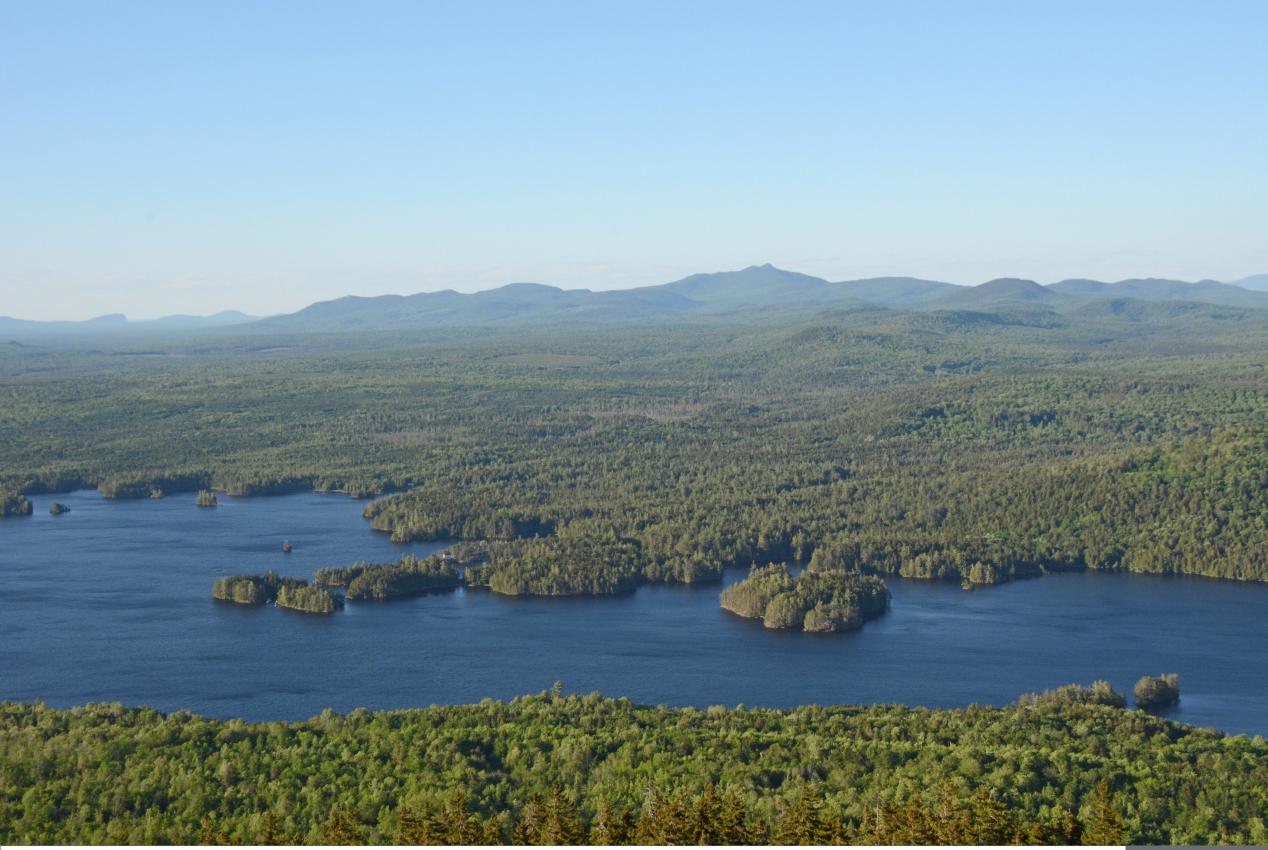
PHOTOSIMULATION 16B: MOSQUITO MOUNTAIN - Overlook Looking Northeast, The Forks PLT

Existing Conditions: Normal view looking northeast from Mosquito Mountain. Burnt Jacket Island in Moxie Pond is visible right of center in image. The existing 115 kV transmission line is mostly screened by vegetation in this view.

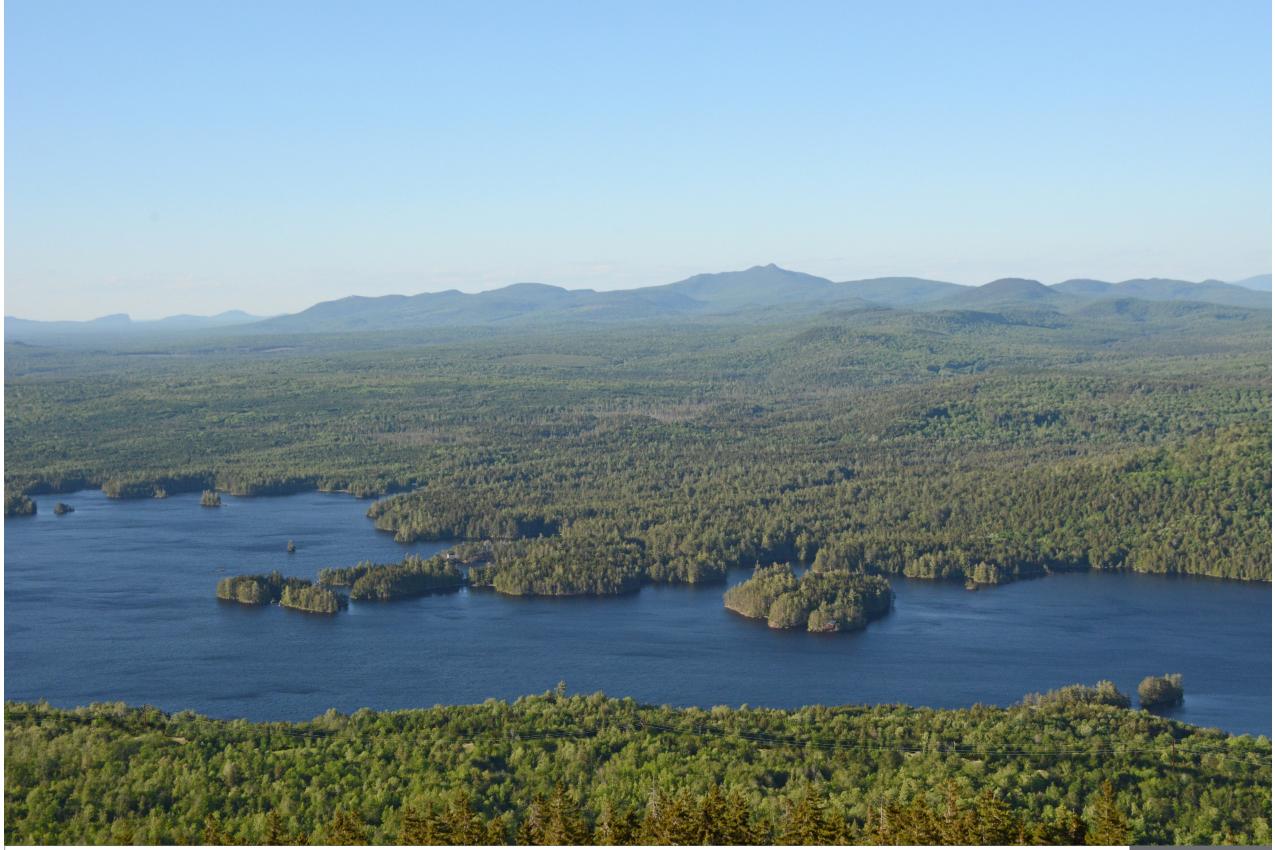
PHOTOSIMULATION 16B: MOSQUITO MOUNTAIN - Overlook Looking Northeast, The Forks PLT

Proposed Conditions: Normal view looking northeast from Mosquito Mountain toward the proposed co-located HVDC transmission line. The existing 150' wide transmission line corridor clearing will be widened by 75' on the western side to accommodate the proposed Co-located HVDC transmission line. Three structures and conductors will be visible from this viewpoint at distances of 0.7 to 0.9 miles.

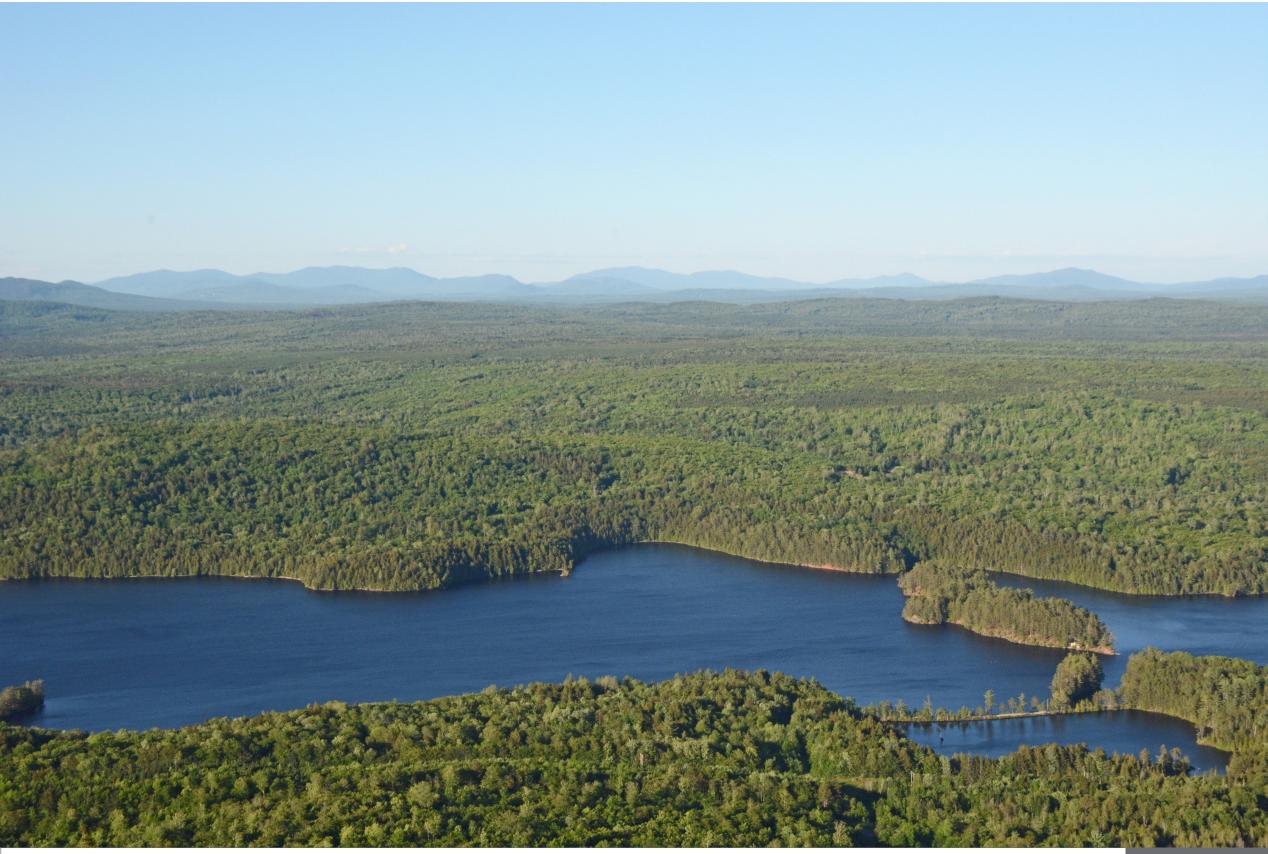
PHOTOSIMULATION 16C: MOSQUITO MOUNTAIN - Overlook Looking Northeast, The Forks PLT

Existing Conditions: Normal view looking east from Mosquito Mountain. Moxie Pond is visible across the entire image with Black Narrows on right in image. The existing 115 kV transmission line and Troutdale Road are visible

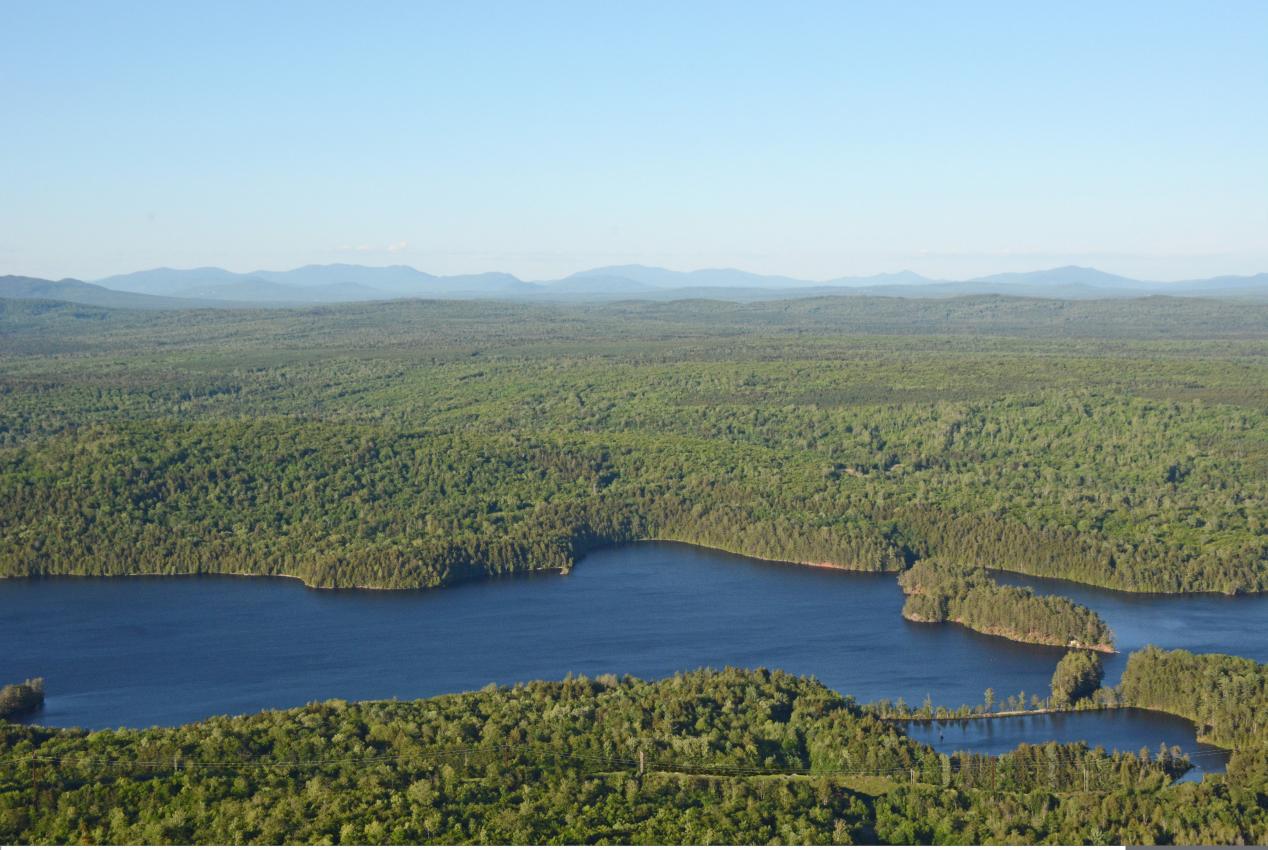
PHOTOSIMULATION 16C: MOSQUITO MOUNTAIN - Overlook Looking Northeast, The Forks PLT

Proposed Conditions: Normal view looking east from Mosquito Mountain toward the proposed co-located HVDC transmission line. The existing 150' wide transmission line corridor clearing will be widened by 75' on the western side to accommodate the proposed co-located HVDC transmission line. Three structures and conductors will be visible from this viewpoint at distances of 0.7 to 0.75 miles.

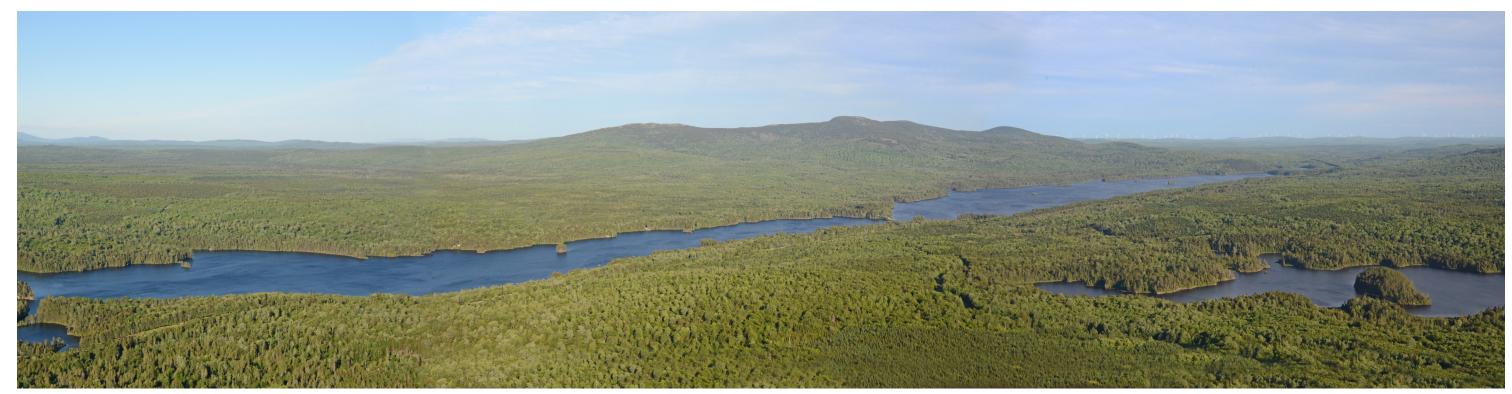
PHOTOSIMULATION 17: MOSQUITO MOUNTAIN - Looking Southeast, The Forks Plt

Proposed Conditions: Continued panoramic view looking from east to south from the eastern overlook of Mosquito Mountain toward the proposed co-located HVDC transmission line (see Photosimulation 17 for view to northeast). The existing 150' wide transmission line corridor clearing will be widened by 75' on the western side to accommodate the proposed HVDC transmission line. Bald Mountain is visible in the center of the image. Mosquito Pond is visible on the right side of the image. Moxie Pond, from Black Narrows to the Southern end, is visible across the entire image. The Bingham Wind Project is visible to the east at 14.5 miles. Up to 13 structures, conductors, and portions of the cleared corridor will be visible from within 3 miles from this viewpoint. See Appendix B: Study Area Photographs for additional images.

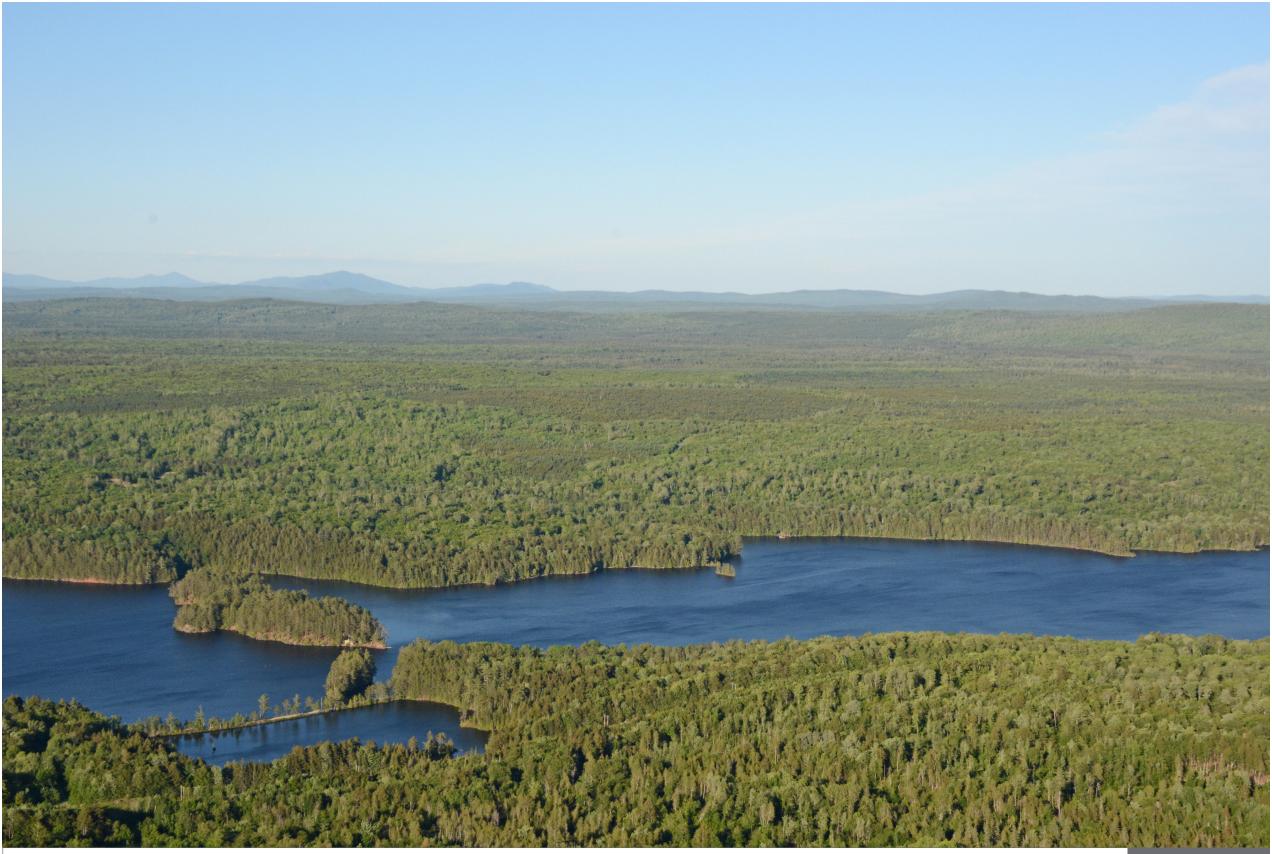
PHOTOSIMULATION 17A: MOSQUITO MOUNTAIN - Looking Southeast, The Forks Plt

Existing Conditions: Normal view looking east from Mosquito Mountain. Black Narrows in Moxie Pond is visible on the left side of the image. The existing 115 kV transmission line and Troutdale Road are visible

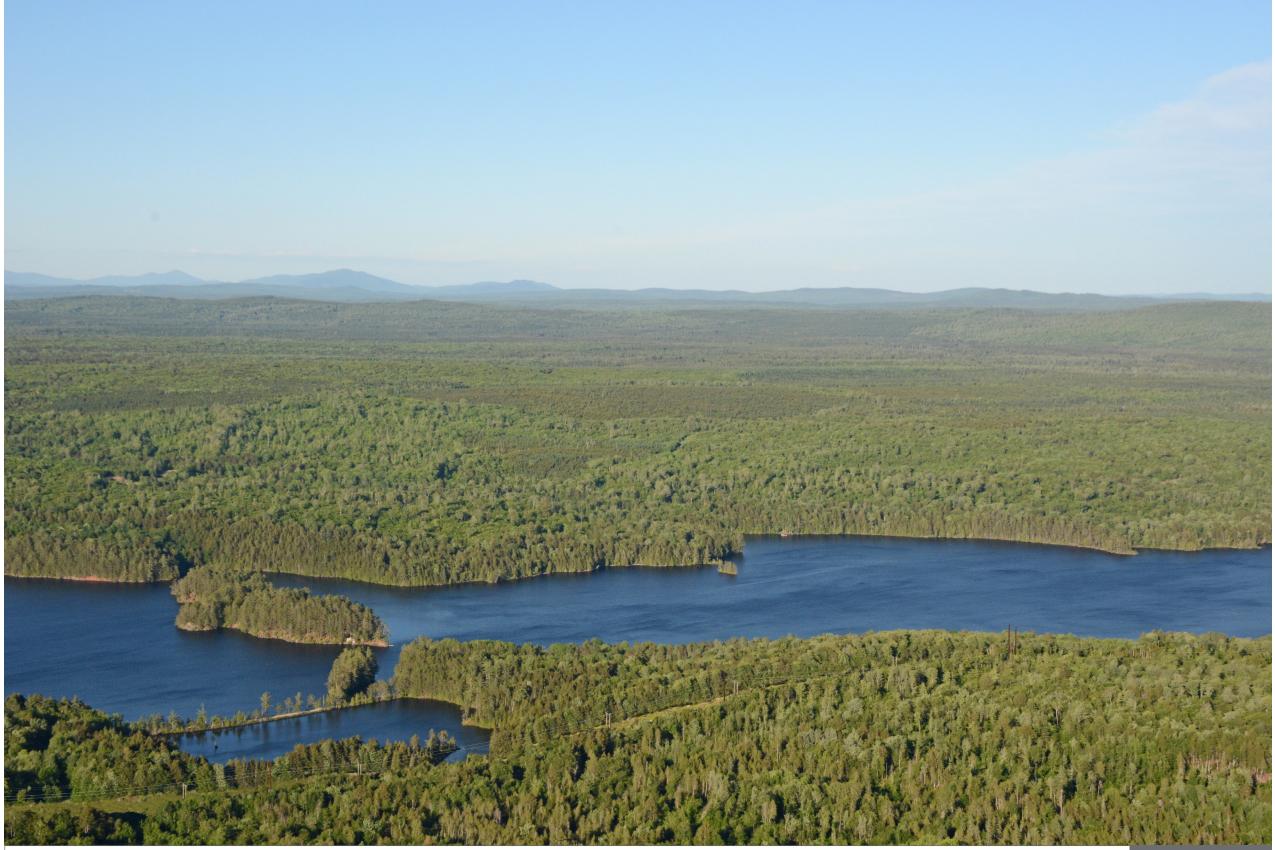
PHOTOSIMULATION 17A: MOSQUITO MOUNTAIN - Looking Southeast, The Forks Plt

Proposed Conditions: Normal view looking south from Mosquito Mountain toward the proposed co-located HVDC transmission line. The existing 150' wide transmission line corridor clearing will be widened by 75' on the western side to accommodate the proposed HVDC transmission line. Bald Mountain is visible in the center of the image. Mosquito Pond is visible on the right side of the image. Moxie Pond is visible across the entire image. The Bingham Wind Project is visible to the east. Three proposed structures and conductors will be visible at distances of 0.75 - 1.0 miles from this viewpoint.
