PHOTOSIMULATION 13: MOXIE POND - North, East Moxie Twp

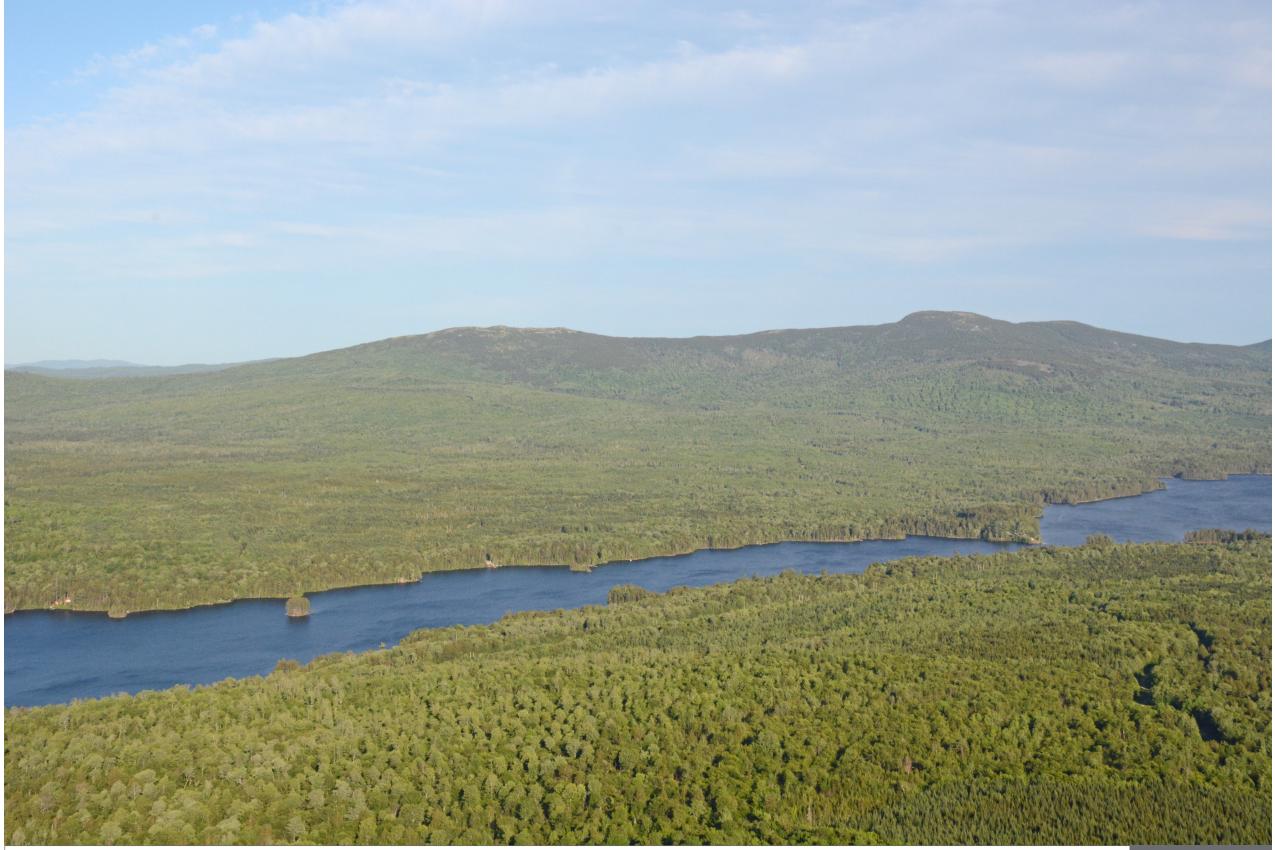
PHOTOSIMULATION 17B: MOSQUITO MOUNTAIN - Looking Southeast, The Forks Plt

Existing Conditions: Normal view looking east from Mosquito Mountain. Bald Mountain North Peak is visible on the left side of the image, and Bald Mountain is visible on the right side of the image. Moxie Pond is visible across the entire image, with Mosquito Narrows on right in image.

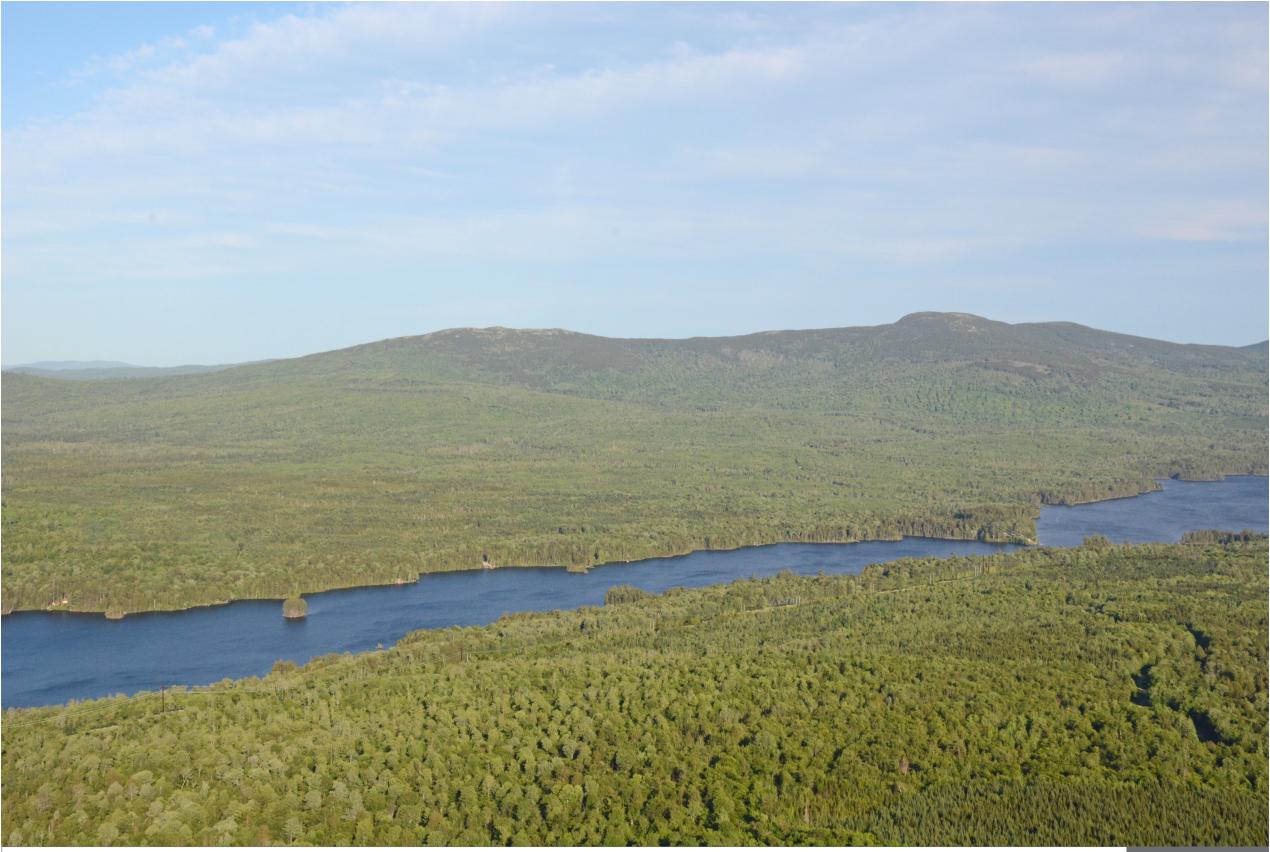
PHOTOSIMULATION 17B: MOSQUITO MOUNTAIN - Overlook Looking Southeast, The Forks Plt

Proposed Conditions: Normal view looking southeast from Mosquito Mountain toward the proposed co-located HVDC transmission line. The existing 150' wide transmission line corridor clearing will be widened by 75' on the western side to accommodate the proposed HVDC transmission line. Six structures, conductors and portions of the cleared corridor will be visible at distances of 1.1 to 1.8 miles.

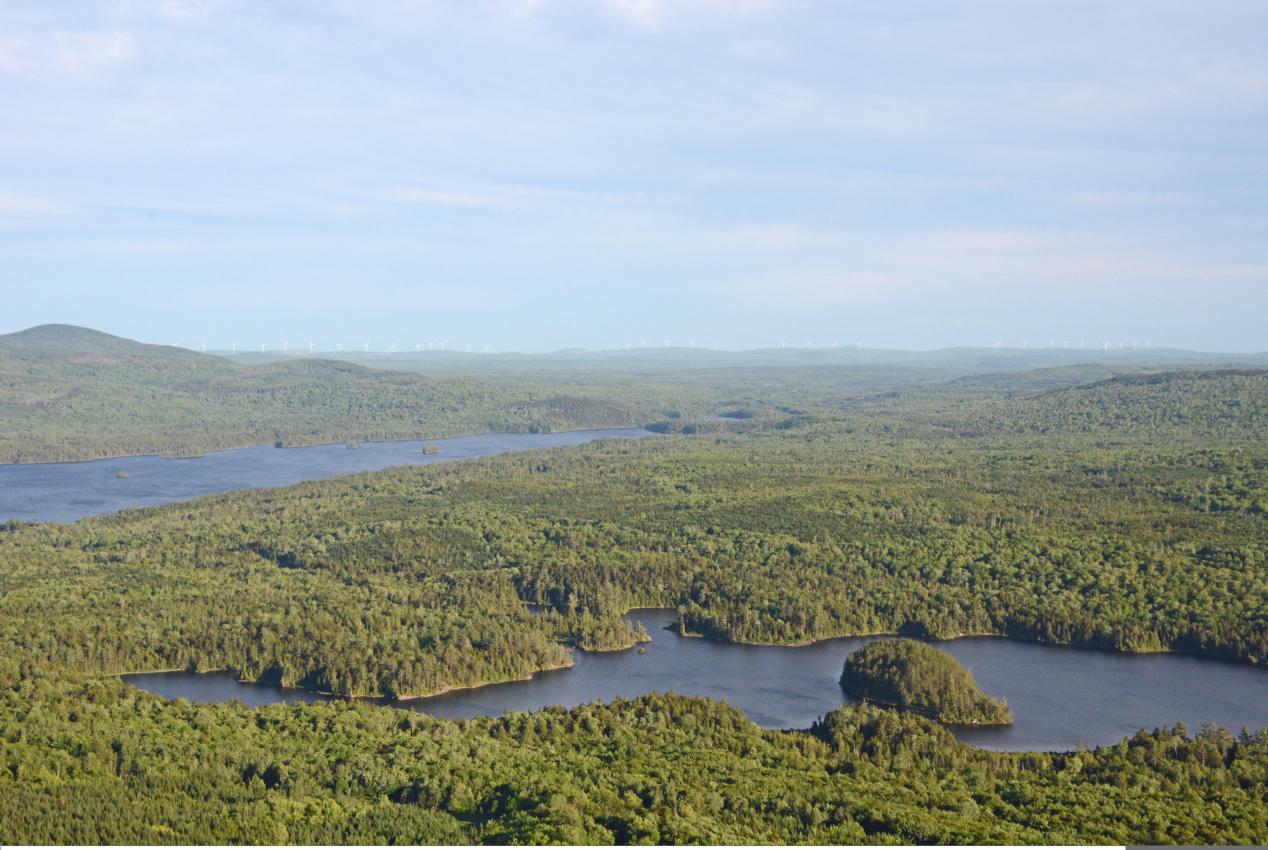
PHOTOSIMULATION 17C: MOSQUITO MOUNTAIN - Looking Southeast, The Forks Plt

Existing Conditions: Normal view looking southeast from Mosquito Mountain . Bald Mountain is visible on the left side of the image. The southern Moxie Pond is visible across the middle of image and Mosquito Pond is visible below in foreground. The Bingham Wind Project is visible 14.5 to 16.6 miles to the southeast.

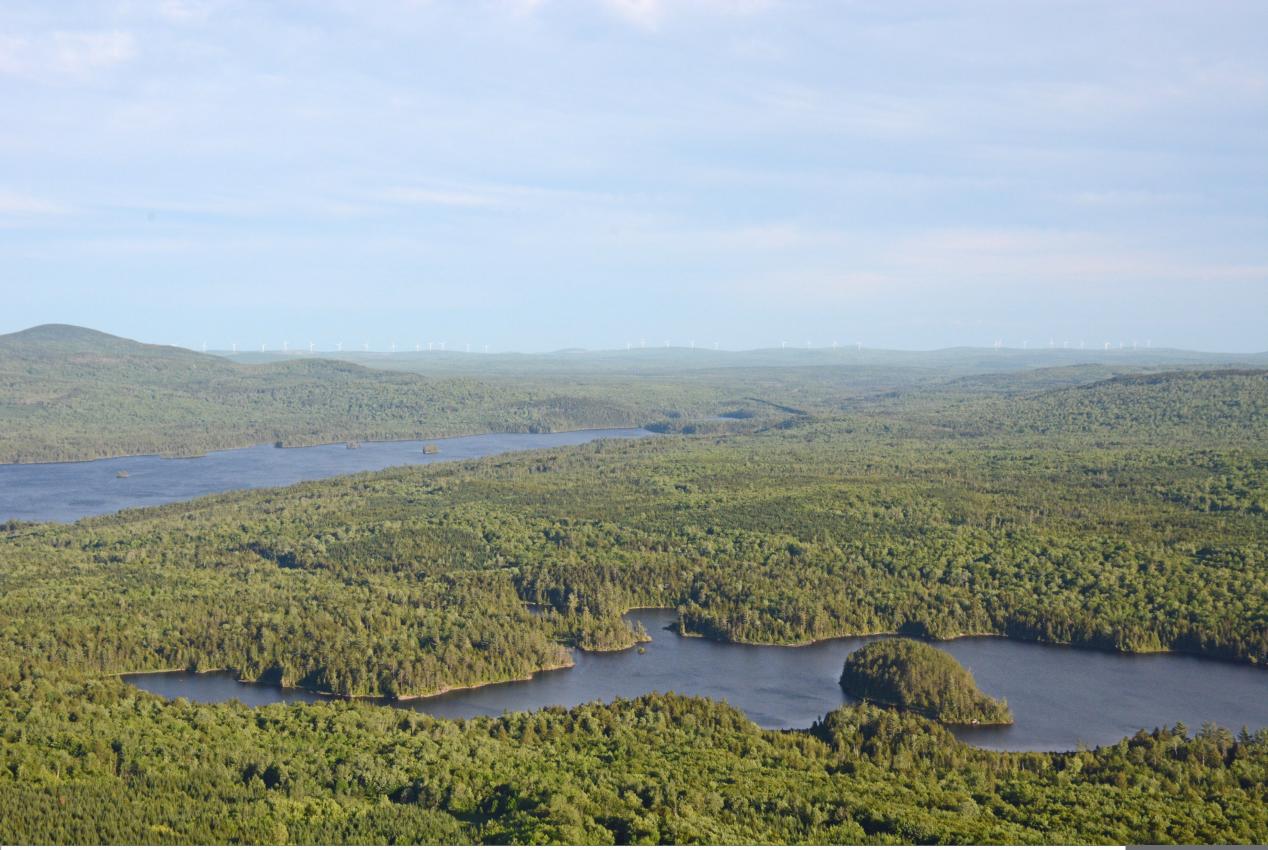
PHOTOSIMULATION 17C: MOSQUITO MOUNTAIN - Looking Southeast, The Forks Plt

Proposed Conditions: Normal view looking southeast from Mosquito Mountain toward the proposed transmission line. The existing 150' wide transmission line corridor clearing will be widened by 75' on the western side to accommodate the proposed HVDC transmission line. Six structures and conductors and portions of the cleared corridor will be visible within three miles.

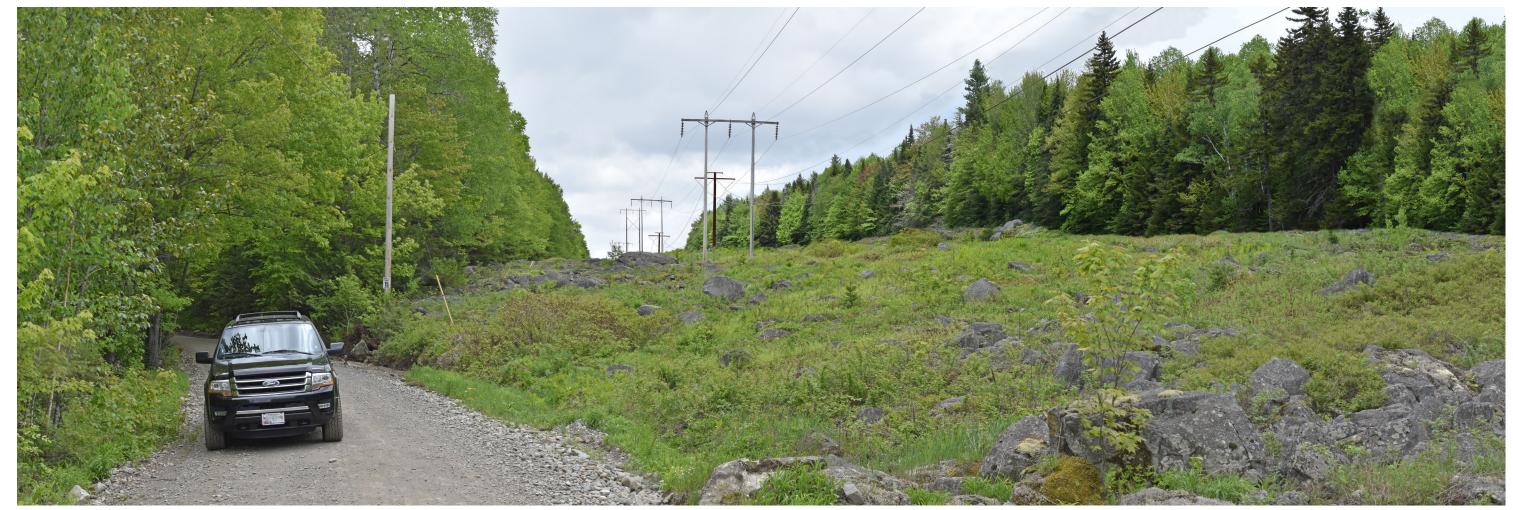
PHOTOSIMULATION 18:TROUTDALE ROAD, The Forks Plt.

Proposed Conditions: Panoramic view looking southeast to south from Troutdale Road in The Forks Plt. toward the proposed co-located HVDC transmission line. Troutdale Road is located within the existing 115 kV transmission line corridor for approximately 1,000 feet. The existing 150' wide corridor clearing will be widened by 75' on the western side to accommodate the new transmission structures will be visible looking to the southeast, and four looking to the northwest. See Appendix B: Study Area Photographs for additional images.

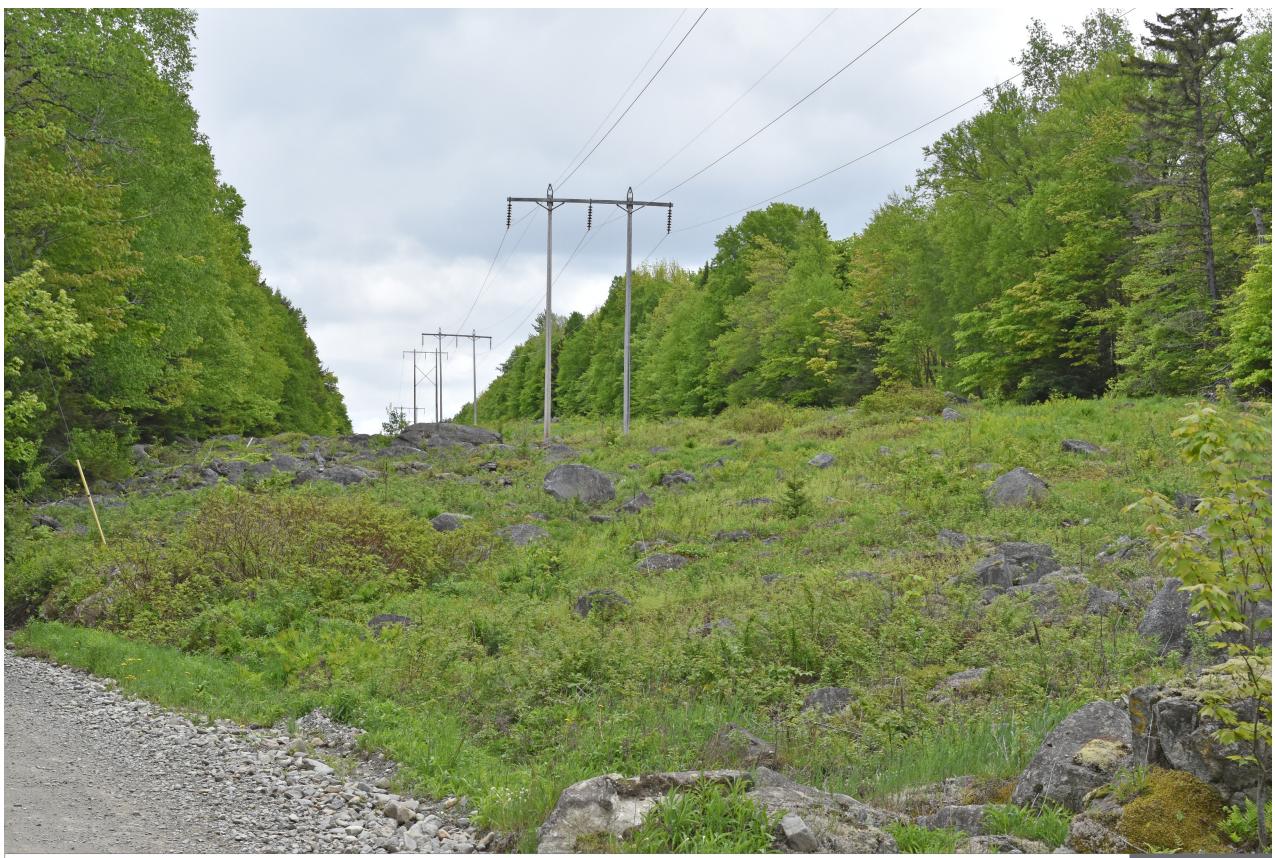
PHOTOSIMULATION 18A:TROUTDALE ROAD, The Forks Plt

Existing Conditions: Normal view looking southeast from Troutdale Road toward the existing 115 kV transmission line within a 150' wide cleared corridor.

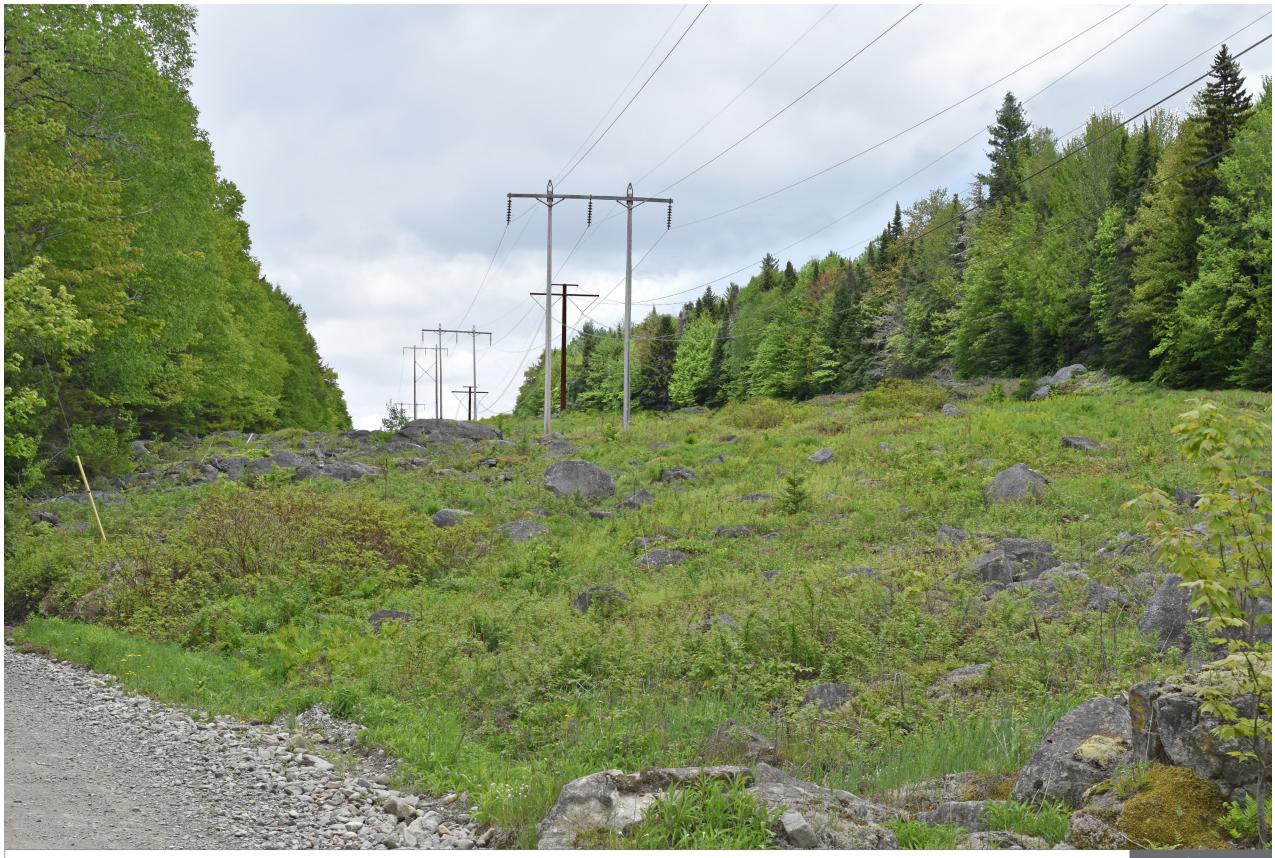
PHOTOSIMULATION 18A:TROUTDALE ROAD, The Forks Plt

Proposed Conditions: Normal view looking southeast from Troutdale Road toward the proposed co-located HVDC transmission line. The existing 150' wide corridor clearing will be widened by 75' on the western side to accommodate the new transmission line. Two HVDC transmission structures will be visible looking to the southeast.

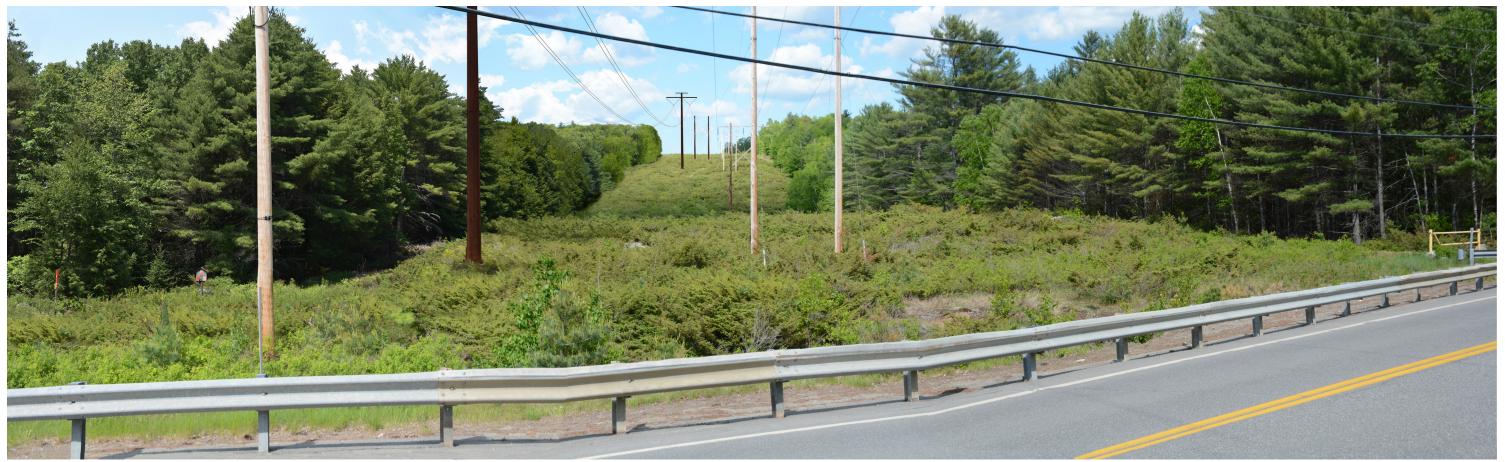
PHOTOSIMULATION 19: ROUTE 201, Moscow

Proposed Conditions: Panoramic view looking from northeast to east from Route 201 in Moscow toward the proposed co-located HVDC transmission line. The Wyman Hydro Electric Facility is visible in the opposite direction of this viewpoint. The existing 225' wide corridor clearing will be widened by 75' on the western side (left of corridor in image) to accommodate the proposed HVDC transmission line. Three structures will be visible from this viewpoint. See Appendix B: Study Area Photographs for additional images.

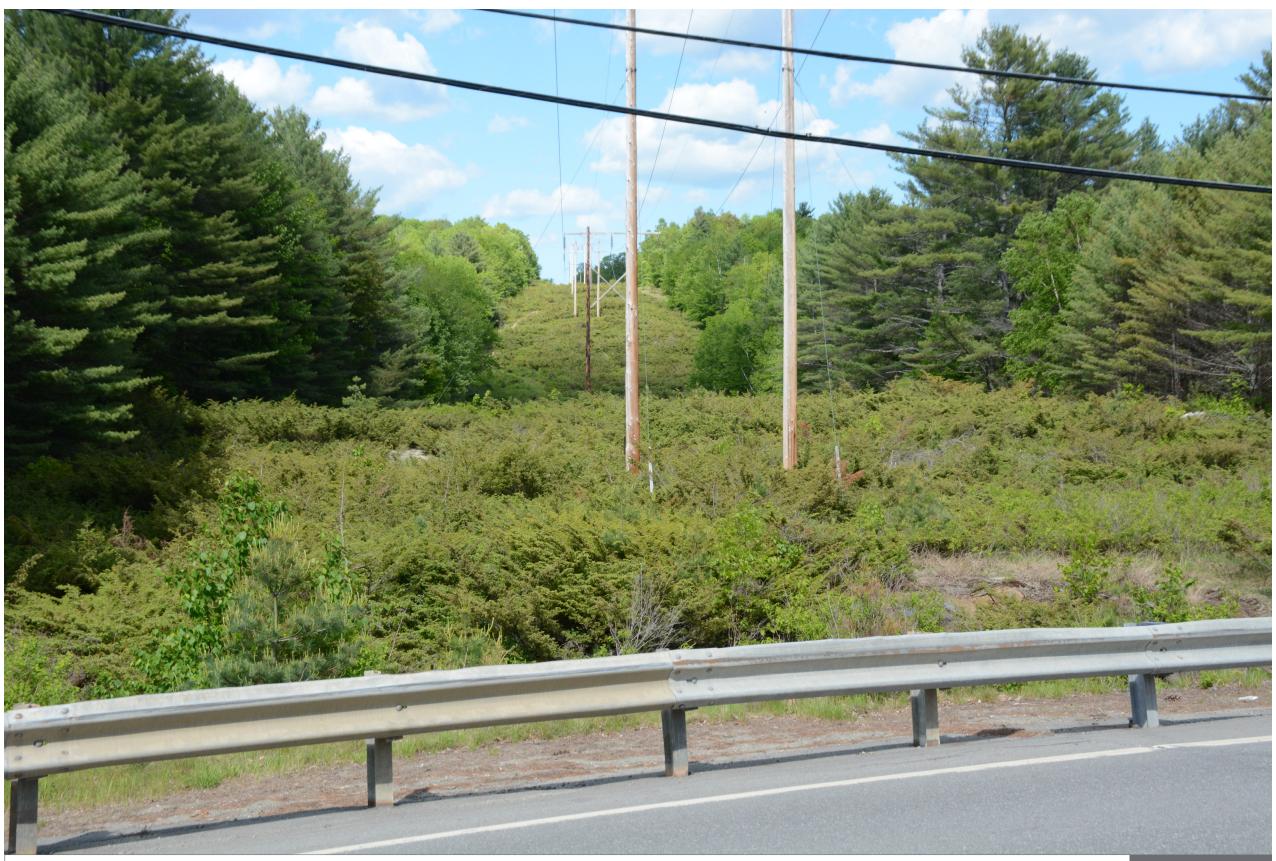
PHOTOSIMULATION 19A: ROUTE 201, Moscow

Existing Conditions: Normal view looking east from Route 201 toward the existing 115 kV transmission line corridor.

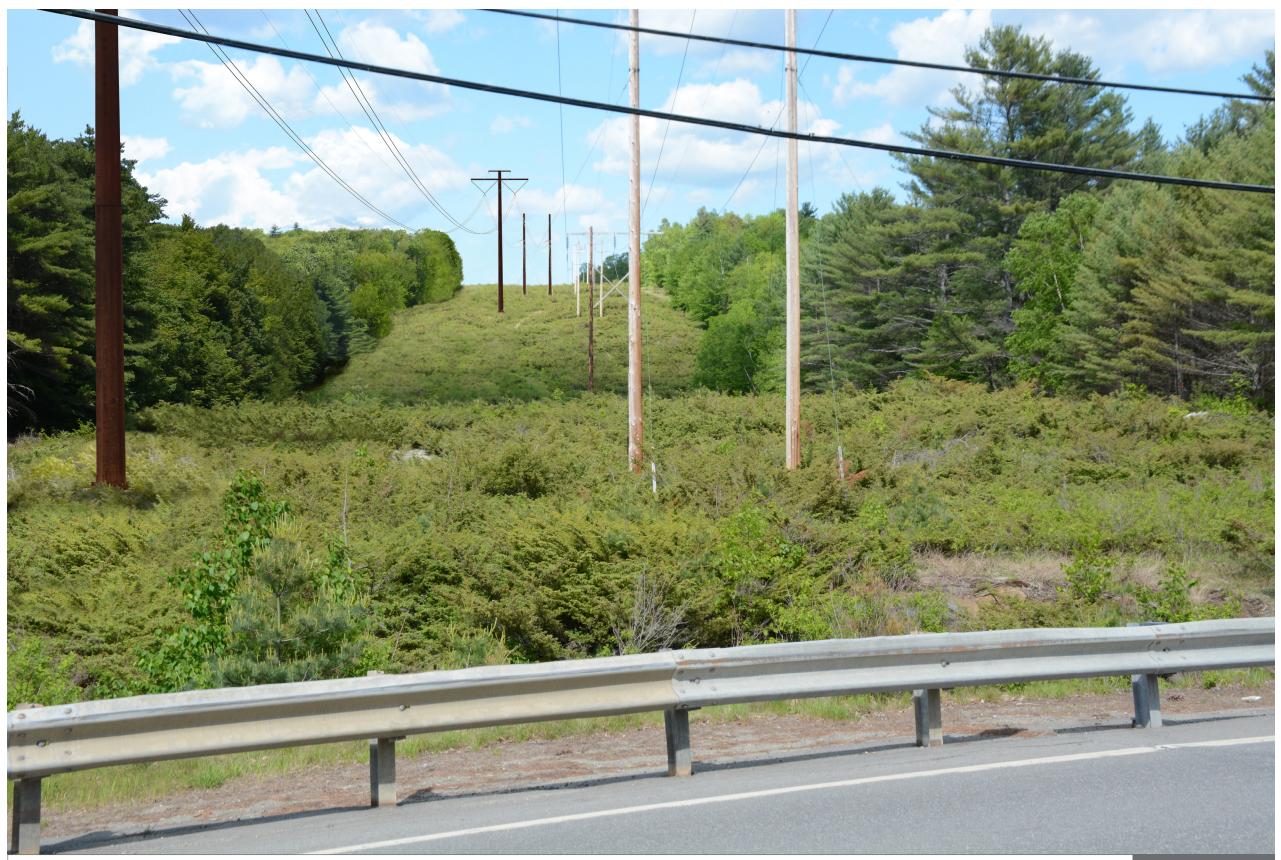
PHOTOSIMULATION 19A: ROUTE 201, Moscow

Proposed Conditions: Normal view looking east from Route 201 in Moscow toward the proposed co-located HVDC transmission line. The existing 225' wide corridor clearing will be widened by 75' on the western side (left of corridor in image) to accommodate the proposed HVDC transmission line. Three structures will be visible from this viewpoint.

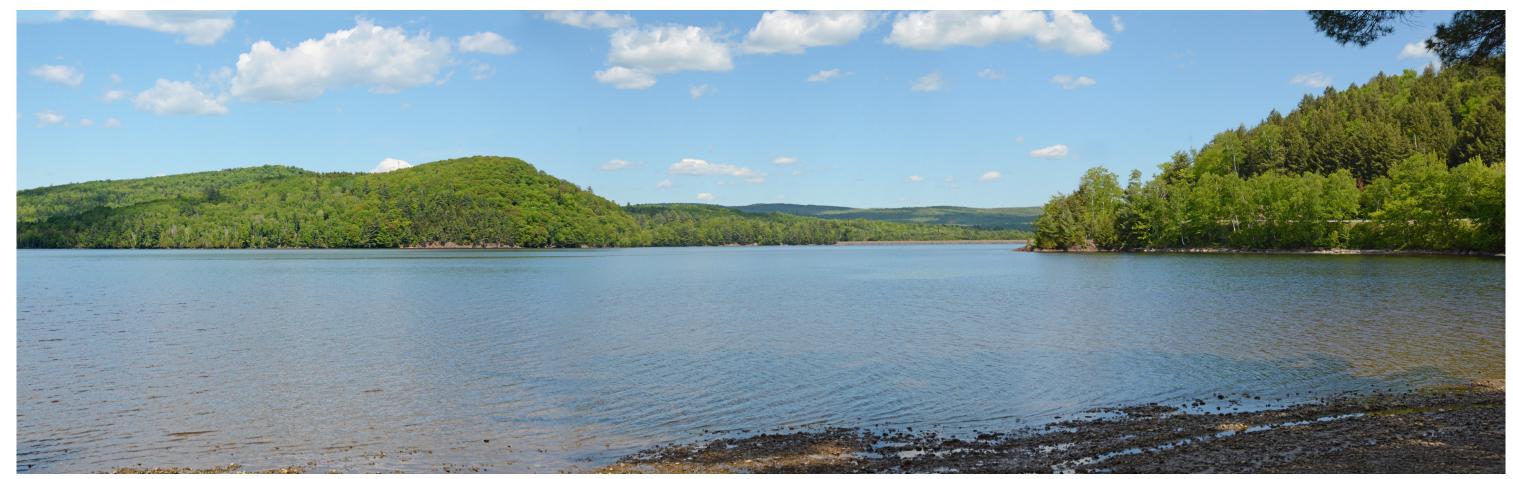
PHOTOSIMULATION 20: WYMAN LAKE RECREATION AREA, Pleasant Ridge Plt

Proposed Conditions: Panoramic view looking from northeast to southeast from the Wyman Lake Recreation Area toward the proposed co-located HVDC transmission line. The proposed HVDC transmission line would be visible adjacent to the existing 115 kV transmission line and seen in context with the Wyman Hydro Dam and portions of six Bingham Wind turbines. Three HVDC transmission structures and conductors will be visible at distances of 0.9 - 1.3 miles from this viewpoint. See Appendix B: Study Area Photographs for additional images.

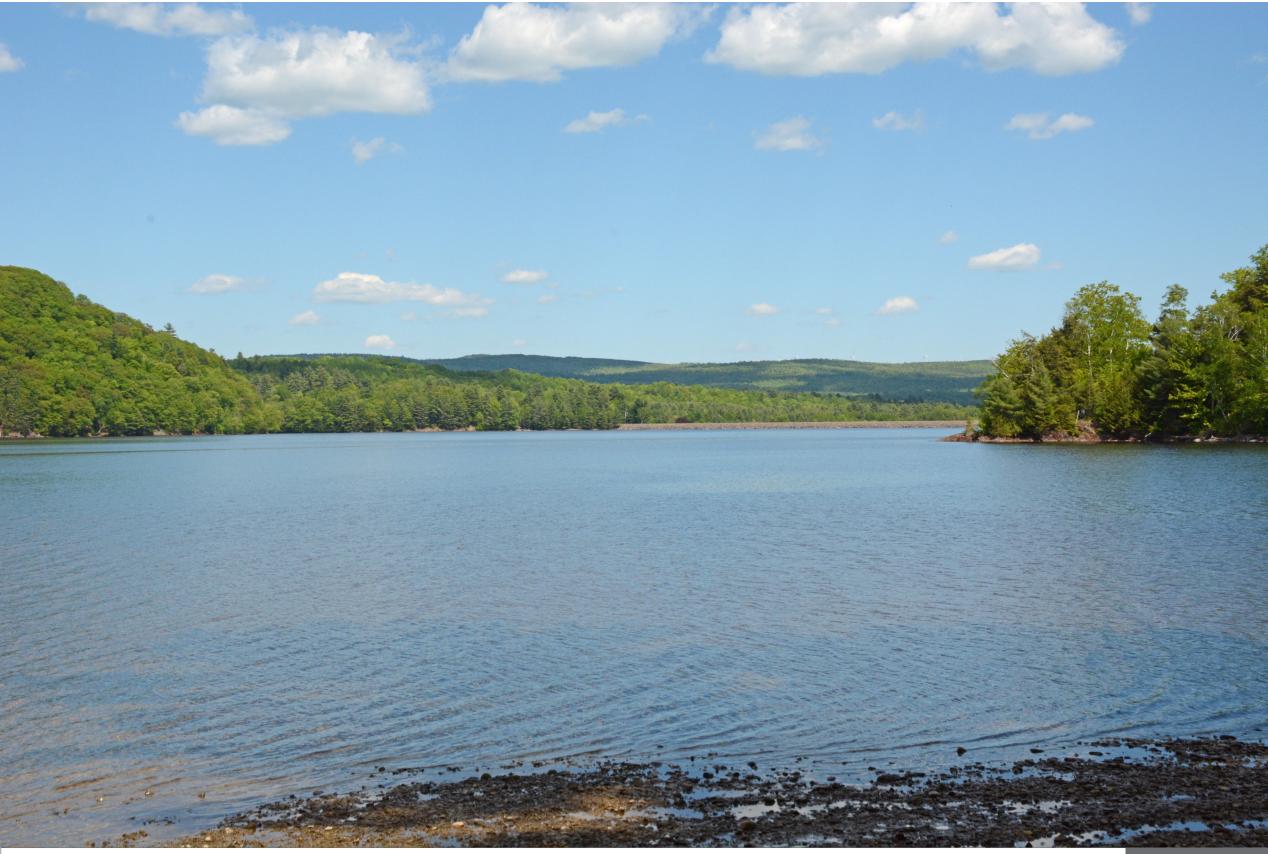
PHOTOSIMULATION 20A:WYMAN LAKE RECREATION AREA, Pleasant Ridge Plt

Existing Conditions: Normal view looking east from the Wyman Lake Recreation Area towards the Wyman Hydro Dam.

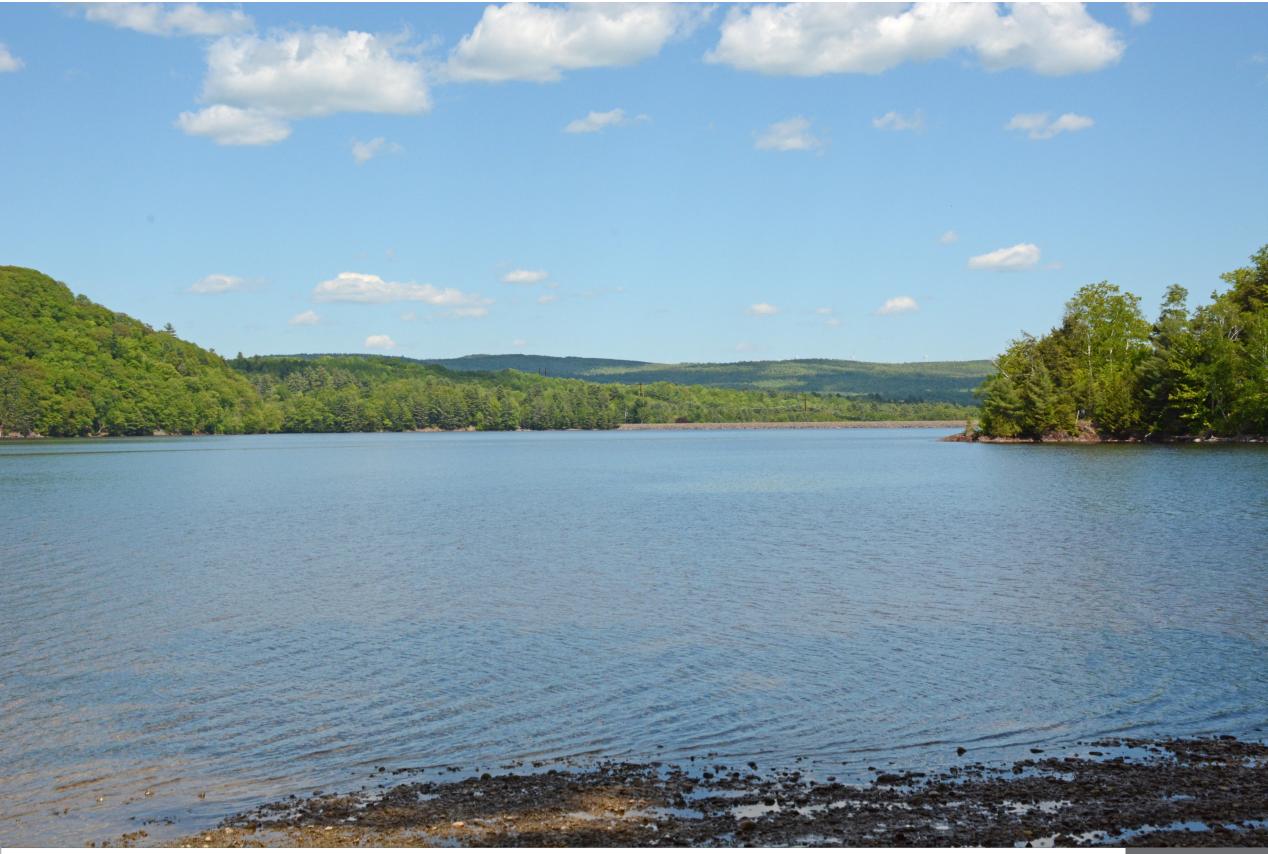
PHOTOSIMULATION 20A: WYMAN LAKE REST AREA, Pleasant Ridge Plt

Proposed Conditions: Normal view looking east from the Wyman Lake Recreation Area toward the proposed co-located HVDC transmission line. The proposed HVDC transmission line would be visible adjacent to the existing 115 kv transmission line and seen in context with the Wyman Hydro Dam and portions of six Bingham Wind turbines. Three structures, conductors, and portions of the cleared corridor will be visible at distances of 0.9 - 1.3 miles from this viewpoint.

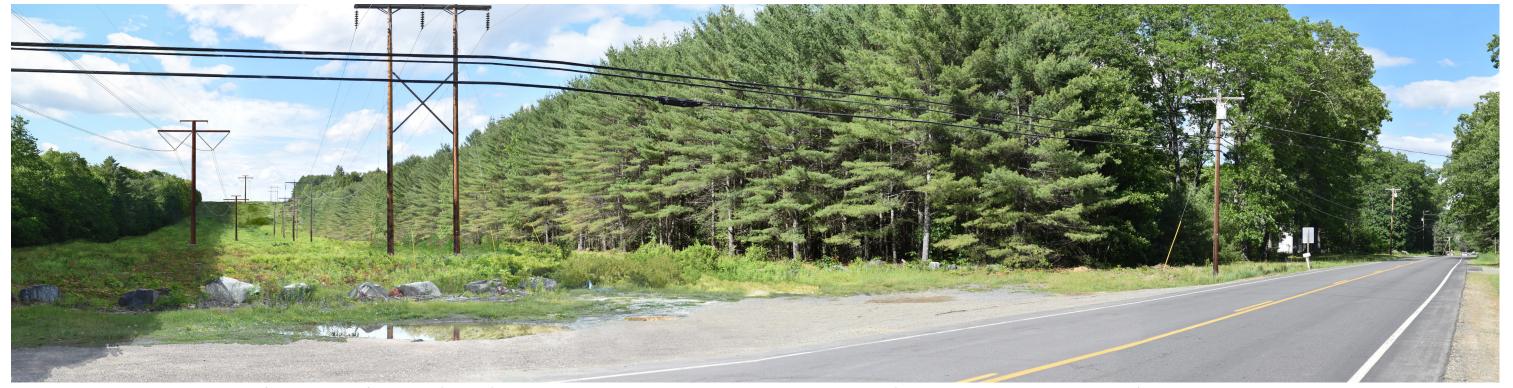
PHOTOSIMULATION 21: ROUTE 8, Anson

Proposed Conditions: Panoramic view looking from north to east from Route 8 (Solon Rd) toward the proposed co-located HVDC transmission line. The existing 150' wide cleared corridor will be widened by 75' on the western side to accommodate the HVDC transmission line. Three of the proposed HVDC structures and conductors will be visible from this viewpoint. See Appendix B: Study Area Photographs for additional images.

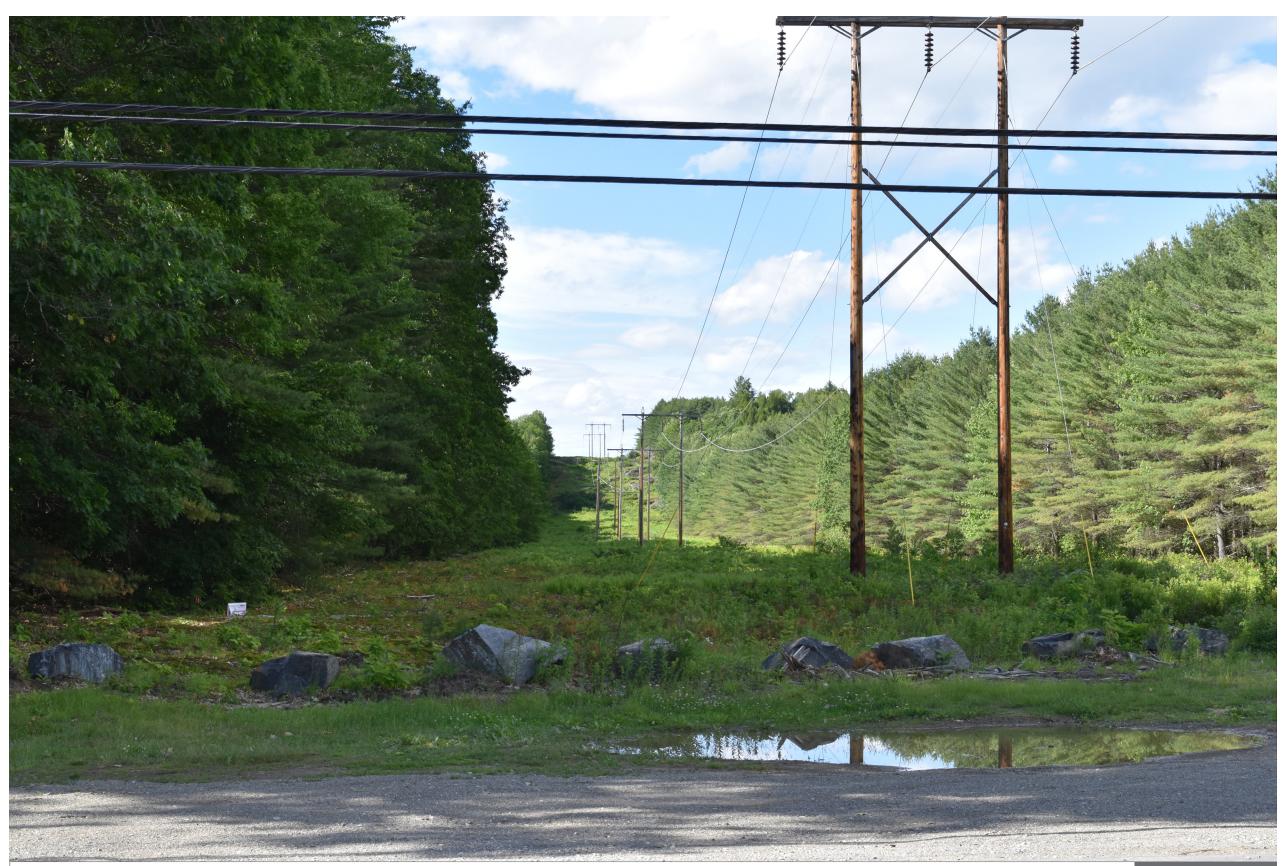
PHOTOSIMULATION 21A: ROUTE 8, Anson

Existing Conditions: Normal view looking north from Route 8 (Solon Rd) at the existing 115 kV transmission line.

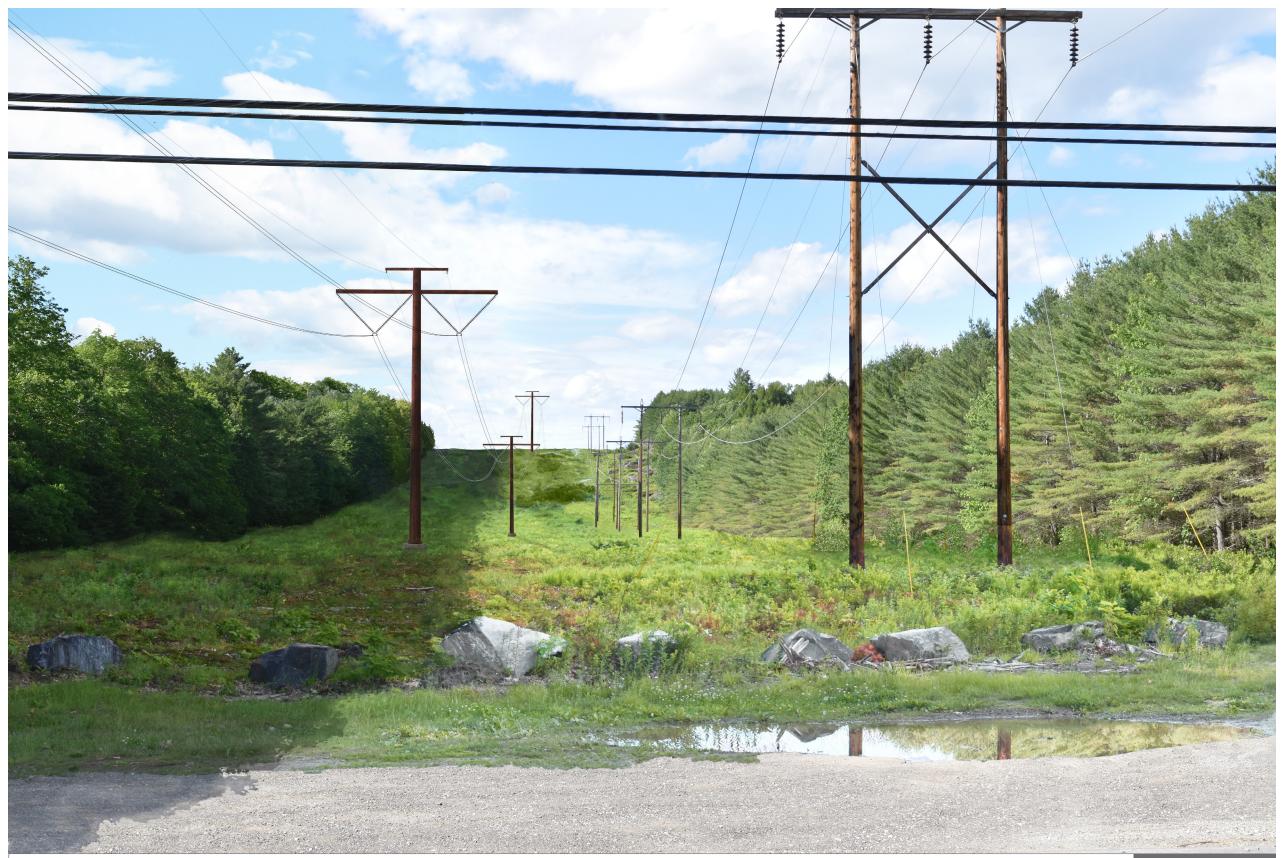
PHOTOSIMULATION 21A: ROUTE 8, Anson

Proposed Conditions: Normal view looking north from Route 8 (Solon Rd) toward the proposed co-located HVDC transmission line. The existing 150' wide cleared corridor will be widened by 75' on the western side to accommodate the proposed HVDC transmission line. Three of the proposed HVDC structures and conductors will be visible from this viewpoint.

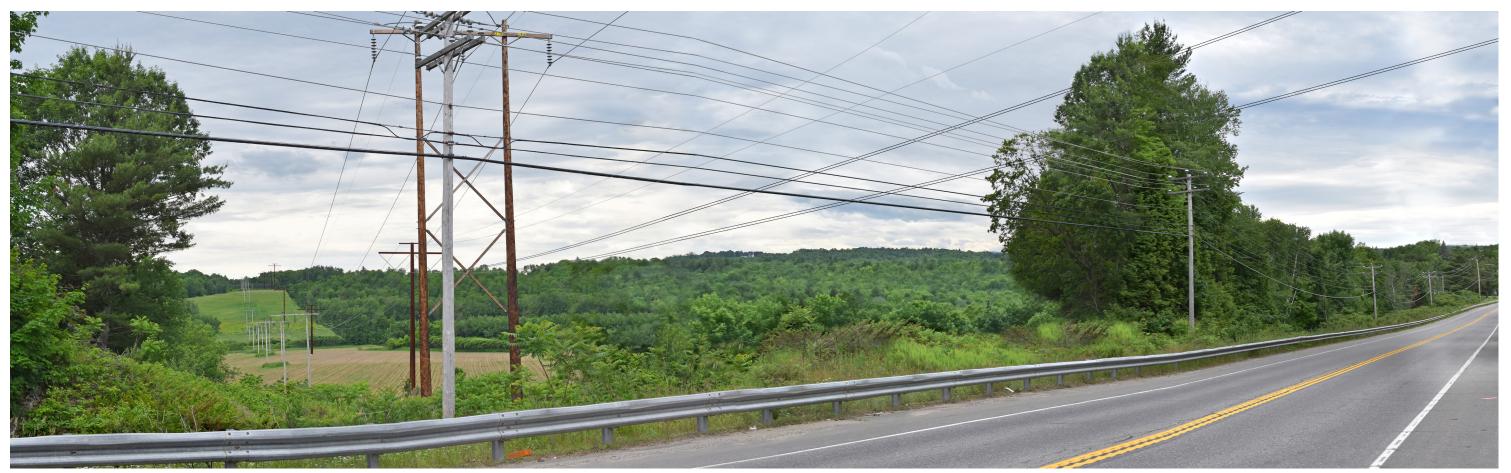
PHOTOSIMULATION 22: ROUTE 2, Farmington

Proposed Conditions: Panoramic view looking from south to west from Route 2 in Farmington toward the proposed co-located HVDC transmission line. The existing 225' wide cleared corridor will be widened by 75' on the western side to accommodate the proposed HVDC transmission line. Six of the proposed HVDC structures and conductors will be visible from this viewpoint.

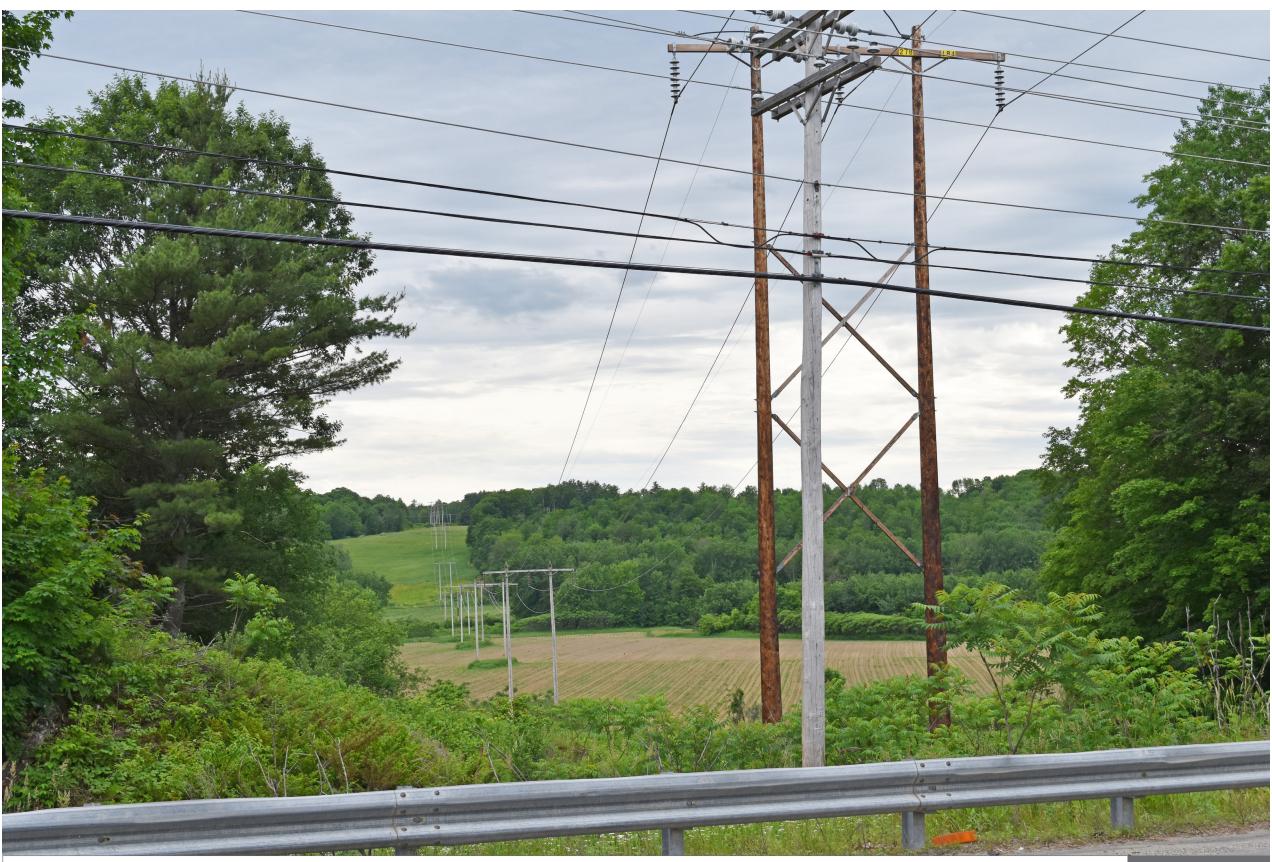
PHOTOSIMULATION 23A: ROUTE 2, Farmington

Existing Conditions: Normal view looking from southwest from Route 2 toward the existing 115 kV transmission line.

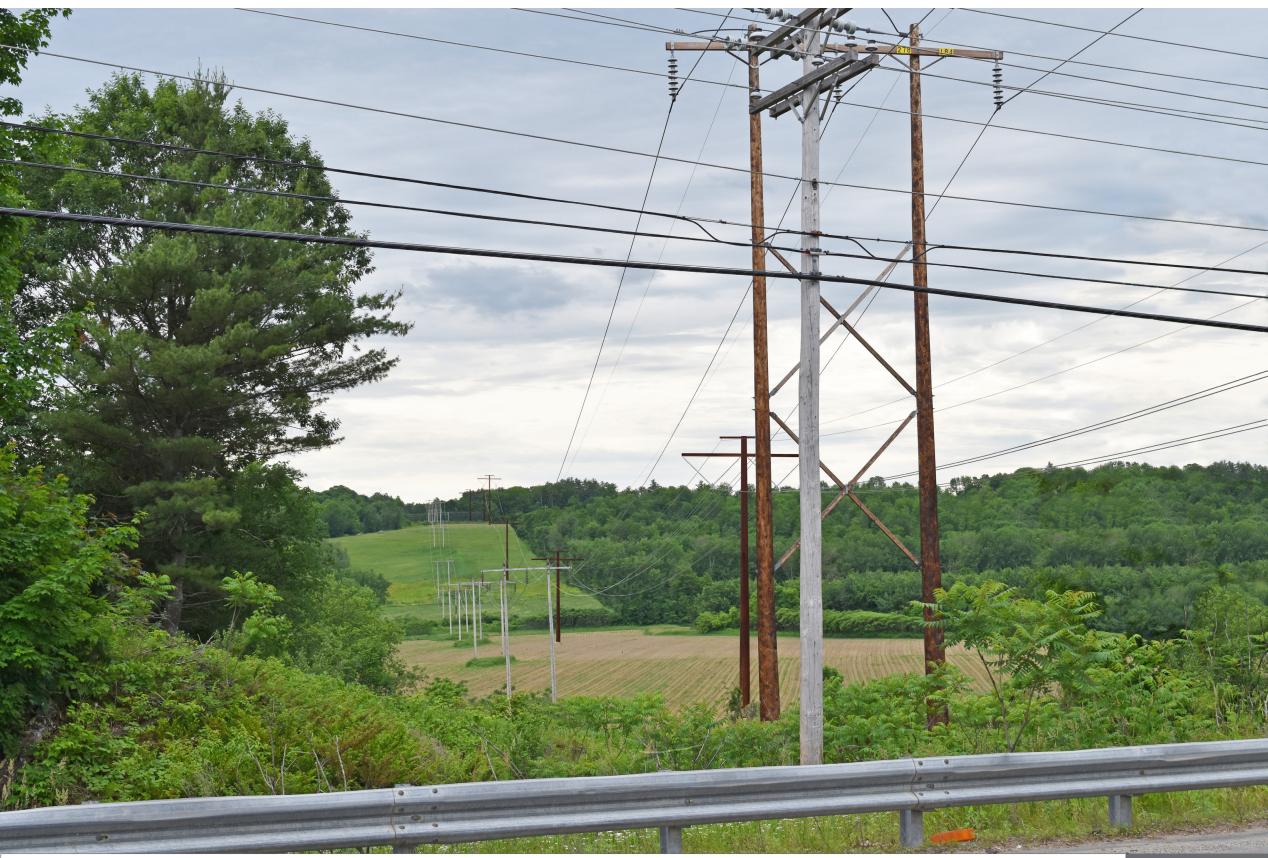
PHOTOSIMULATION 23A: ROUTE 2, Farmington

Proposed Conditions: Normal view looking from southwest from Route 2 toward the proposed co-located HVDC transmission line. The existing 225' wide cleared corridor will be widened by 75' on the western side to accommodate the new HVDC transmission line. Six of the proposed HVDC structures and conductors will be visible from this viewpoint.

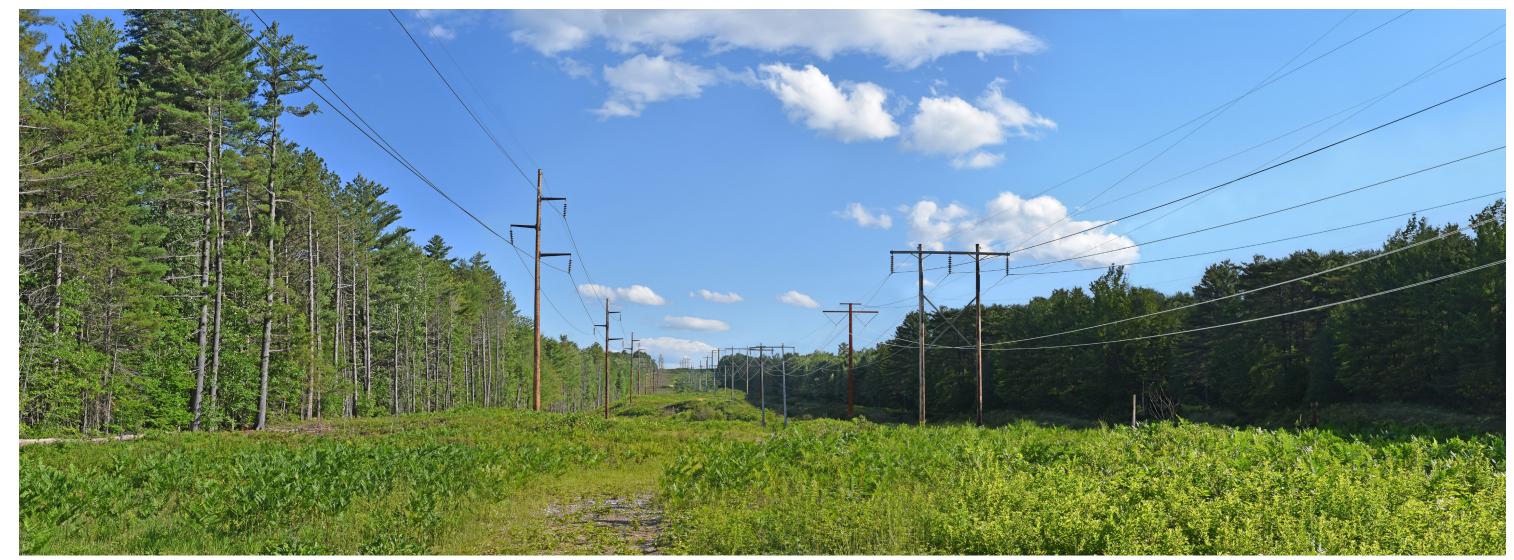
PHOTOSIMULATION 23: ANDROSCOGGIN RIVERLANDS STATE PARK, Existing Transmission Line, Leeds

Proposed Conditions: Panoramic view looking from southeast to southwest from an access road crossing the existing transmission line within the Androscoggin Riverlands State Park toward the proposed co-located HVDC transmission line. The existing 225' corridor clearing will be widened by 75' on the western side to accommodate the new transmission line. See Appendix B: Study Area Photographs for additional images of the State Park.

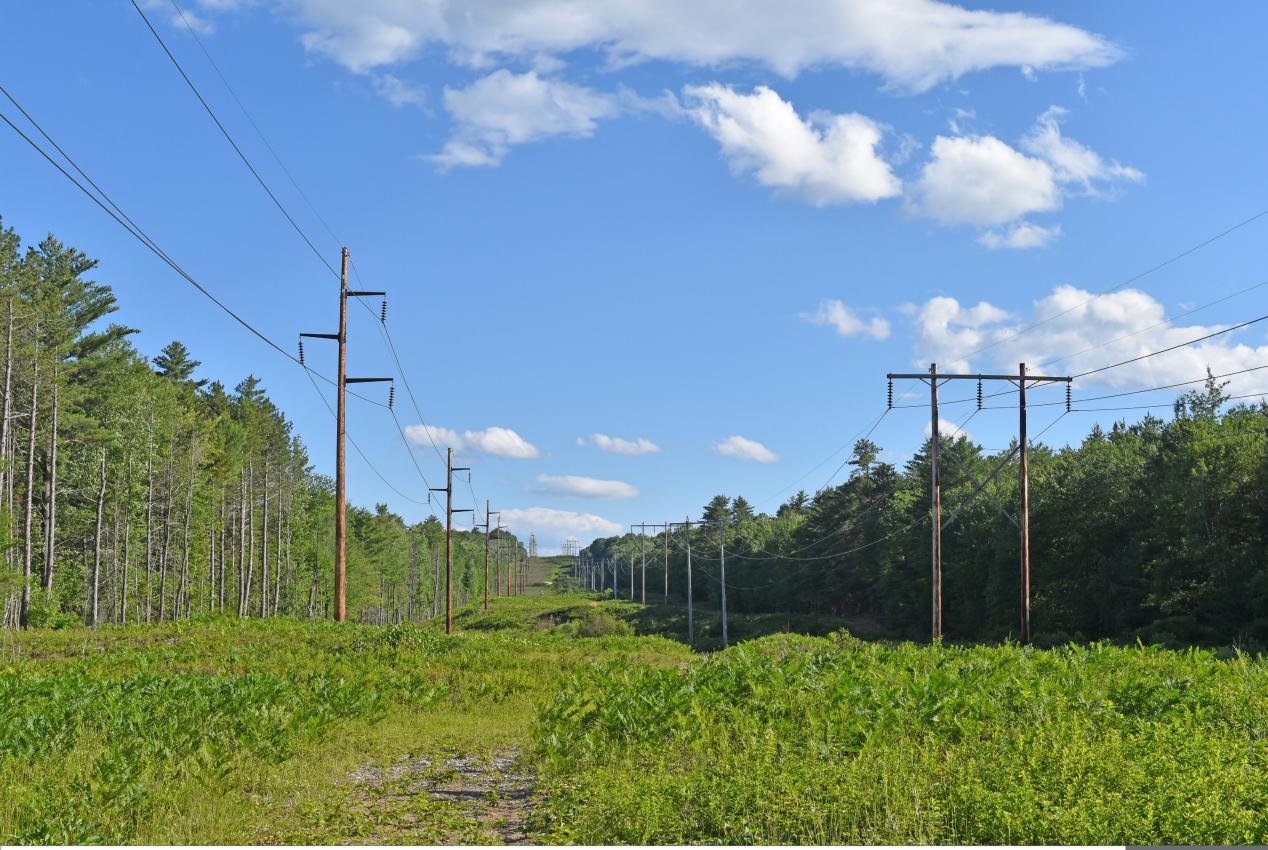
PHOTOSIMULATION 23A: ANDROSCOGGIN RIVERLANDS STATE PARK, Existing Transmission Line, Leeds

Existing Conditions: Normal view looking south from an access road within the Androscoggin Riverlands State Park crossing the existing transmission line.
