PHOTOSIMULATION 13: MOXIE POND - North, East Moxie Twp

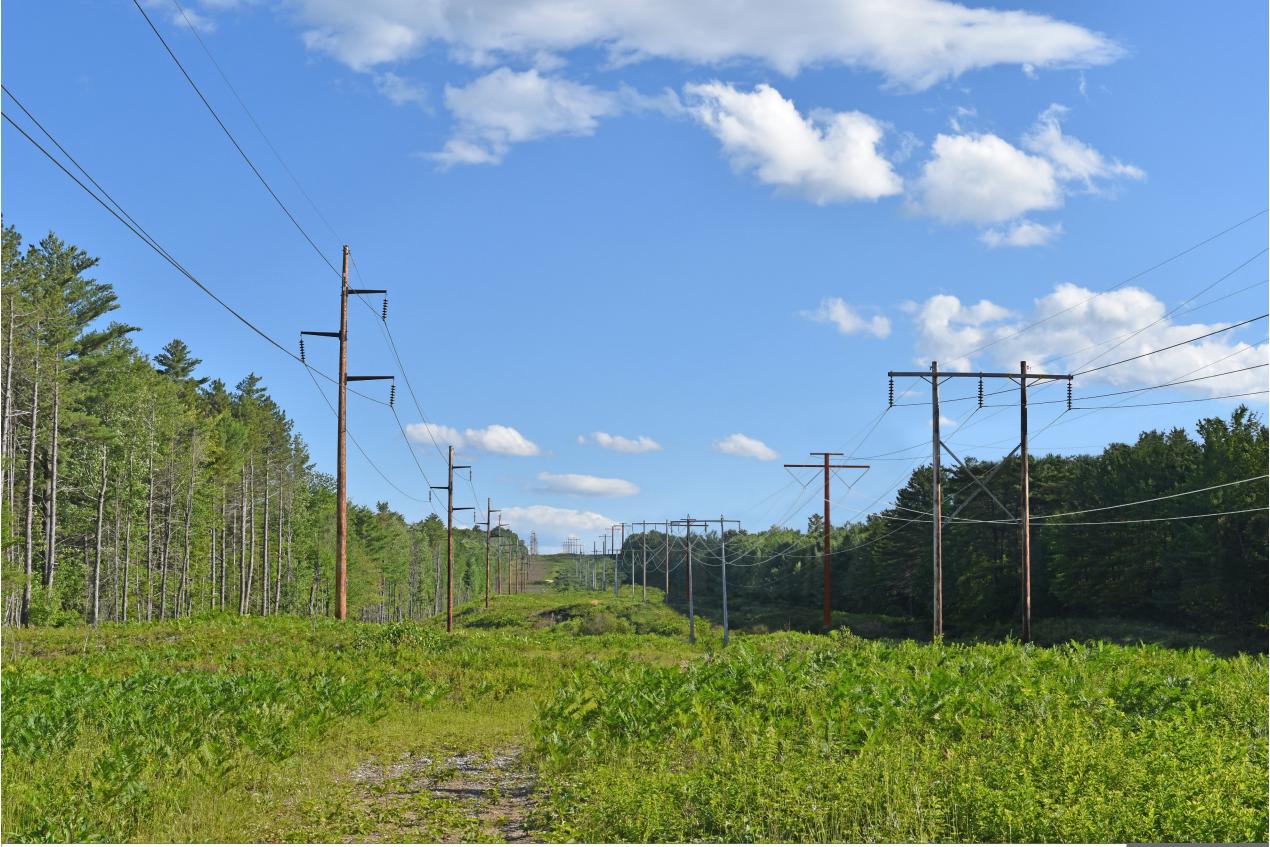
PHOTOSIMULATION 23A: ANDROSCOGGIN RIVERLANDS STATE PARK, Existing Transmission Line, Leeds

Proposed Conditions: Normal view looking south from an access road (off Church Hill Road) crossing the existing transmission line within the State Park toward the proposed co-located HVDC transmission line. The existing 225' corridor clearing will be widened by 75' on the western side to accommodate the new transmission line.

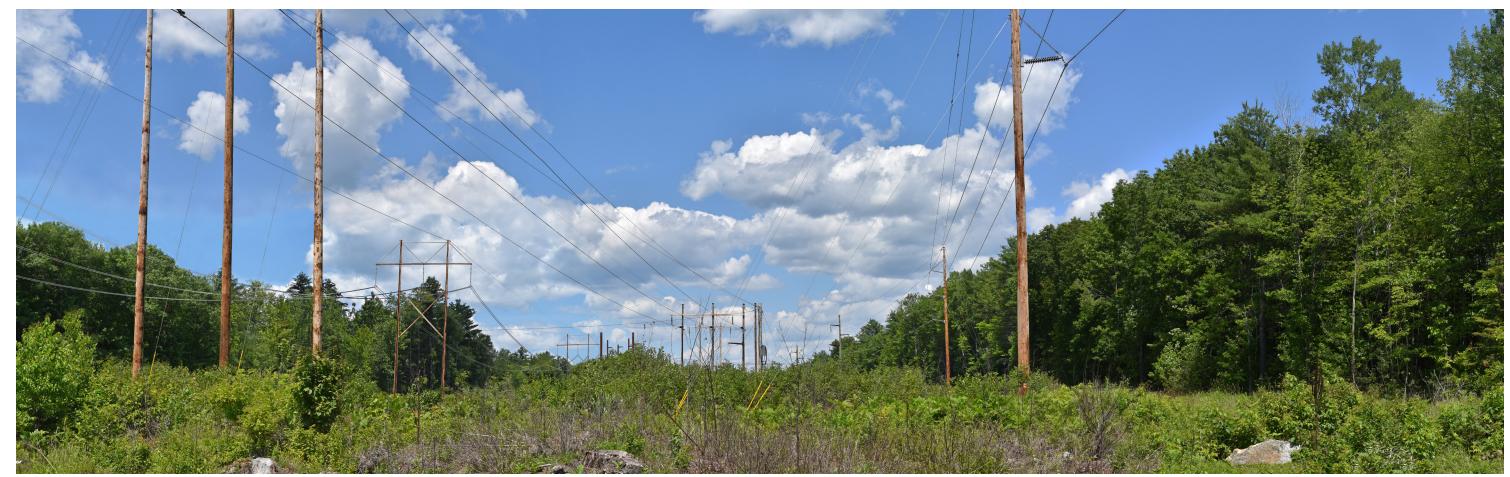
PHOTOSIMULATION 24: MERRILL ROAD, Lewiston

Proposed Conditions: Panoramic view looking from north to northeast from Merrill Road toward the proposed Merrill Road Converter Station and co-located HVDC transmission line. The Converter Substation will be located approximately 2,400 feet north of Merrill Road and screened from view by the existing vegetation on the east side of the corridor to remain. The cleared corridor will be widened by 75' on the west side, (left side of corridor in image), to accommodate the proposed 345 kV to +/- 320 kV transmission line connection to the Larabee Substation, located south of this viewpoint. A 20' wide gravel access road, gate, and grassed lined stormwater facility will be visible from Merrill Road, but screened from view by vegetation from this viewpoint.

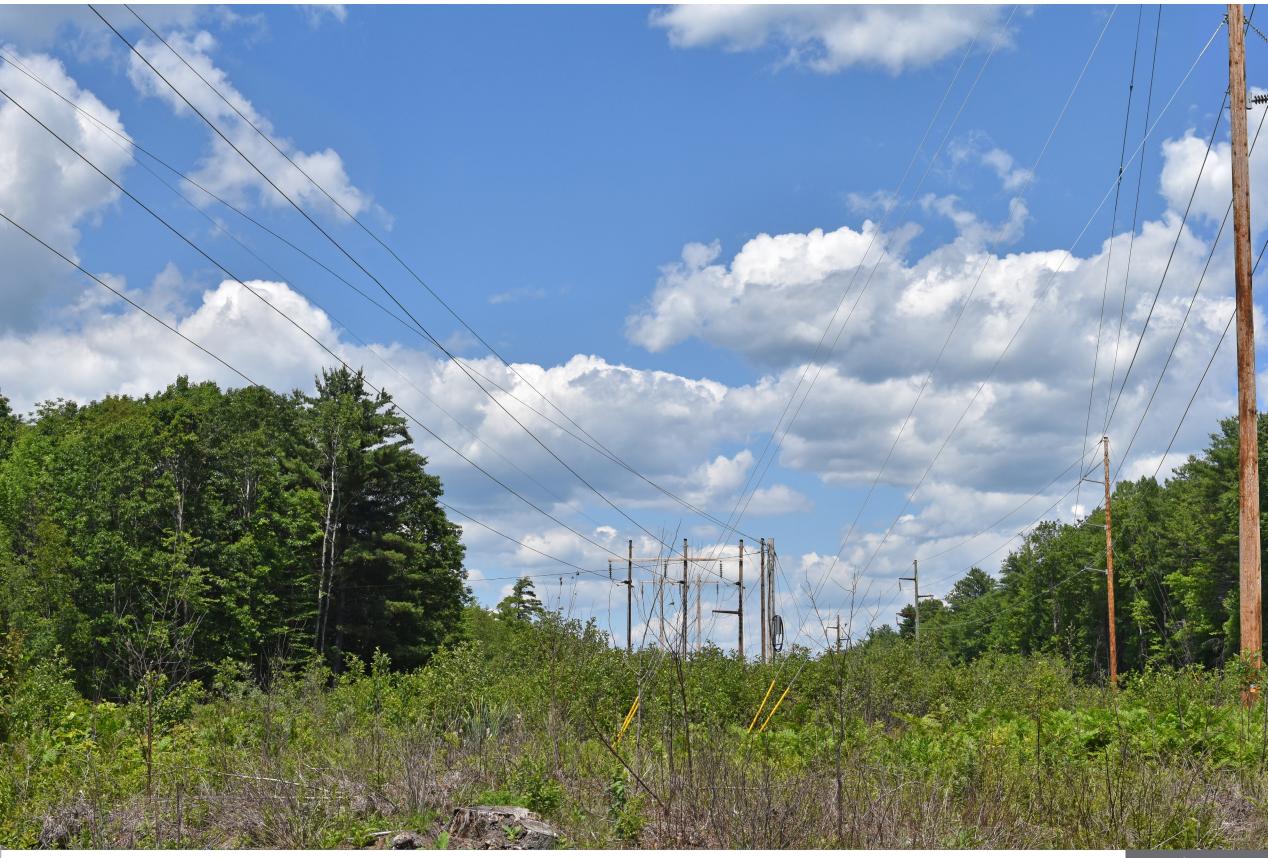
PHOTOSIMULATION 24A: MERRILL ROAD, Lewiston

Existing Conditions: Normal view looking from north from Merrill Road.

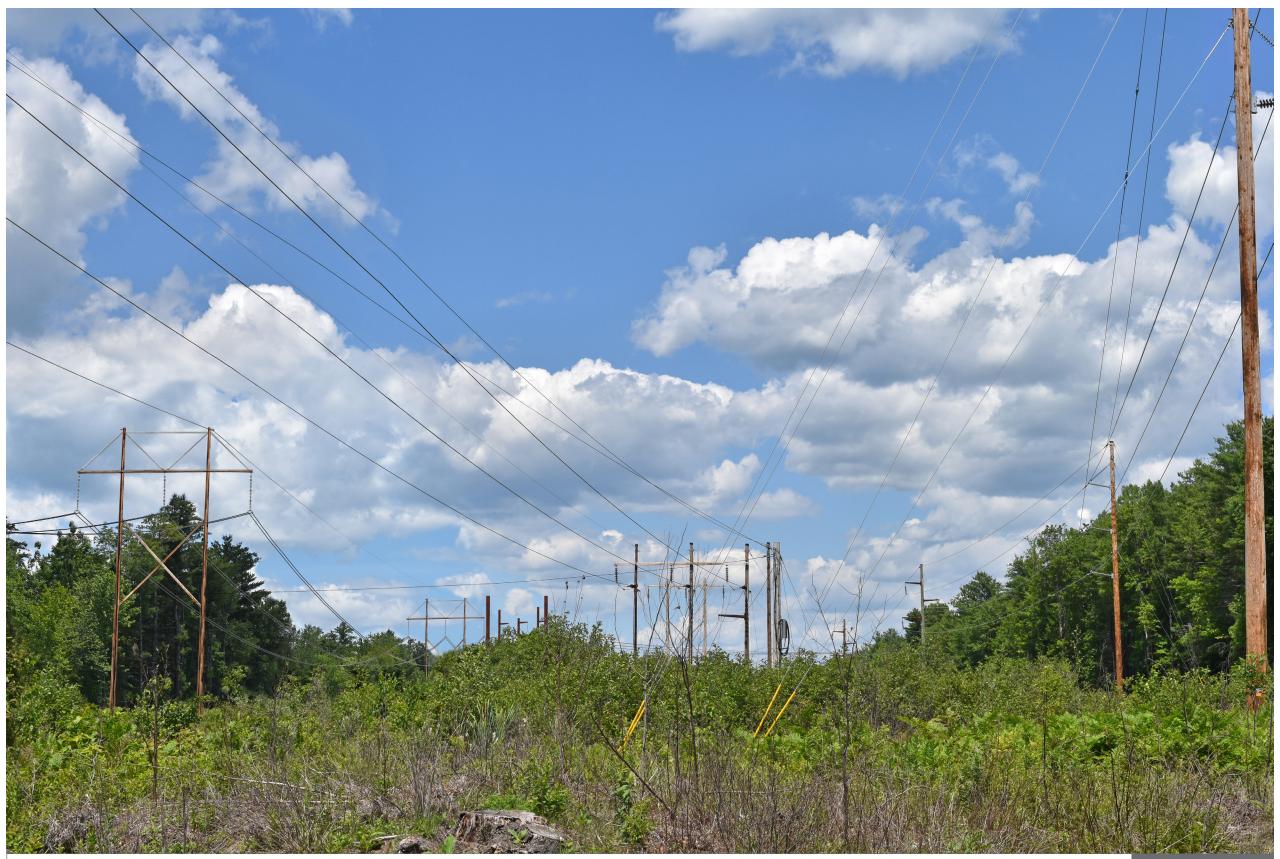
PHOTOSIMULATION 24A: MERRILL ROAD, Lewiston

Proposed Conditions: Normal view looking from north from Merrill Road toward the proposed Merrill Road Converter Station and co-located HVDC transmission line. The cleared corridor will be widened by 75' on the west side, (left side of corridor in image), to accommodate the proposed 345 kV to +/- 320 kV transmission line connection to the Larabee Substation, located south of this viewpoint.
