August 22, 2019

Project 171.05027.008

RE: Response to Review Comments  
Nordic Aquafarms Inc., Land-based Aquaculture Facility  
Belfast, Maine  
L-28319-26-A-N

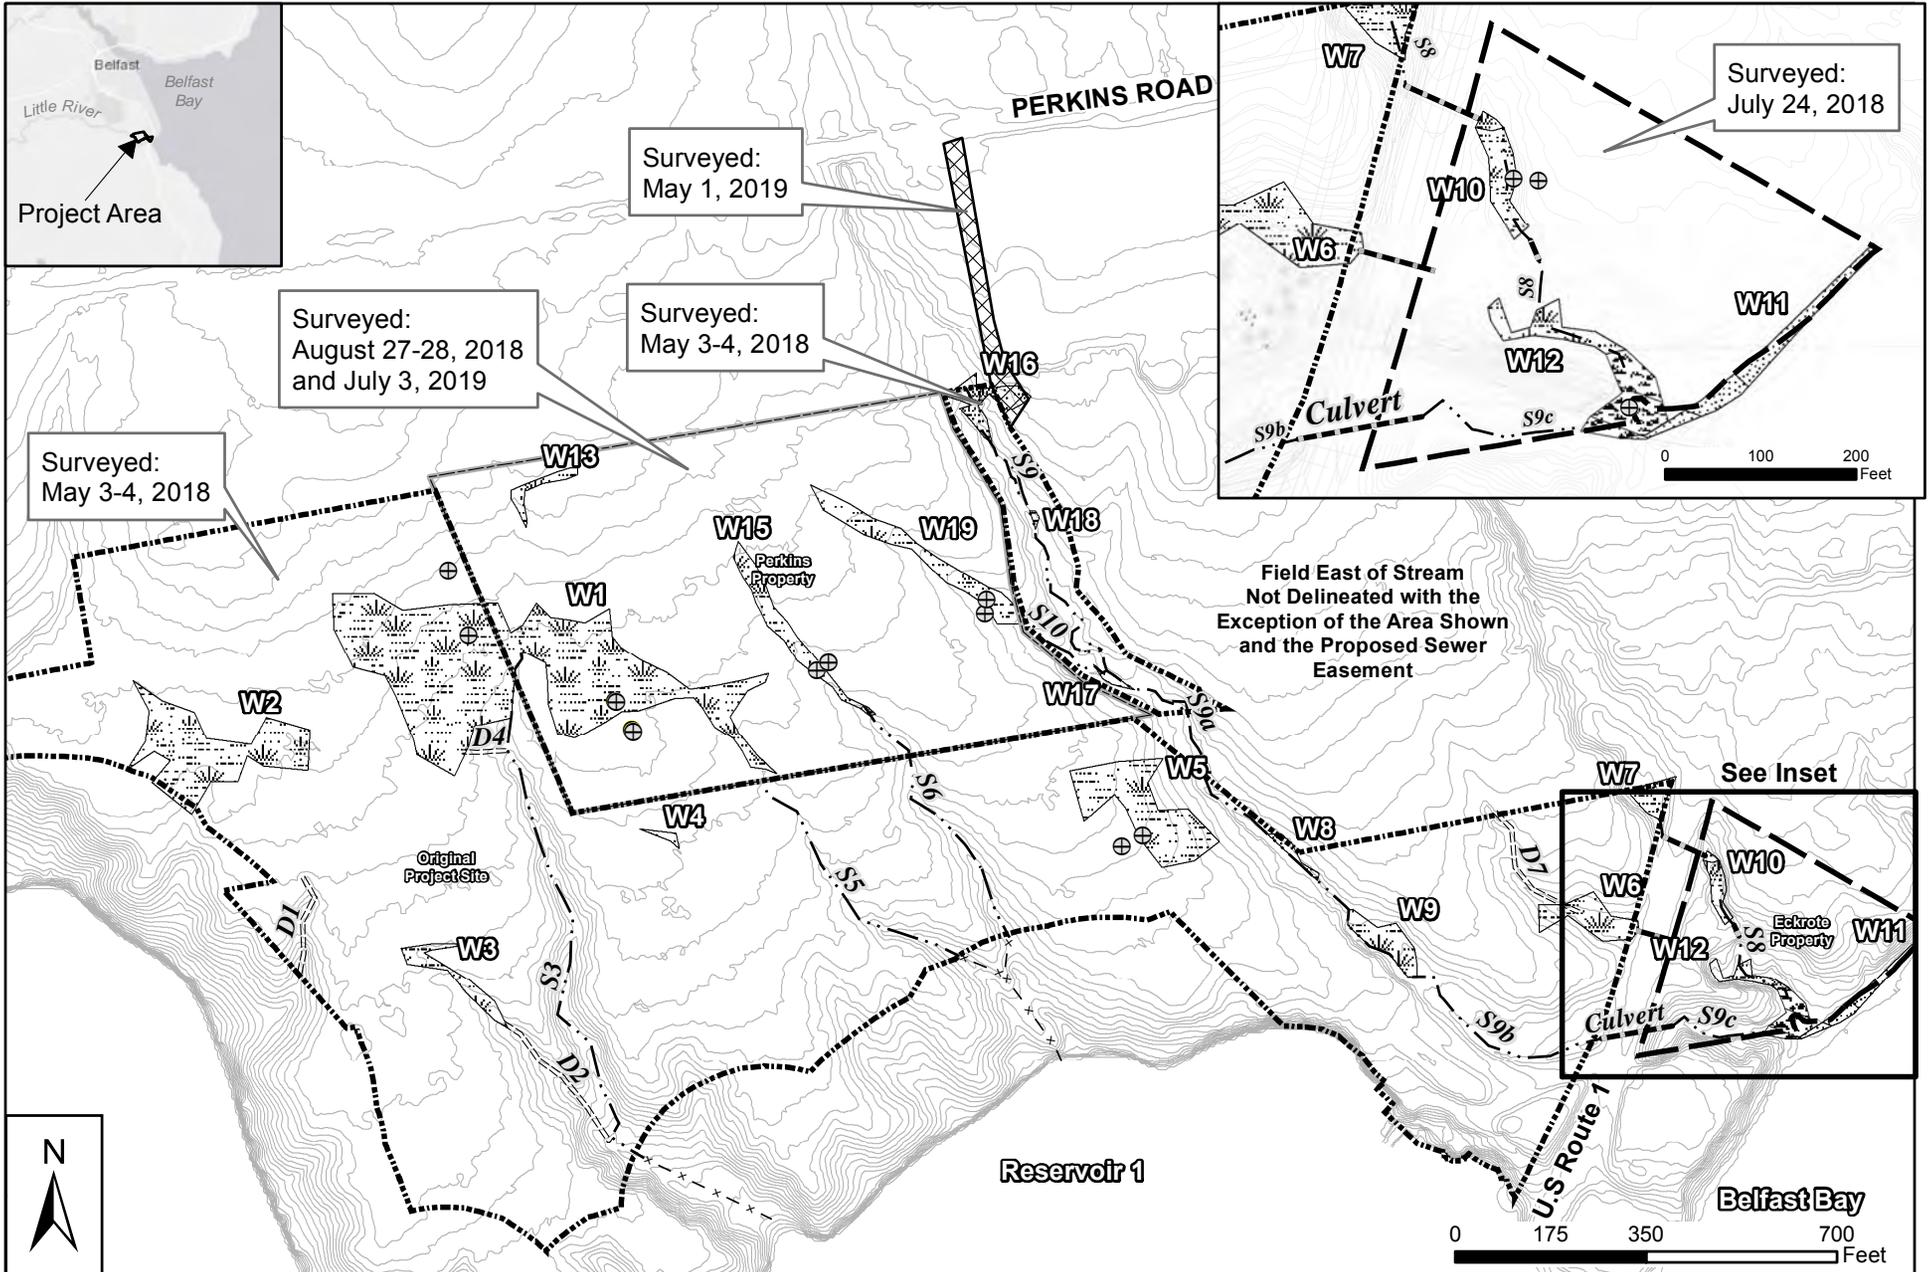
**Belfast Aquaculture Project**  
**Revised Wetland and Stream Survey**  
**Date: August 14, 2019**

Preamble: As discussed in individual responses below, additional assessment of site drainages and wetlands delineation was conducted by Normandeau on July 3, 2019. A Revised Wetland and Stream Survey Map is included as **Attachment A**. Changes include the elongation of streams S3 and S6, along with the expansion of wetland W15 and delineation of wetland W19. These wetland and stream updates, along with minor development alterations, are reflected in the Revised Wetland and Stream Impact Map included as **Attachment B**. Please refer specifically to these drawings to view the most updated wetland and stream mapping. An updated summary of project wetland and stream impacts is provided below in **Tables 1 through 3**. These tables supersede tables provided in the previously submitted NRPA application.

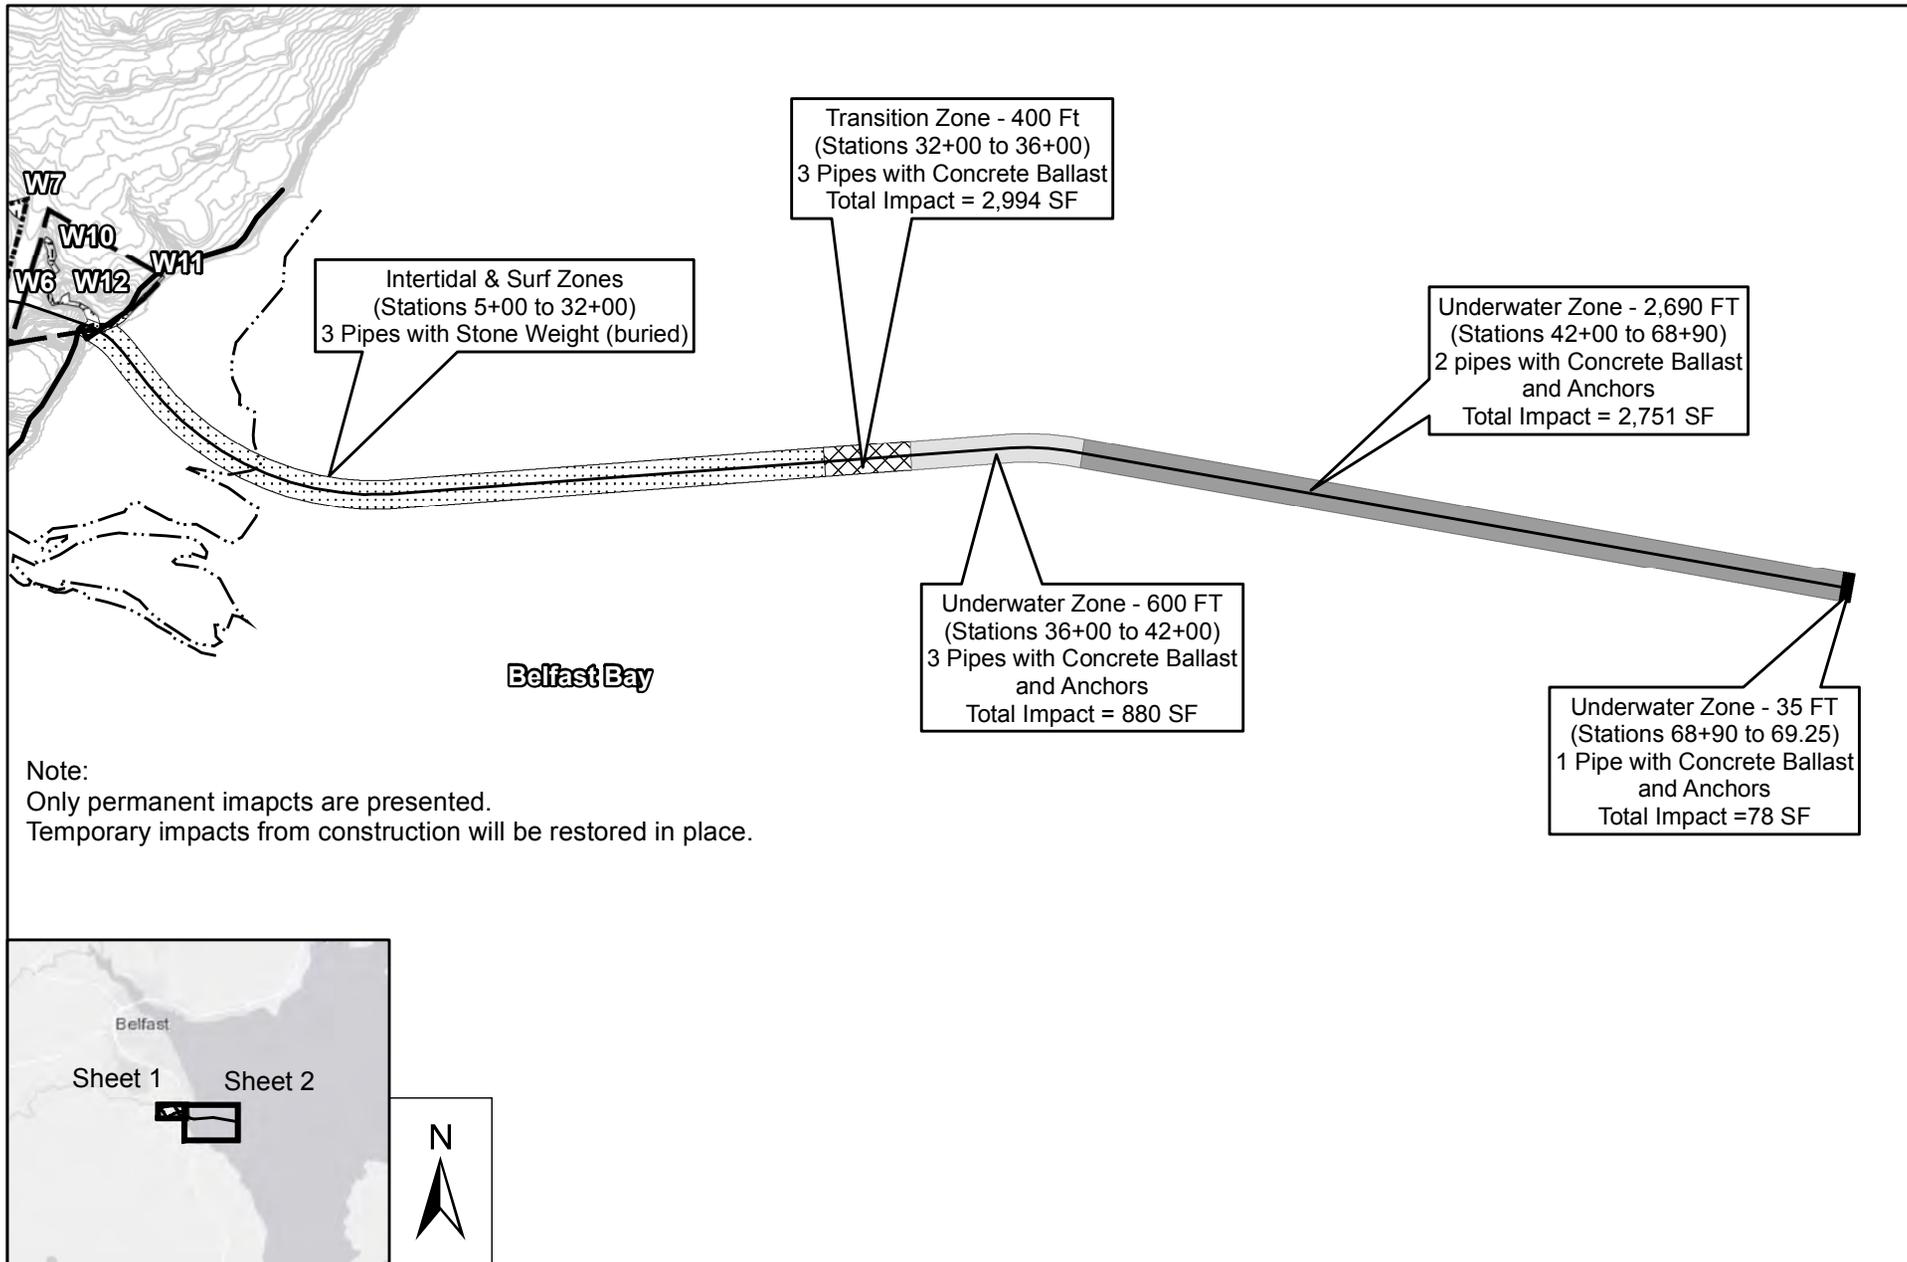
Revised Wetland and Stream Impact Map

**Belfast Aquaculture Project**  
**Wetland and Stream Impact Mapping**  
**August 16, 2019**

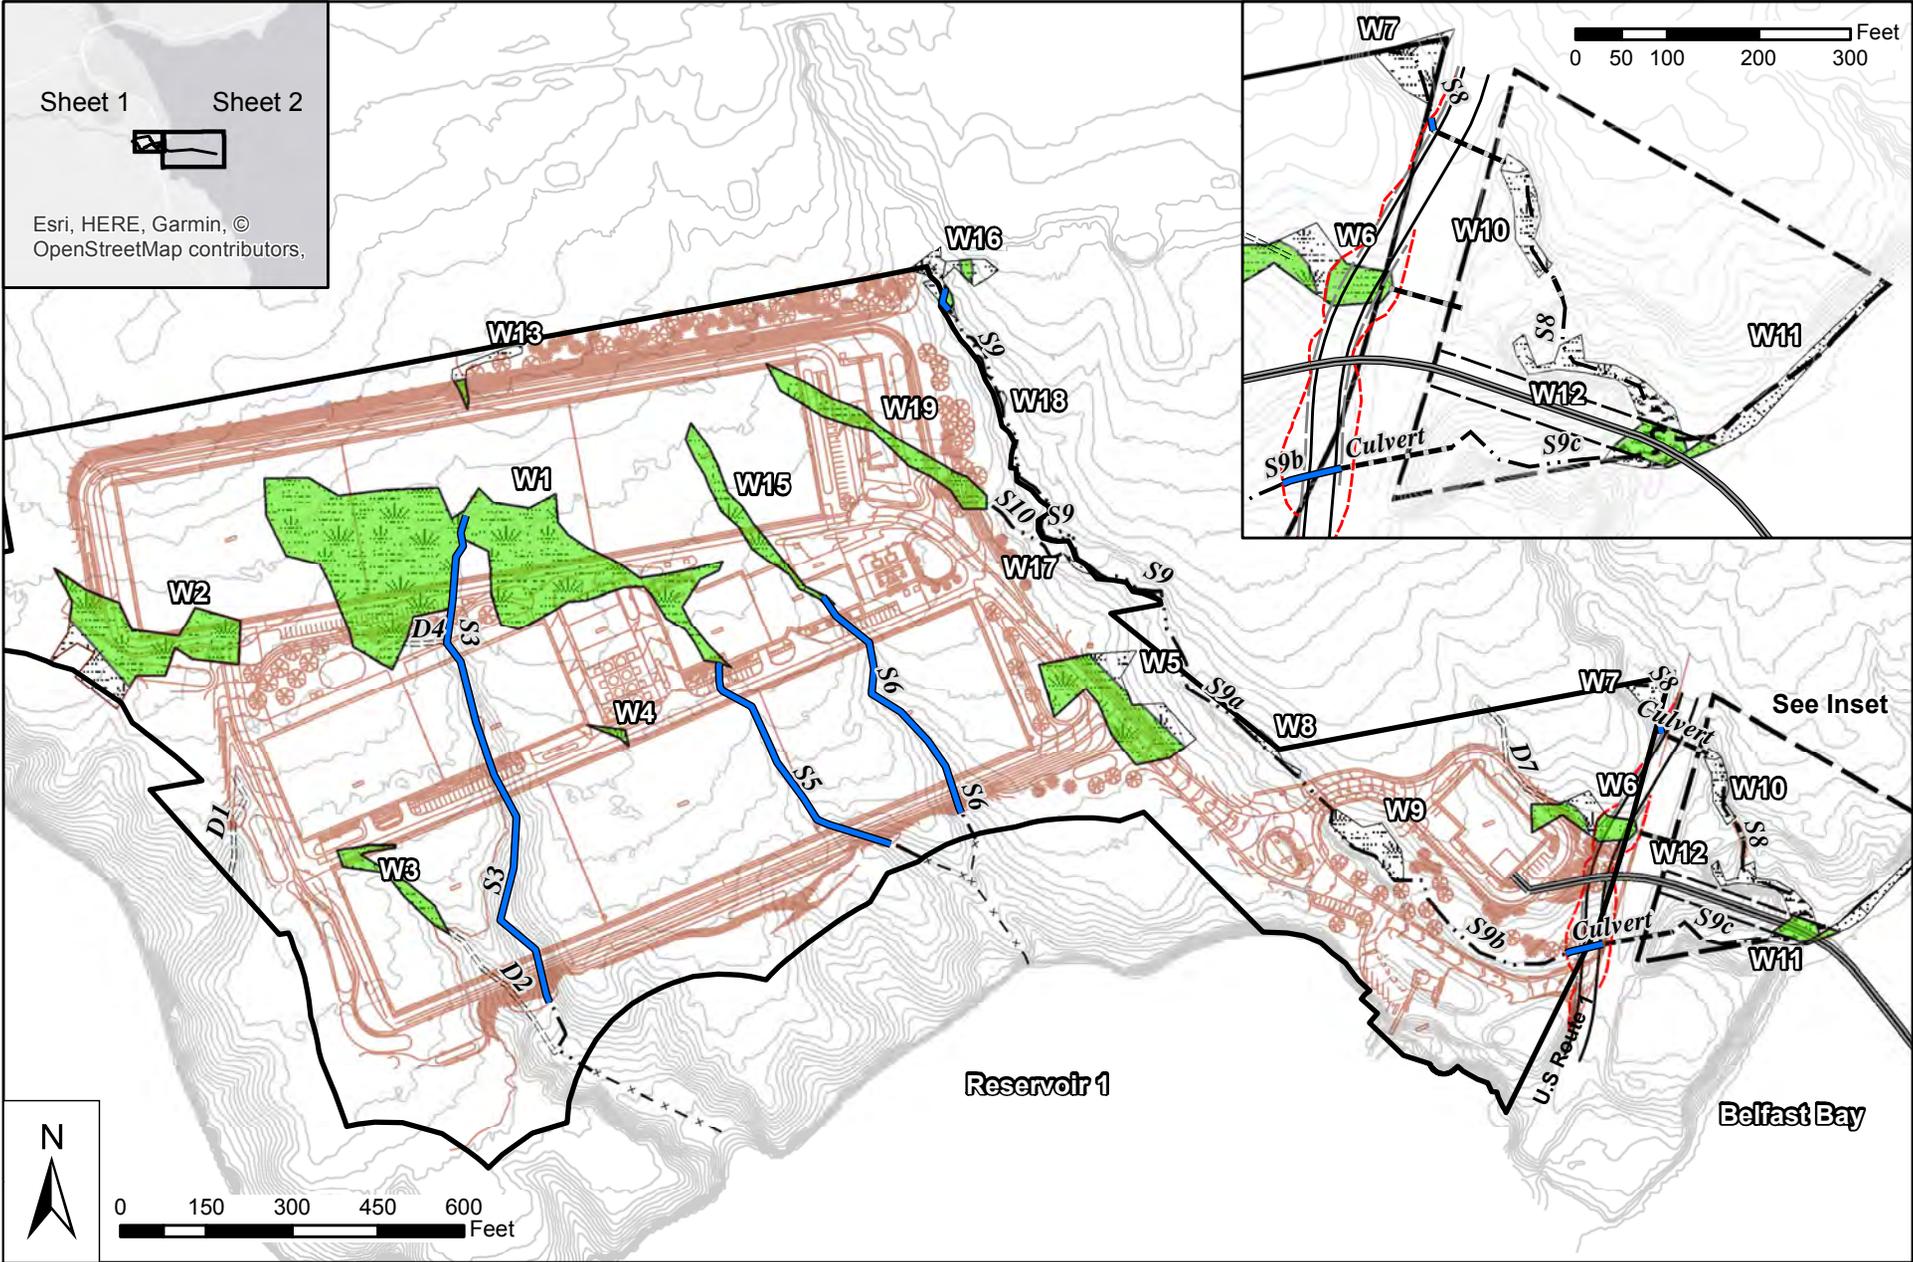
**Belfast Aquaculture Project**  
**Wetland and Stream Impact Mapping**  
 August 16, 2019      Sheet 1 of 2

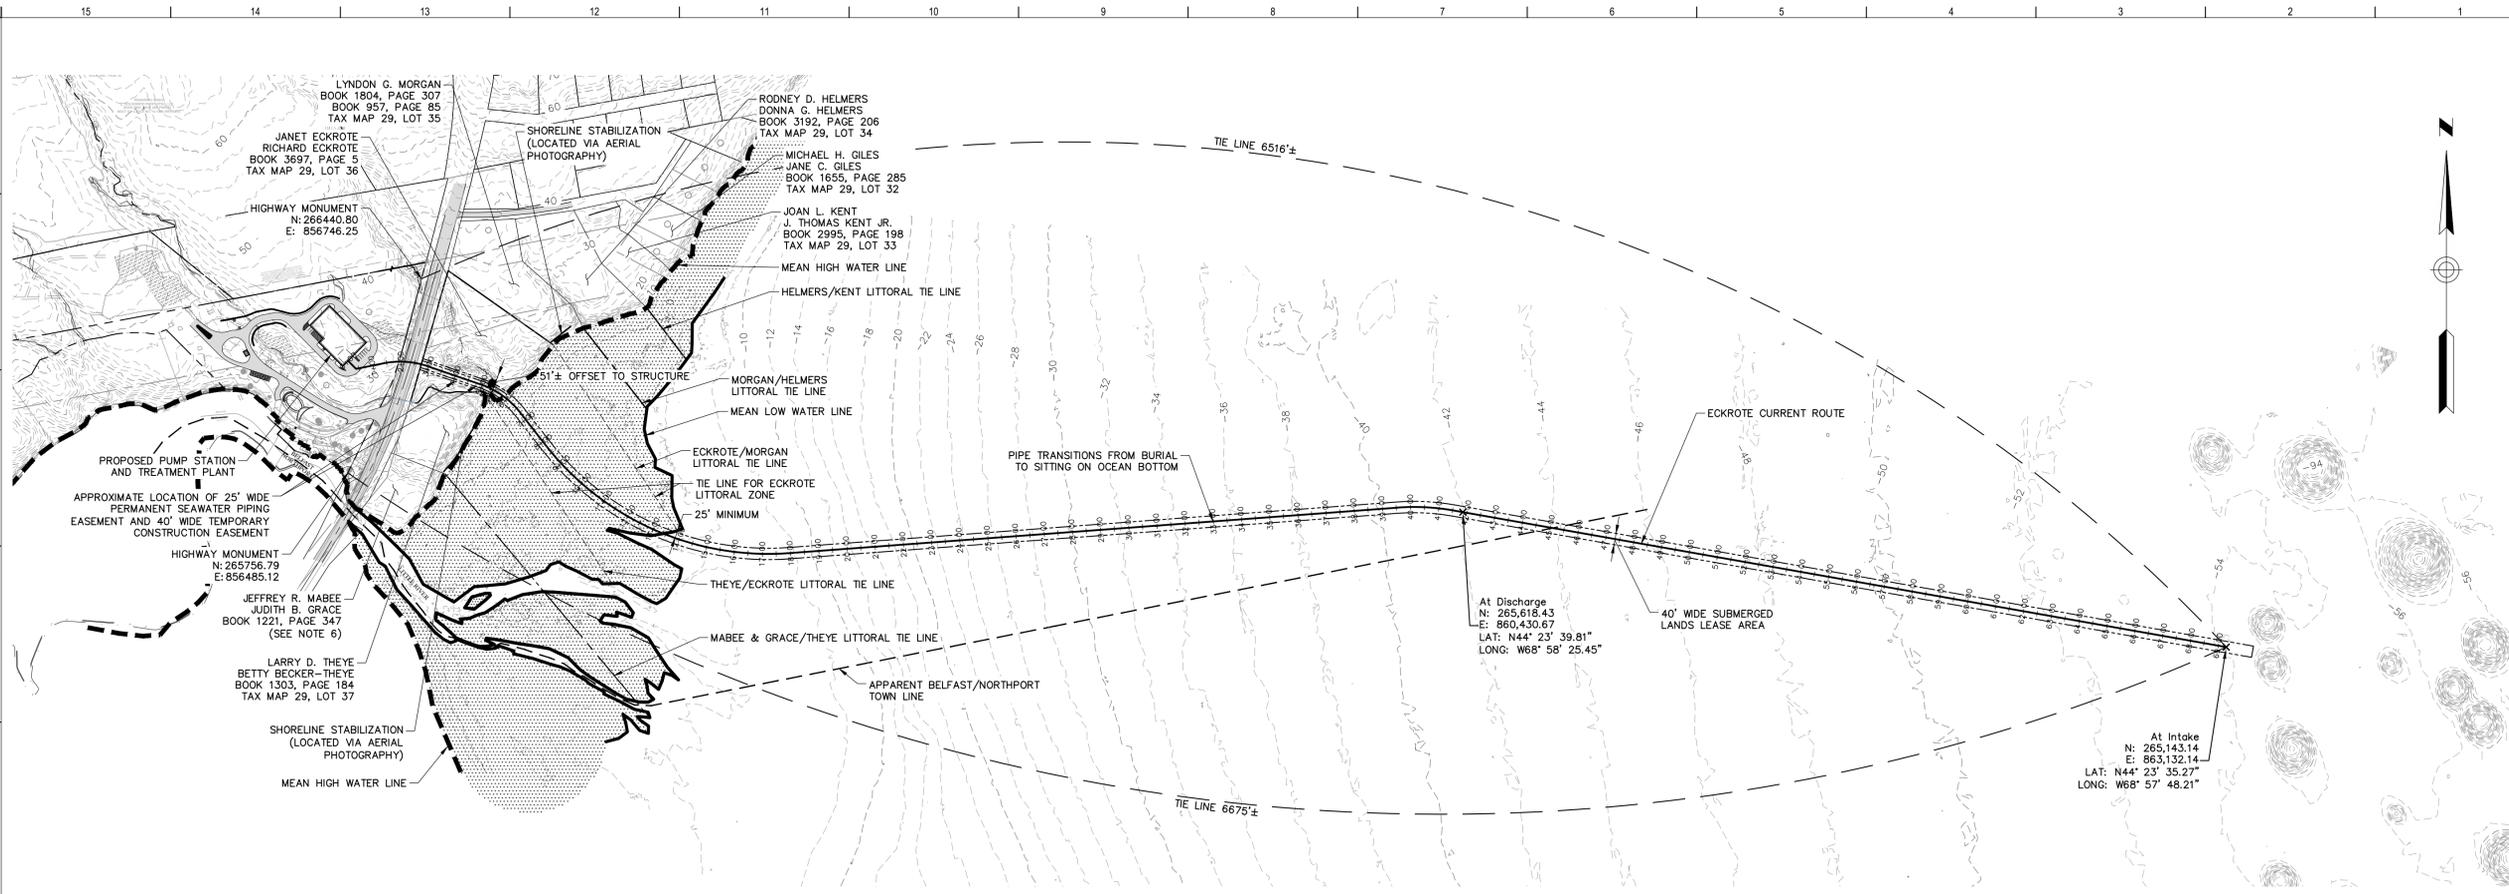
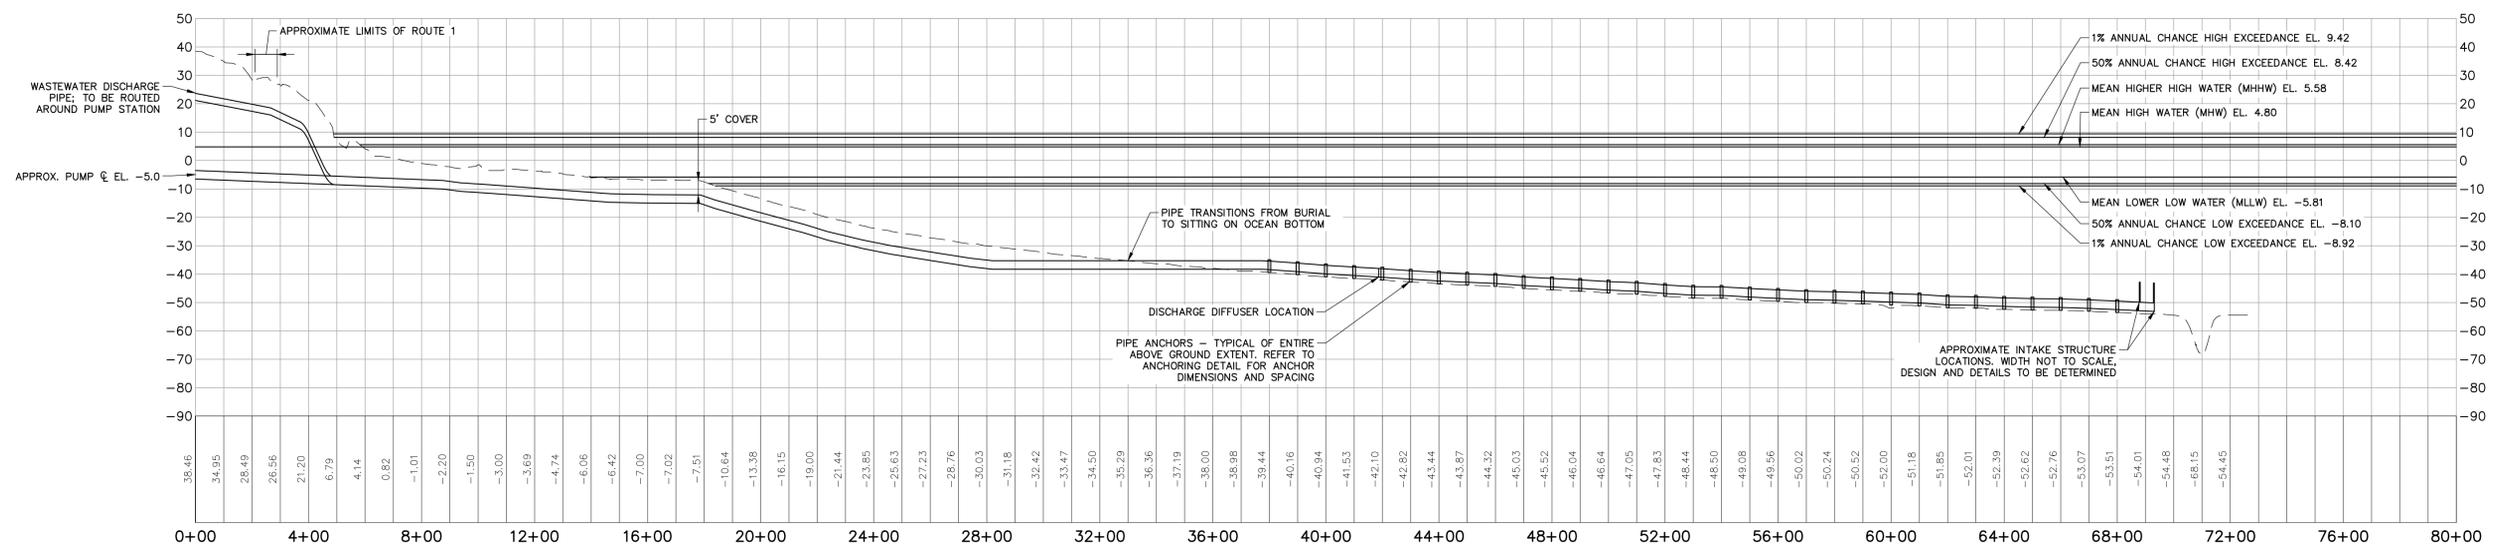
JOB CAPTAIN: **CS101**

**PLAN**  
SCALE: 1" = 300'

**PROFILE STA. 0+00 TO STA. 80+00**  
HORIZONTAL SCALE: 1" = 300'  
VERTICAL SCALE: 1" = 30'

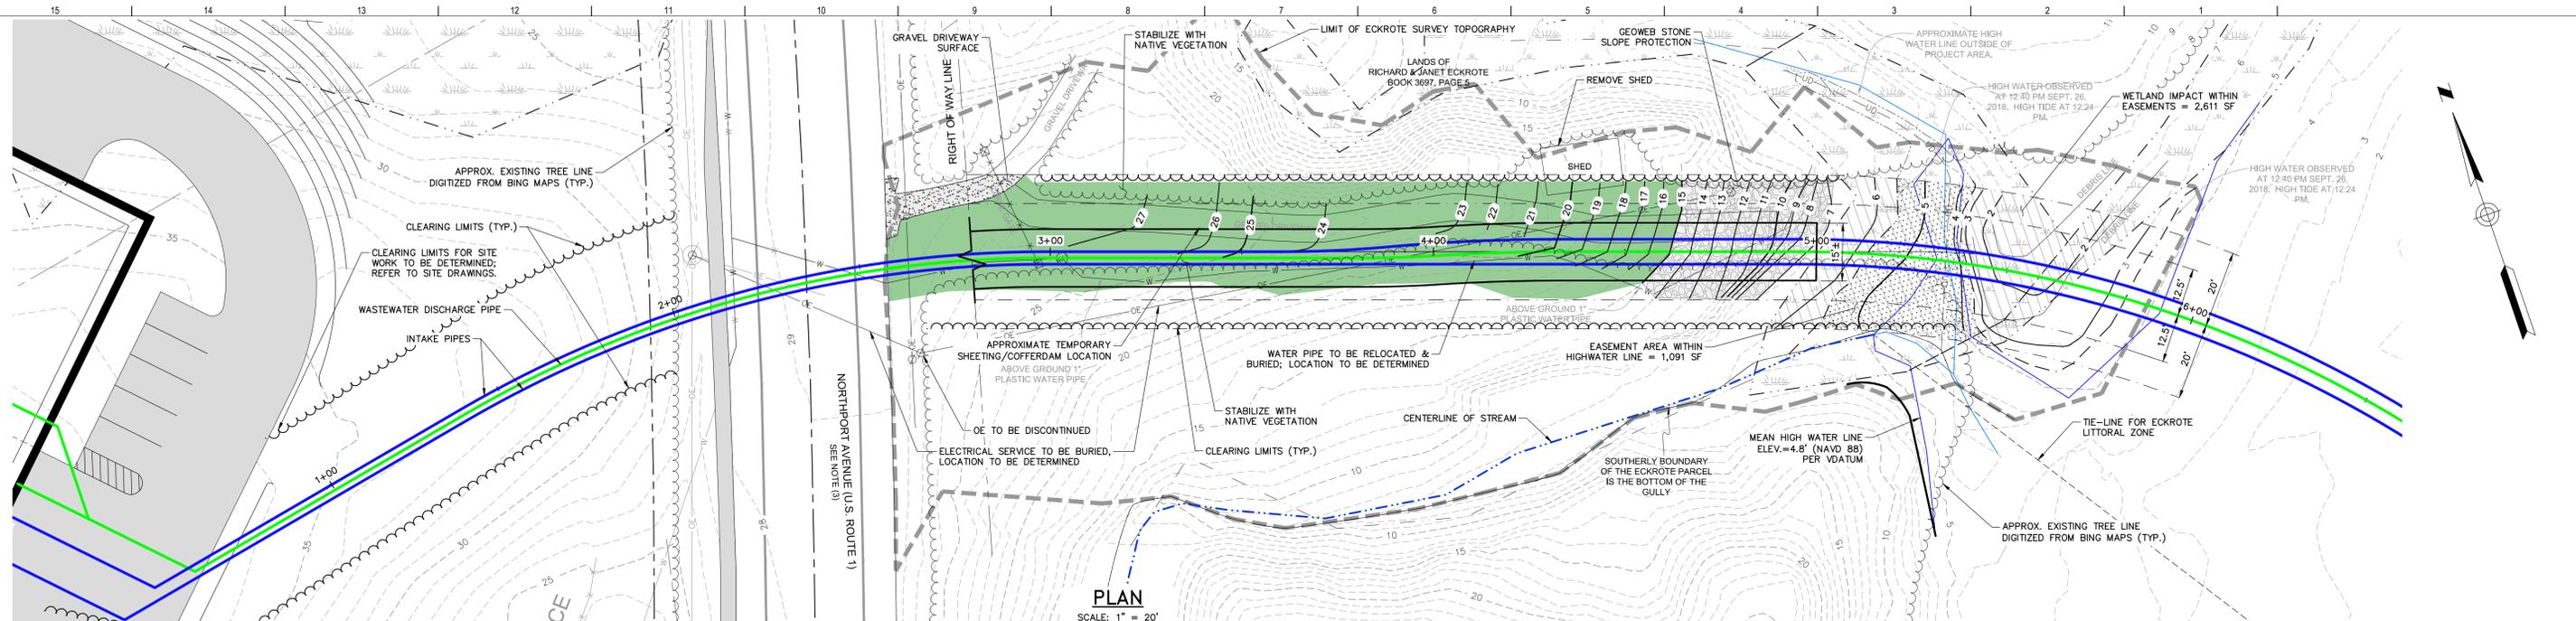
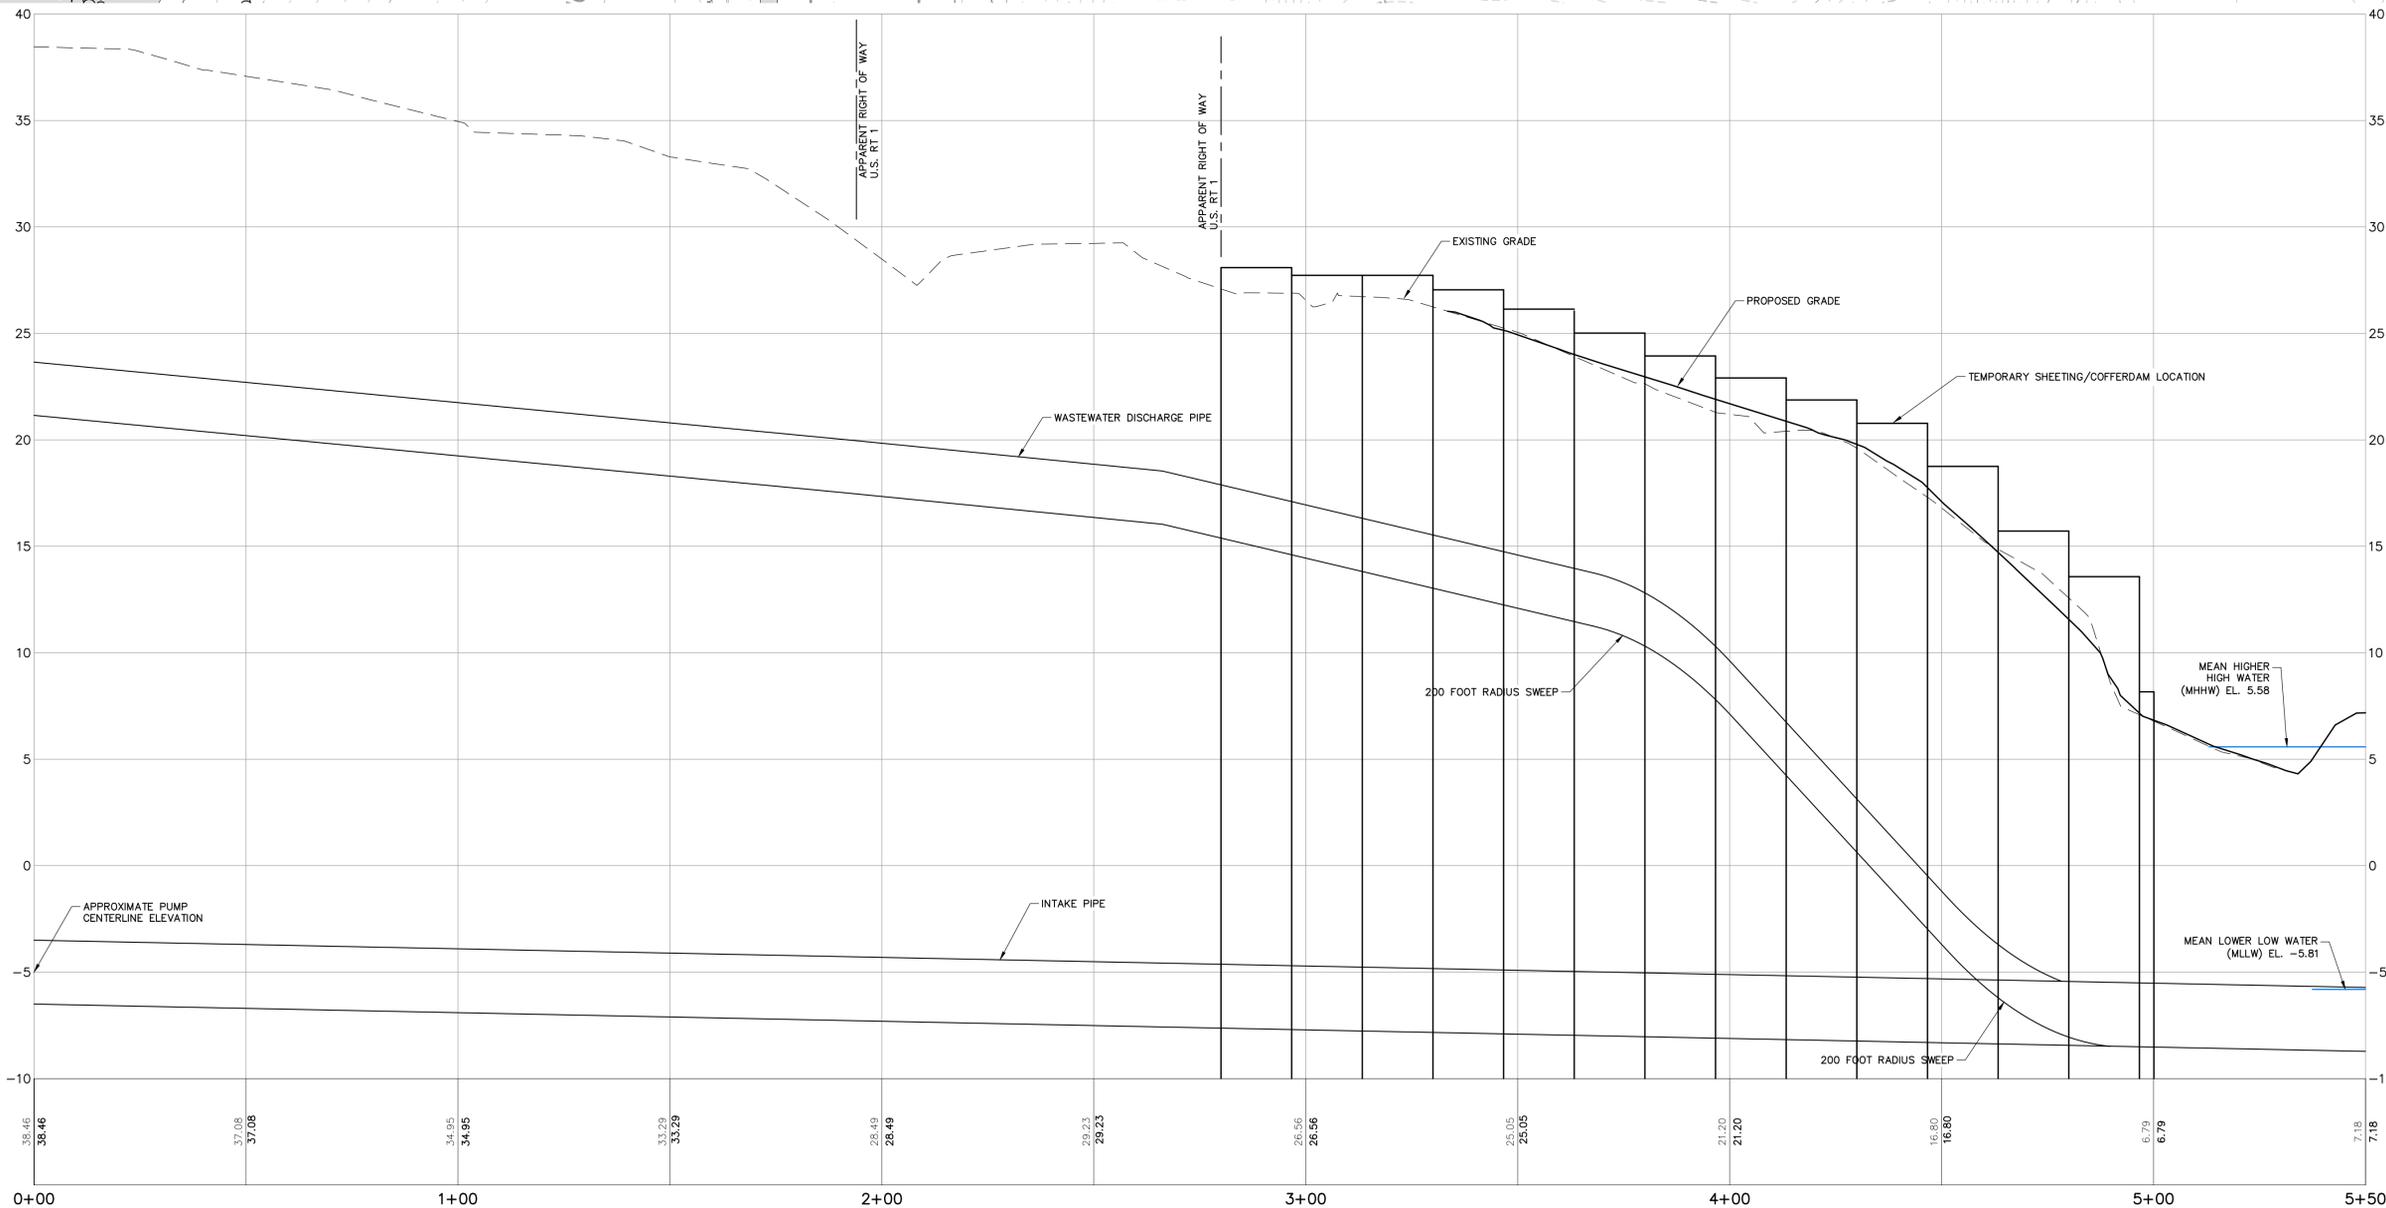
PROJECT MANAGER: PROJECT NO: 18076  
JOB CAPTAIN: **CS102**

**PLAN**  
SCALE: 1" = 20'

**PROFILE STA. 0+00 TO STA. 5+50**

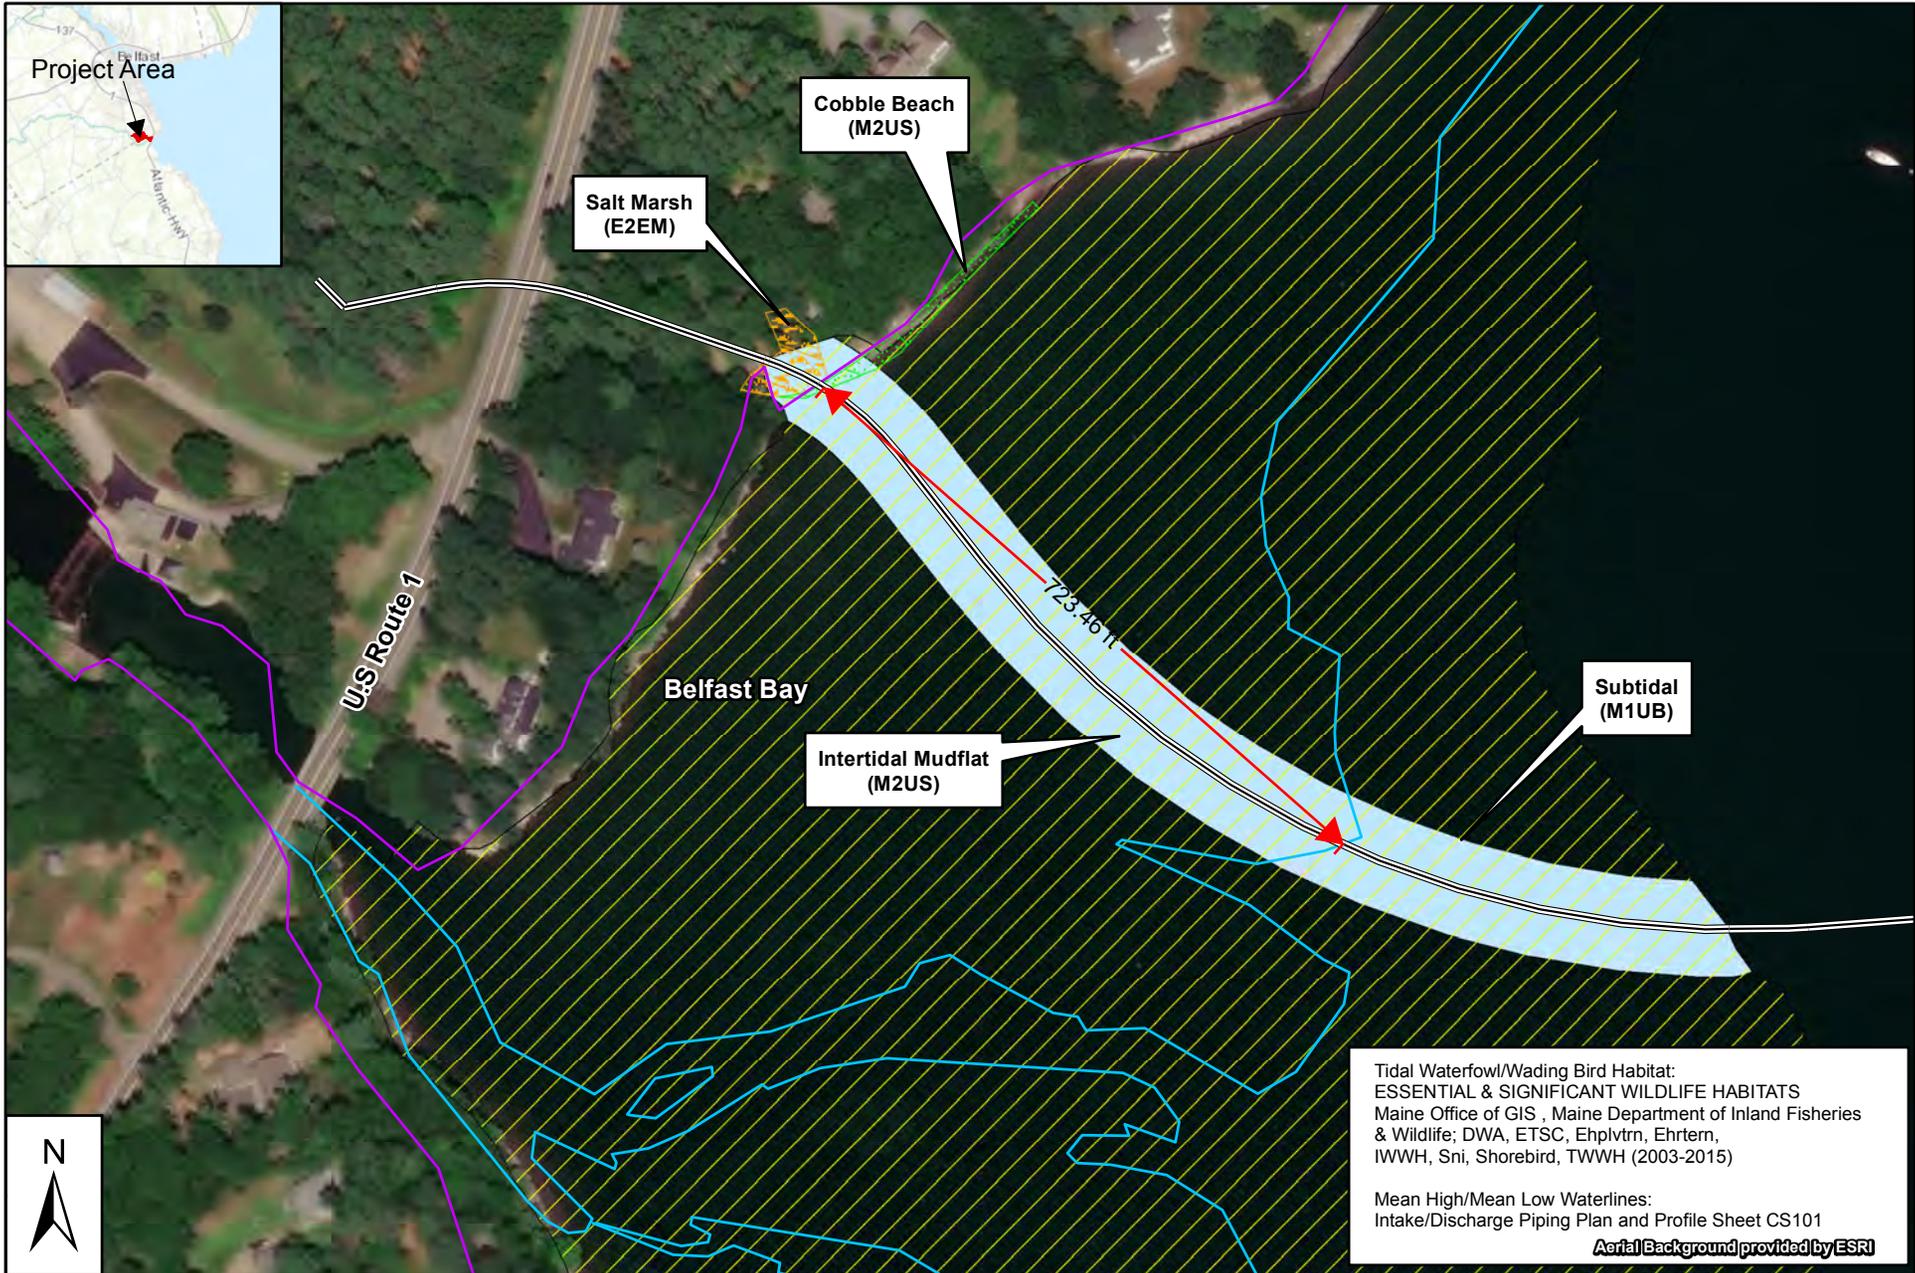
Tidal Waterfowl and Wading Bird Habitat Pipeline Impact Area

**Belfast Aquaculture Project  
 Pipeline Impact Area TWWH  
 Date: August 13, 2019**

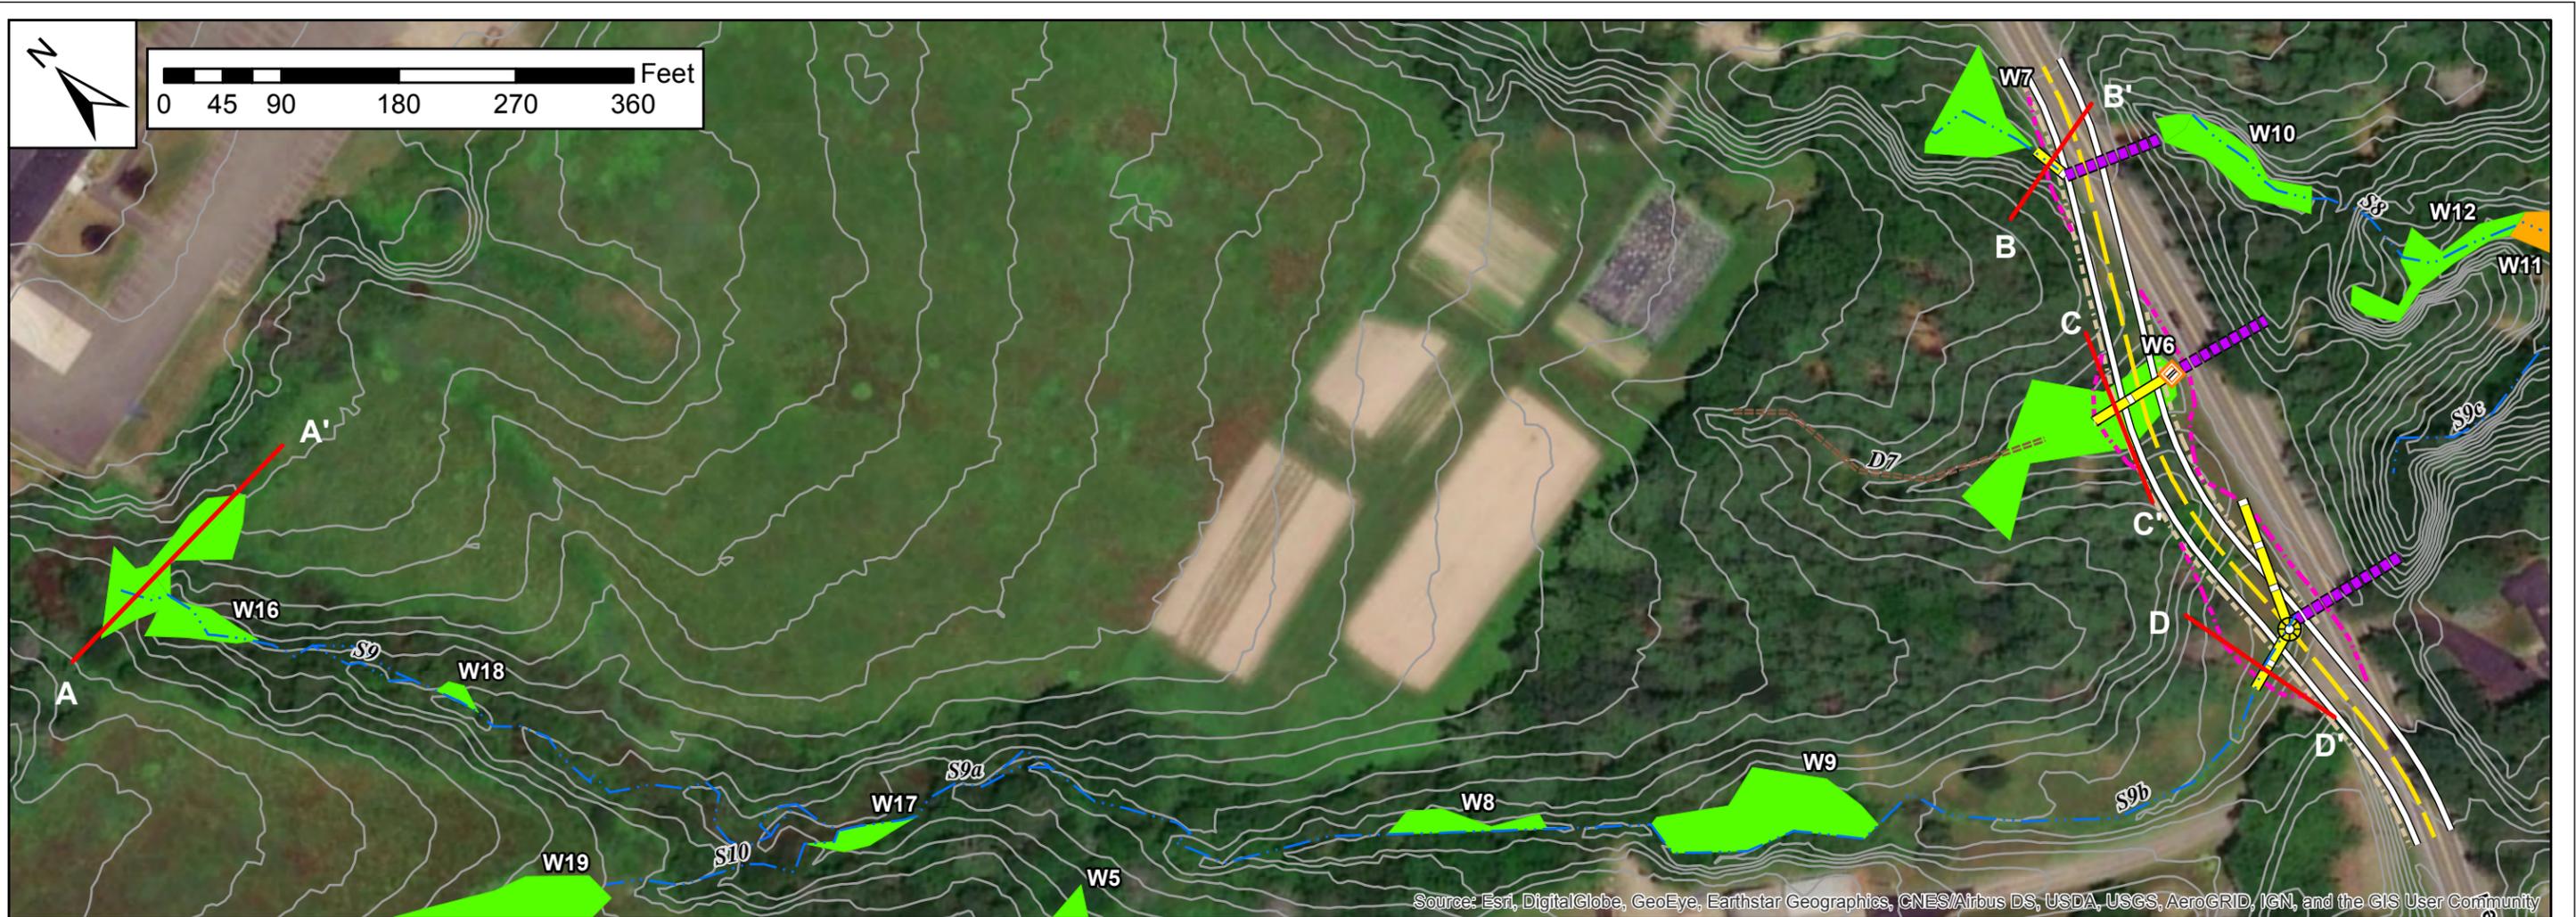
**Belfast Aquaculture Project  
Cross Section Map  
Date: August 16, 2019  
SHEET 3**

Cross sections of existing conditions at the temporary crossings of S9 have been developed (**Attachment E**, Sheet 3). Cross sections are provided for the sewer crossing of S9 and the Route 1 by-pass crossing of S9. The existing condition cross sections will be used to restore these areas to original grade once the sewer line is installed and the by-pass is removed. Additional grading changes for restoration planting are not planned.

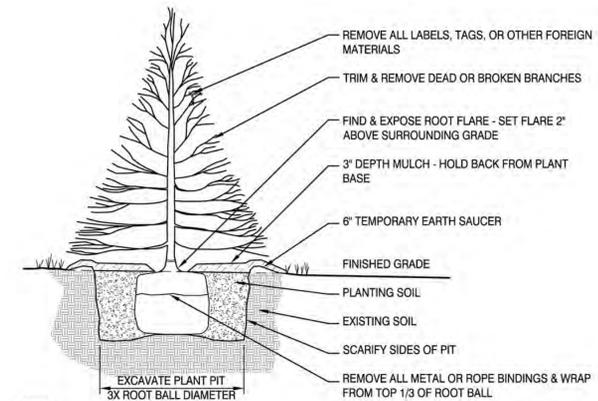
1. TREE TO BE SET PLUMB.
2. SECURE TREE AS MAY BE REQUIRED ACCORDING TO TREE SIZE, LOCATION, & WIND/WEATHER CONDITIONS.
3. IF USING ROOTBALL STABILIZATION, FOLLOW MANUFACTURER'S RECOMMENDATIONS.

STANDARD EVERGREEN TREE PLANTING (H1) NOT TO SCALE

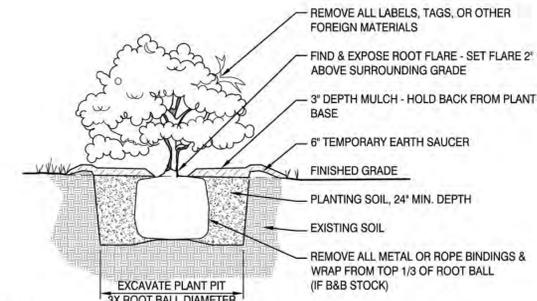
1. SHRUB TO BE SET PLUMB.

STANDARD SHRUB PLANTING (D1) NOT TO SCALE

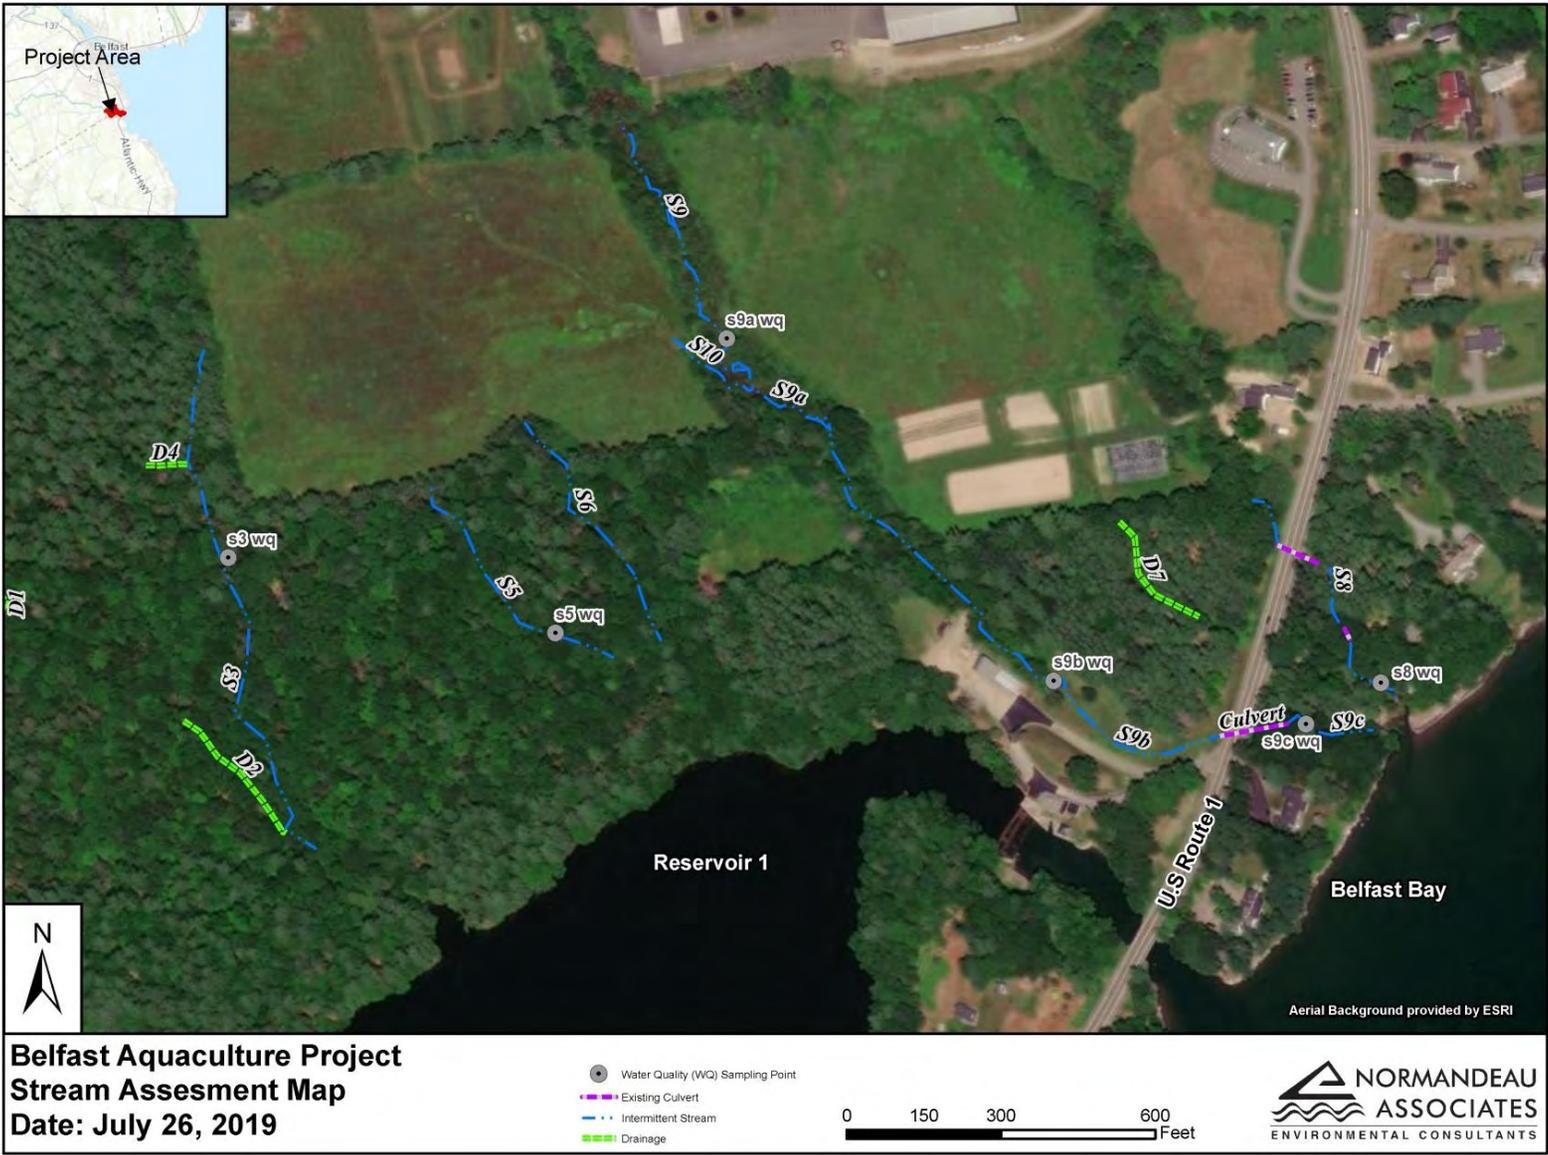
Figure 1. Belfast Aquaculture Project Stream Assessment Map.

A qualitative assessment of all site streams was conducted on July 19-22, 2019, using the Qualitative Habitat Evaluation Index, concurrent with additional mapping of site drainages and wetlands delineation. Results of this assessment are included in the attached Stream Assessment Report, dated July 29, 2019 (**Attachment G**). In summary the QHEI found that overall the streams scored low. The streams exhibited low invertebrate diversity, largely due to minimal water, and low quality silty substrate and the streams do not have characteristics conducive to providing fish habitat due to either intermittent flows or no potential connection to known downstream fish habitat, low dissolved oxygen, and poor substrate quality. The streams assessed received QHEI scores between 18 and 42 out of 100, and corresponding Index of Biotic Integrity (IBI) ratings were between poor and very poor.
