August 22, 2019

Project 171.05027.008

RE: Response to Review Comments  
Nordic Aquafarms Inc., Land-based Aquaculture Facility  
Belfast, Maine  
L-28319-26-A-N

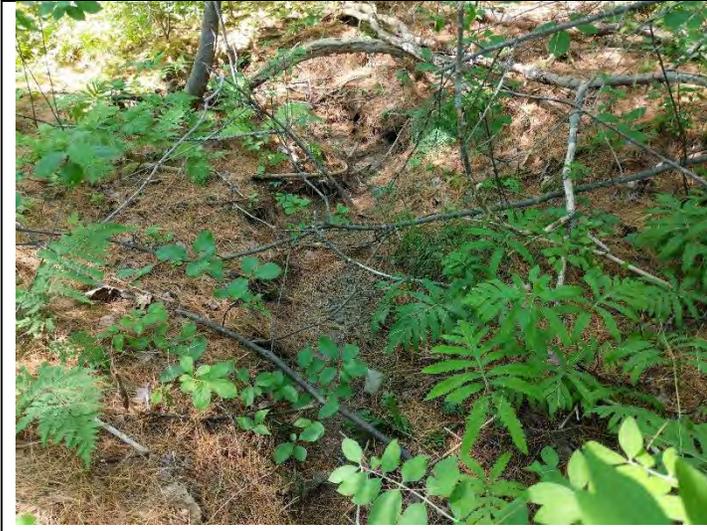
**Photo #: 1**

S3 – dry portion covered with pine needles.

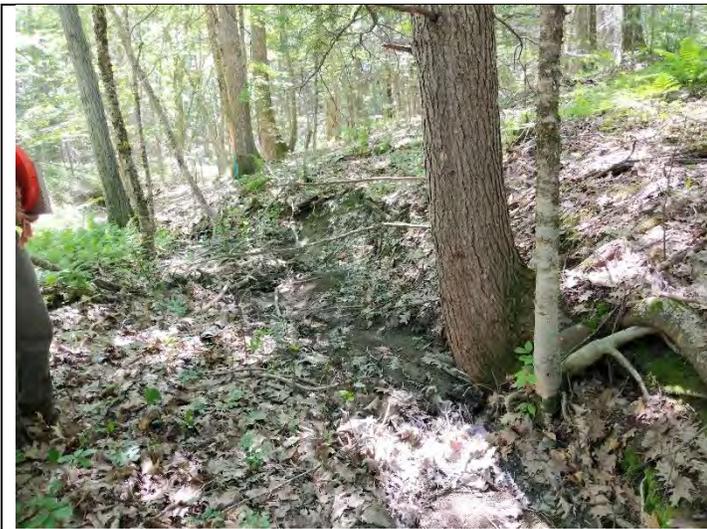
**Photo #: 2**

S3 – looking downstream near edge of the project area.

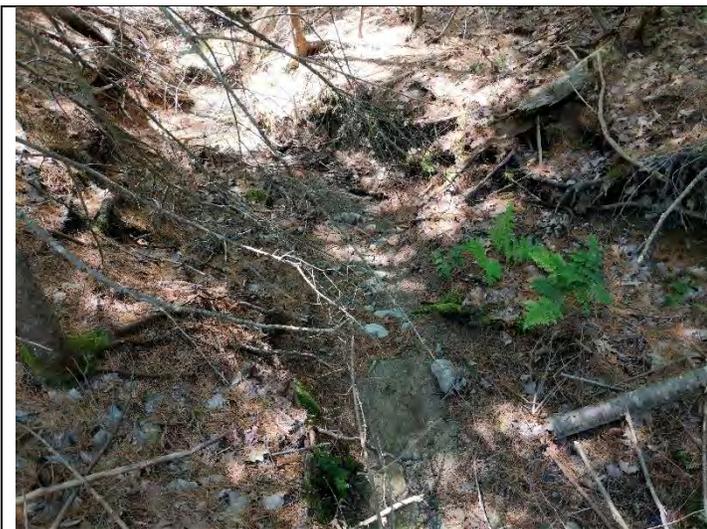
**Photo #: 3**

S3 – near upstream start of channelized flows.

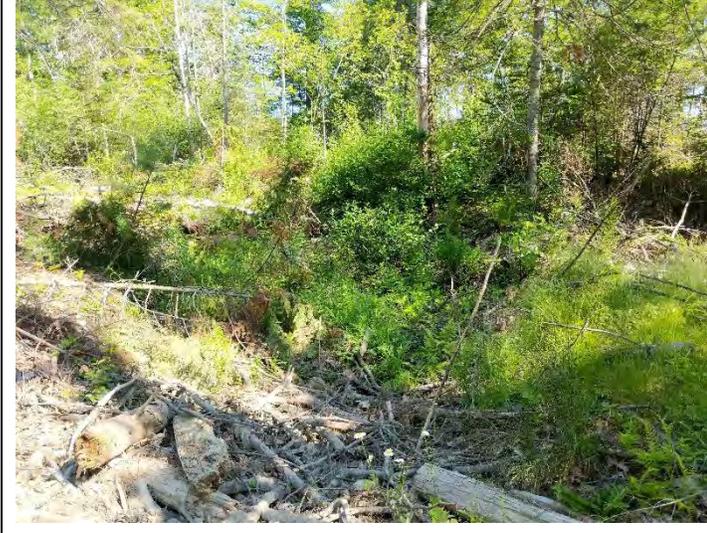
**Photo #: 4**  
S5 – looking downstream from middle section.

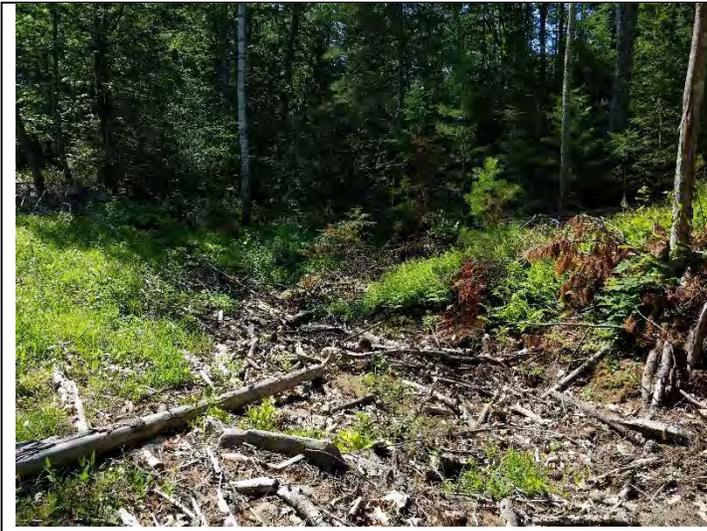
**Photo #: 5**  
S5 – Looking upstream from middle section.

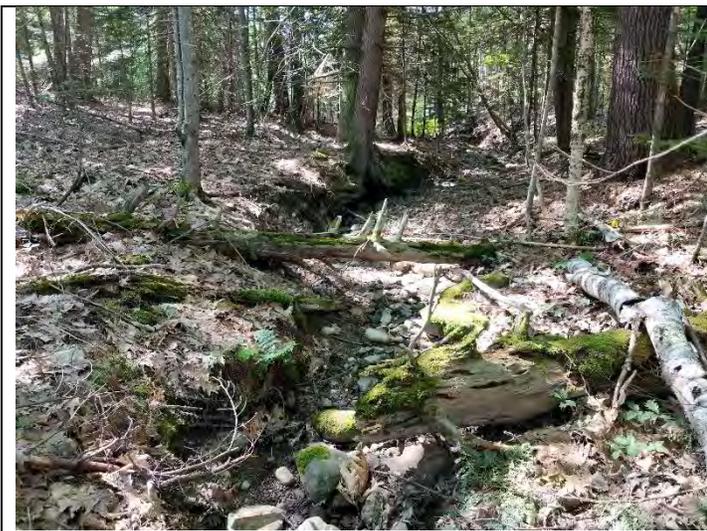
**Photo #: 6**  
S5 – Looking upstream in upper portion.

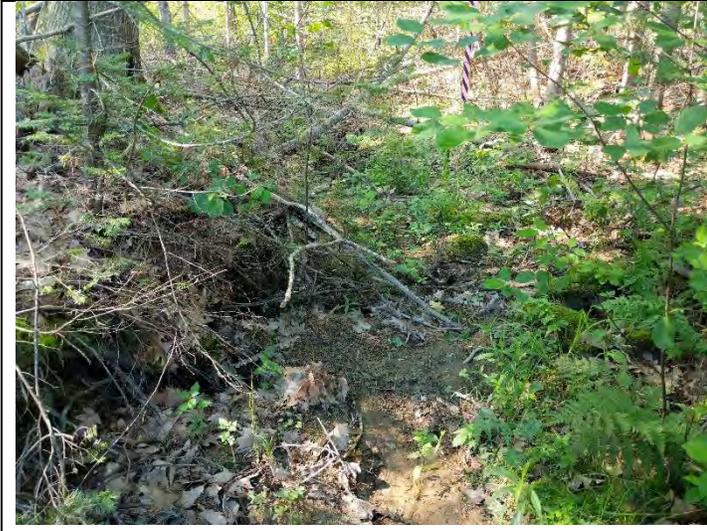
**Photo #: 7**

S6 – Looking downstream from upstream portion.

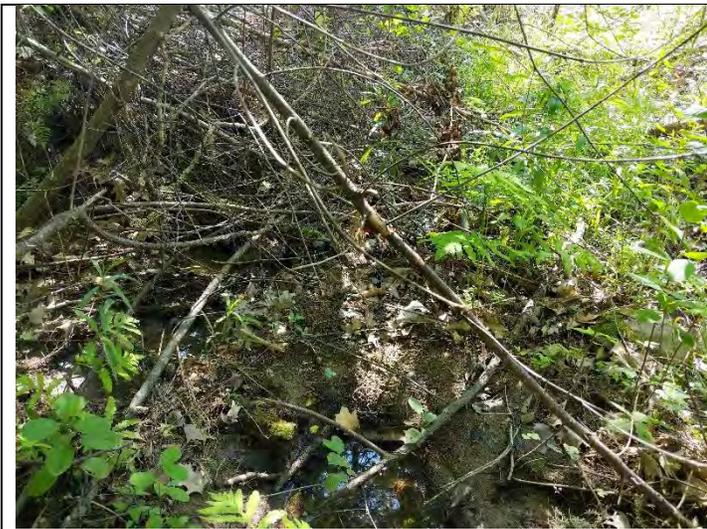
**Photo #: 8**

S6 – Isolated small pool.

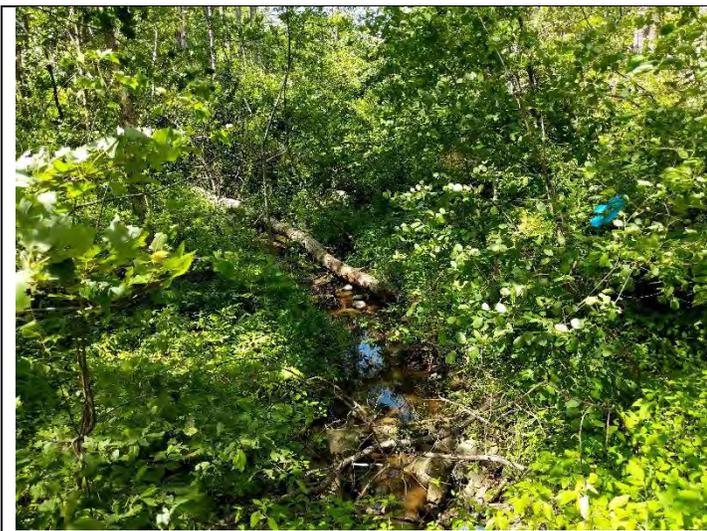
**Photo #: 9**

S8 – Looking downstream from Eckrote driveway.

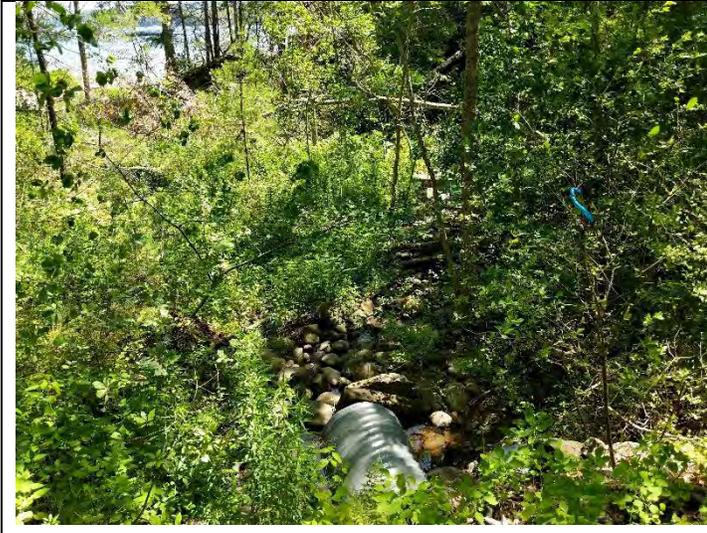
**Photo #: 10**

S8 – Looking downstream from Route 1.

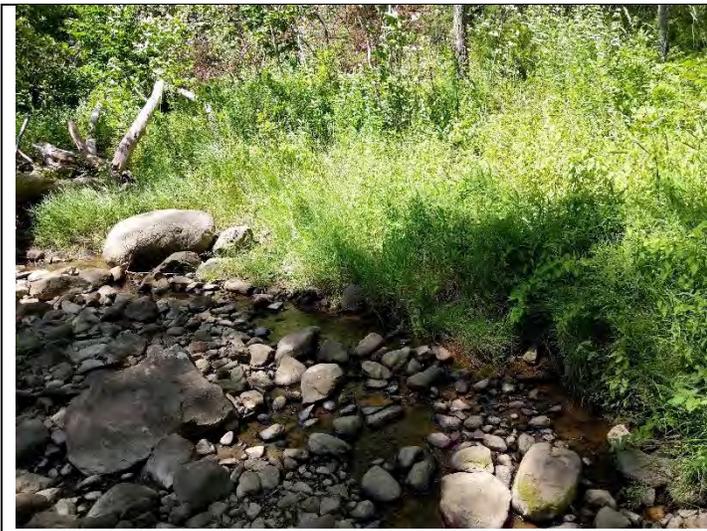
**Photo #: 11**

S8 – Looking upstream from the downstream portion.

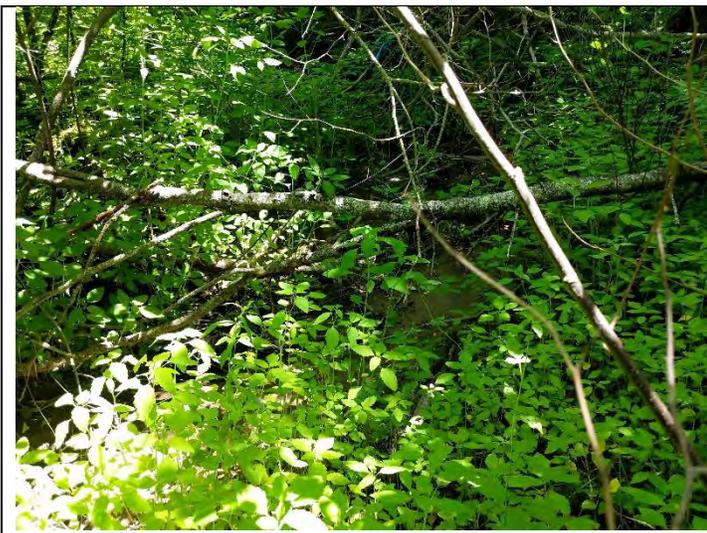
**Photo #: 12**

S9a – Densely vegetated portion, facing downstream.

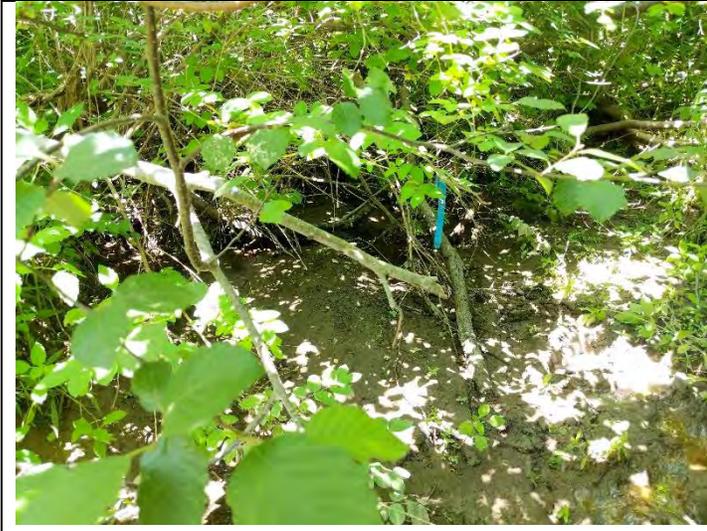
**Photo #: 13**

S9a – Densely vegetated portion looking upstream.

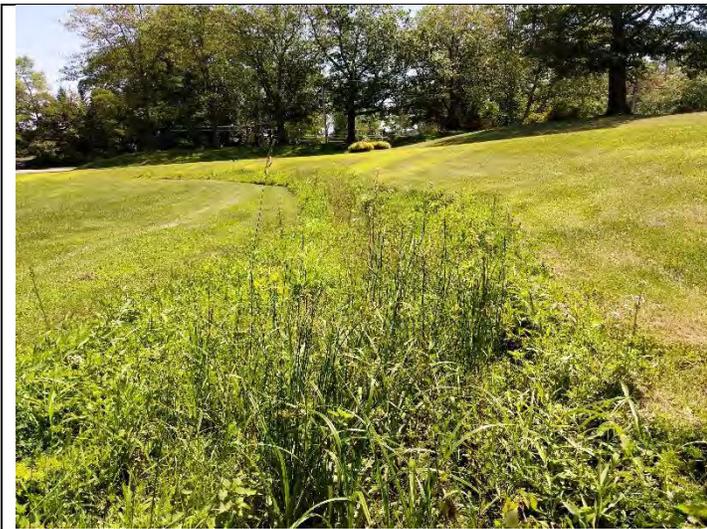
**Photo #: 14**

S9b – Cleared reach, facing downstream.

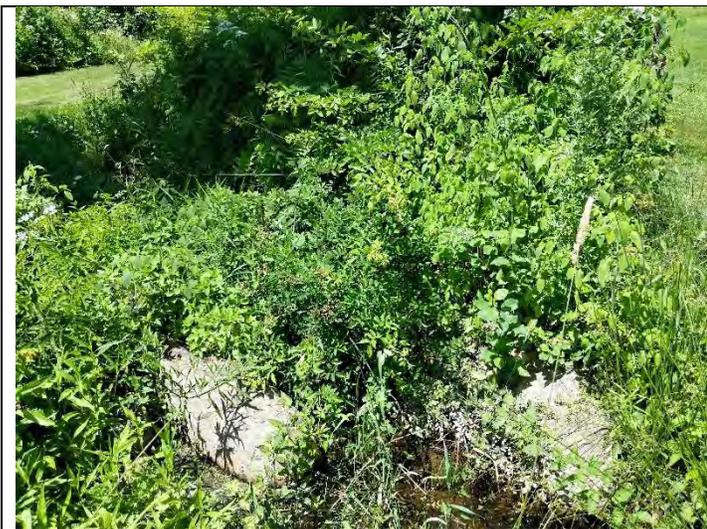
**Photo #: 15**

S9b – Cleared reach, facing upstream.

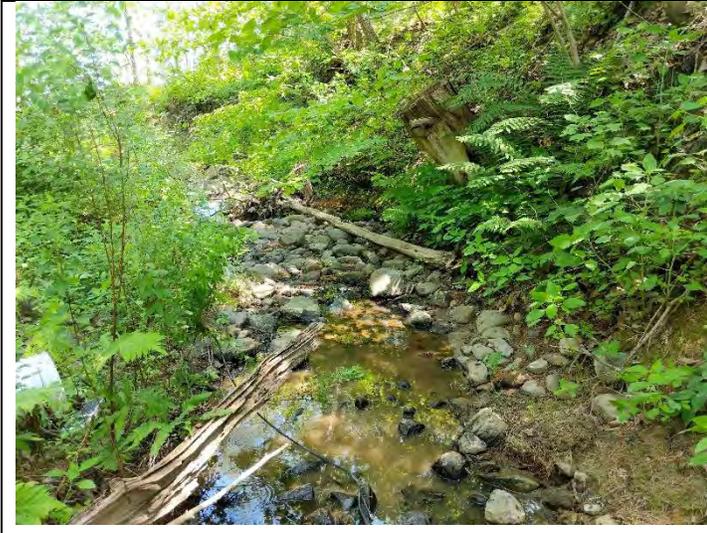
**Photo #: 16**

S9c – Lower reach near Belfast Bay, facing downstream.

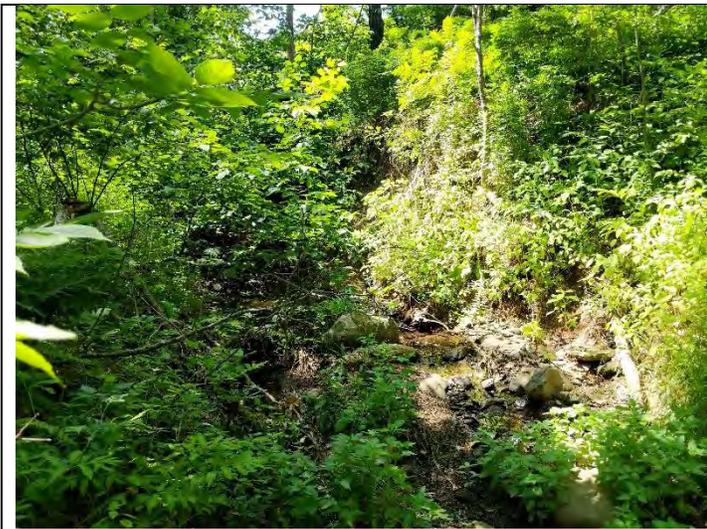
**Photo #: 17**

S9c – Lower reach, facing upstream.

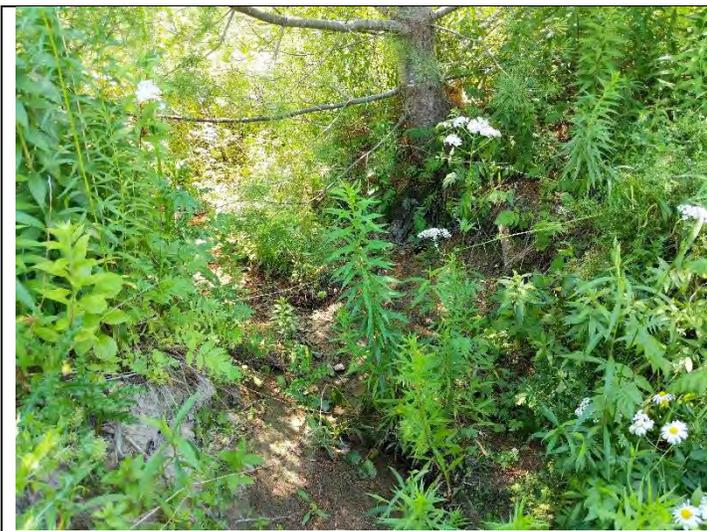
**Photo #: 18**

S10 – Looking downstream from field.

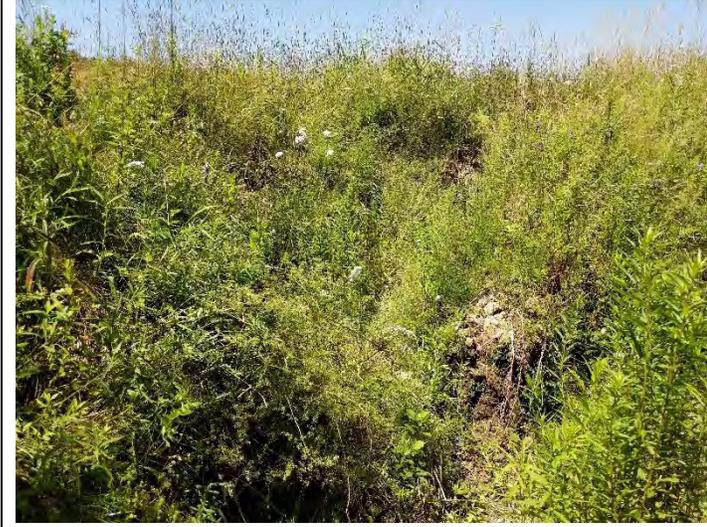
**Photo #: 19**  
S10 – Facing upstream  
from the edge of the  
field.

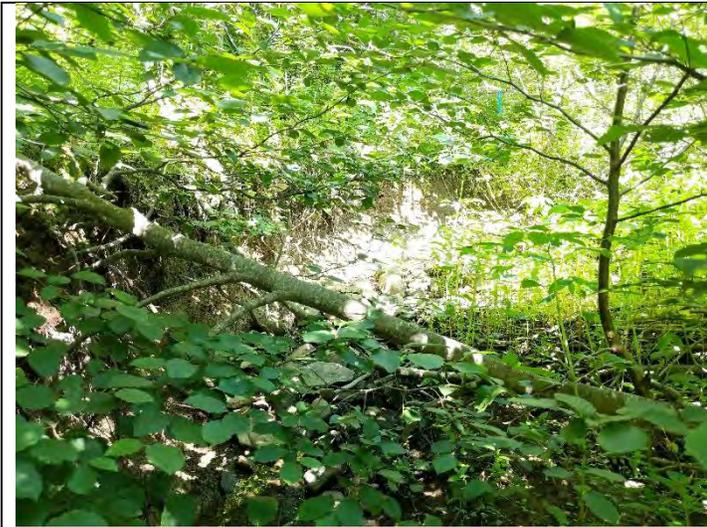
**Photo #: 20**  
S10 – Facing upstream  
from shrub portion.

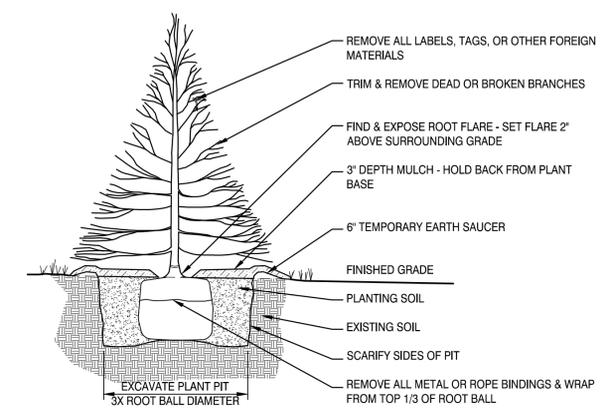
- NOTES:
- TREE TO BE SET PLUMB.
  - SECURE TREE AS MAY BE REQUIRED ACCORDING TO TREE SIZE, LOCATION, & WIND/WEATHER CONDITIONS.
  - IF USING ROOTBALL STABILIZATION, FOLLOW MANUFACTURER'S RECOMMENDATIONS.

STANDARD EVERGREEN TREE PLANTING (H1) NOT TO SCALE

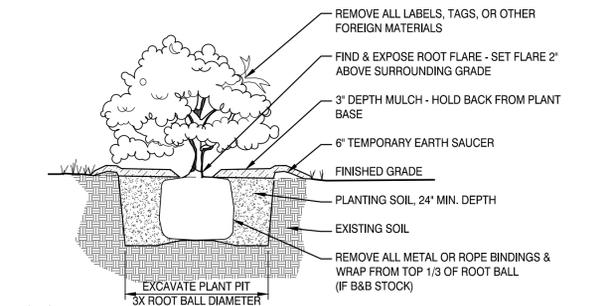
- NOTES:
- SHRUB TO BE SET PLUMB.

STANDARD SHRUB PLANTING (D1) NOT TO SCALE

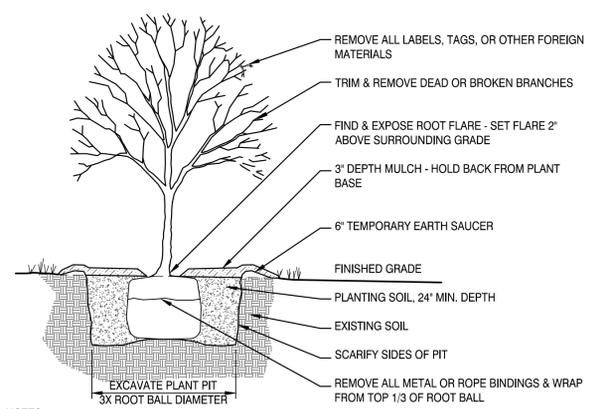
- NOTES:
- TREE TO BE SET PLUMB.
  - SECURE TREE AS MAY BE REQUIRED ACCORDING TO TREE SIZE, LOCATION, & WIND/WEATHER CONDITIONS.
  - IF USING ROOTBALL STABILIZATION, FOLLOW MANUFACTURER'S RECOMMENDATIONS.

STANDARD DECIDUOUS TREE PLANTING (A1) NOT TO SCALE
