A-15-1

Winnicut River Greenland, NH

A-15-1 Winnicut River

Strategy Purpose To divert oil from upper Winnicut River and Packer Brook

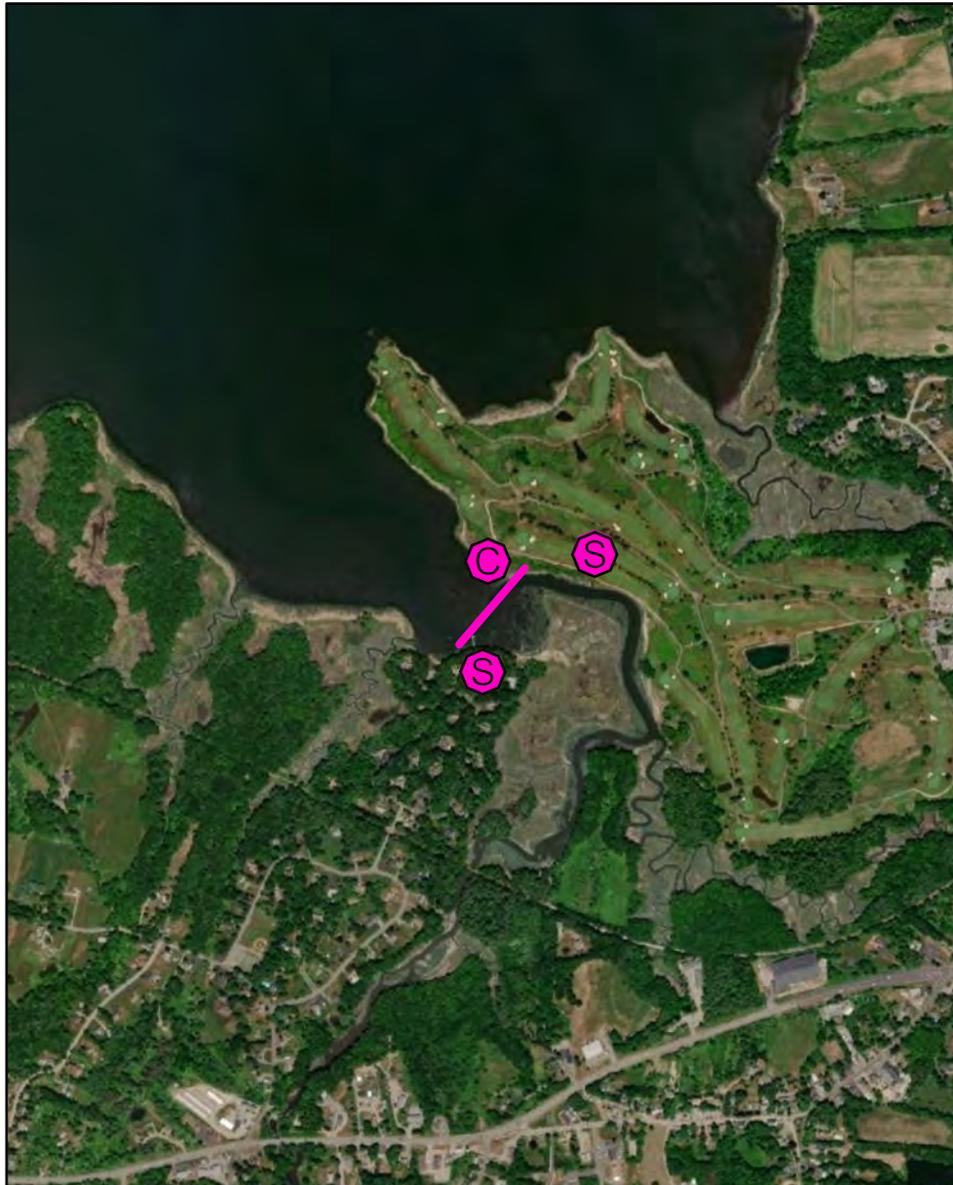
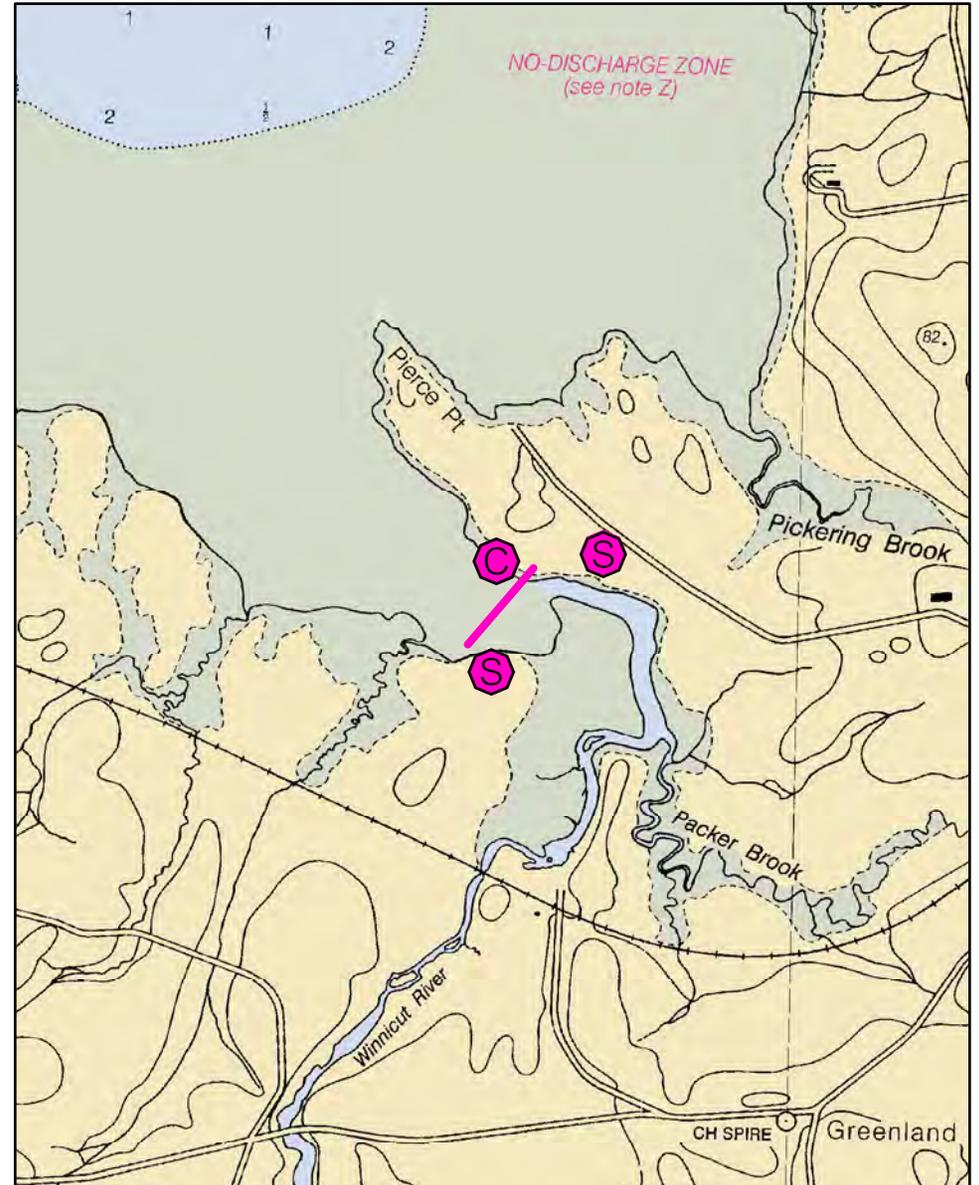
Work Assignment Deploy 700 feet of containment boom from Portsmouth Country Club golf course, 80 Country Club Lane, Greenland, on the north side of the river southward within the river channel to cover Winnicut River and Packer Brook.

Length of Boom (feet) 700 **Type of Boom** 12" to 18" containment boom
