# C-13-1

## Camden Harbor

### Camden, ME

**Strategy Purpose** To exclude oil from Camden Harbor

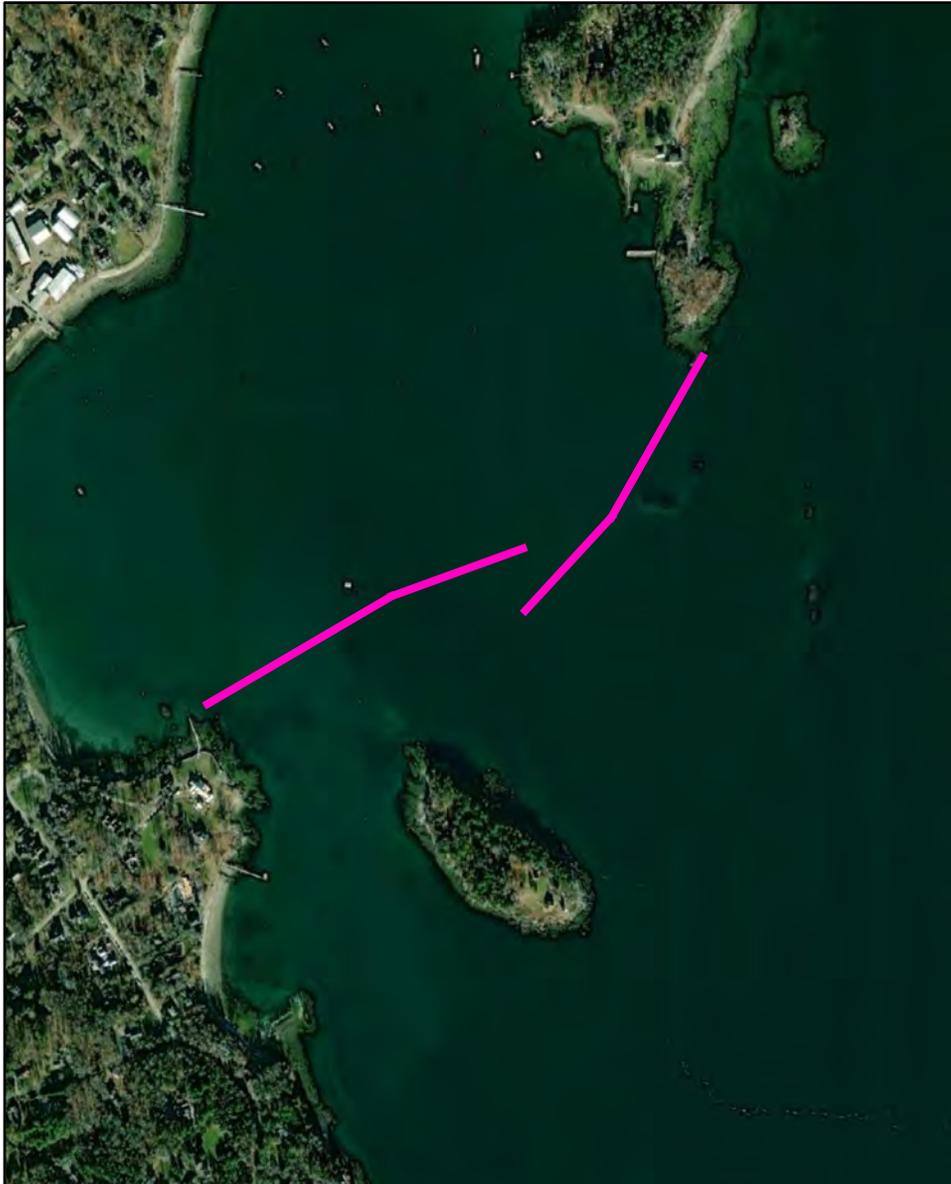
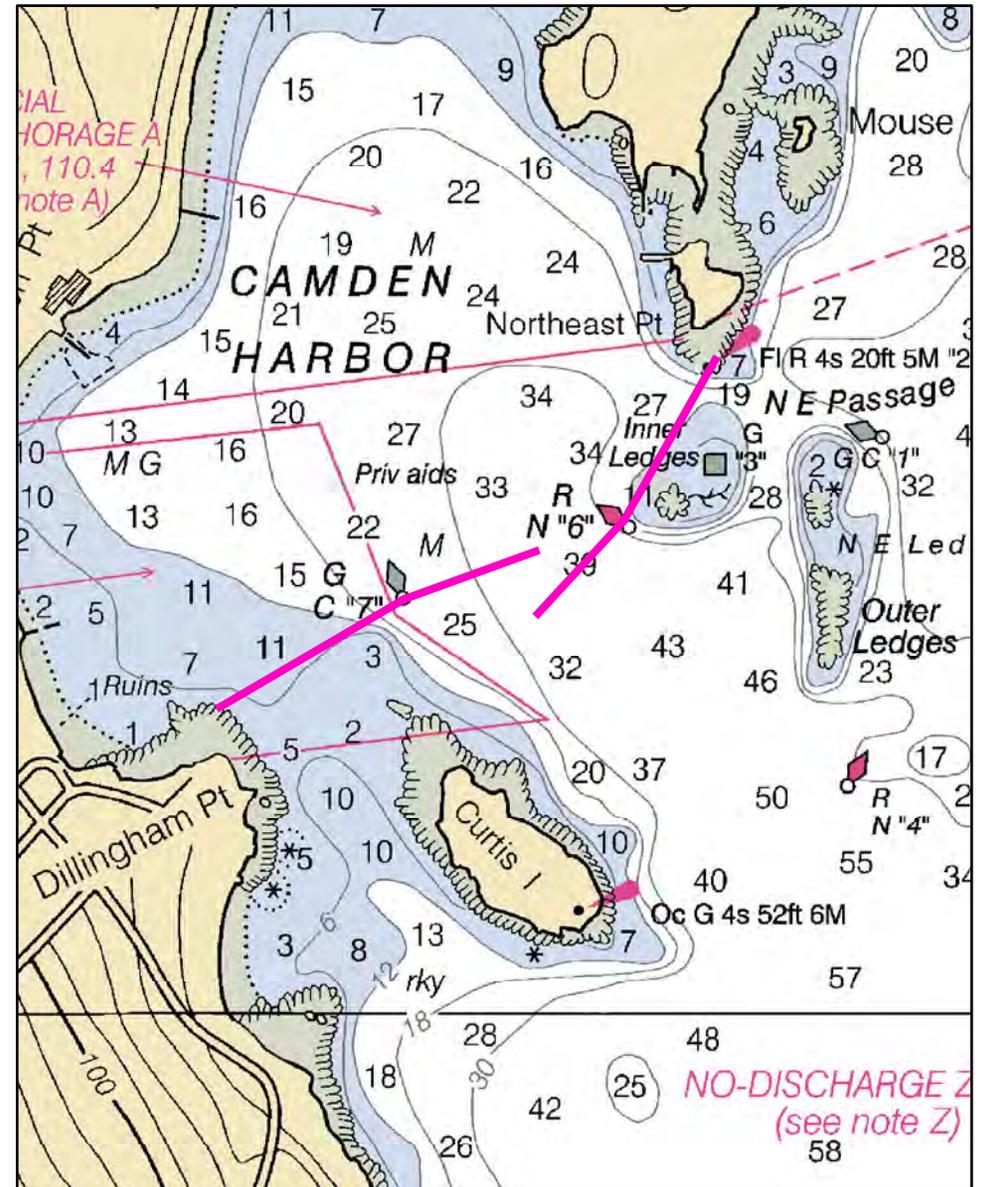
**Work Assignment** Deploy 1000 feet of boom from Dellingham Point to vicinity of Green Can "7". Deploy two 600 foot sections of boom between Green Can "7" and Red Nun "6", leaving room for boat passage. Deploy 1000 feet of boom from vicinity of Red Nun "6" to Flashing Red Buoy near Northeast Point.
