Great East Lake Watershed-Based Protection Plan

2022-2032

Acton Wakefield Watersheds Alliance
Great East Lake Improvement Association

Great East Lake Watershed Survey Report 2021

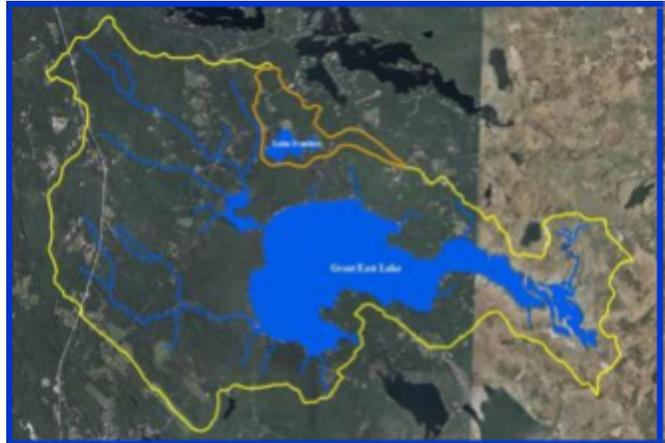
The area of Great East Lake is 1,707 acres (2.67 square miles) while the area of the entire watershed is approximately 9,990 acres (15.53 square miles). The maximum water depth is 102 feet, with an average depth of 35 feet. The lake is located in the towns of Wakefield, NH and Acton, ME. The shoreline of Great East Lake is highly developed with only about 7% of the shoreline undeveloped. All precipitation that falls in the watershed drains directly into the lake through a network of streams, ditches, and overland flow.

The major outlet is at the southeast end of the lake. This outlet is dam controlled and the outflow travels through a canal and enters Horn Pond. A public boat launch is located immediately adjacent to the dam. Great East Lake is part of a larger watershed along with Lovell Lake, Horn Pond, Lake Ivanhoe, and Wilson Lake as the headwaters of the Salmon Falls River, which serves as the border between New Hampshire and Maine. The Salmon Falls River converges with the Cocheco River to become the Piscataqua River and eventually empties into the Gulf of Maine.

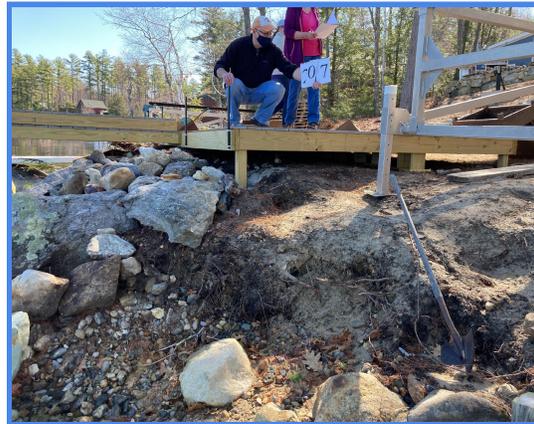
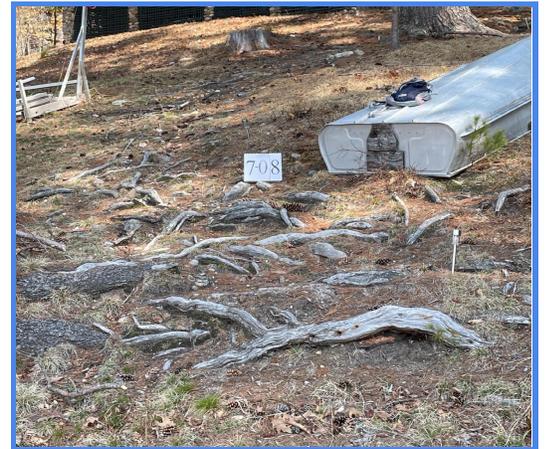
Common Erosion Issues

Gully Erosion - forms when fast moving water forms a channel on bare soil and begins to pick up and transport sediment downhill to the lake. Most visually obvious form of erosion. Smaller gullies are referred to as rills.

Shoreline Erosion - Shoreline can erode both from stormwater runoff and intense wind and wave action. The root systems of plants on the shoreline work to stabilize soil on the slope and protect it from eroding. In the absence of permanent, woody vegetation, the bank soils have no structure and can easily erode into the lake.

Sheet Erosion - Less apparent than a gully. Occurs when soil erodes in equal amounts across the landscape and the soil level lowers. Exposed roots are evidence of this. Roots naturally grow underground, so the amount of soil loss equals at least the height of the exposed roots. Sheet erosion often goes unnoticed and can lead to significant soil loss.

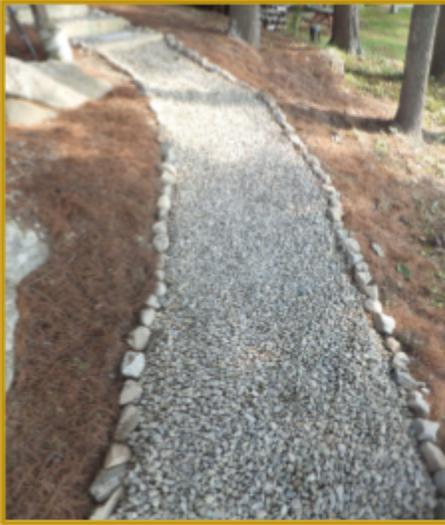
Infiltration Path - a trench filled with crushed stone that traps stormwater. Can replace dirt paths susceptible to runoff.

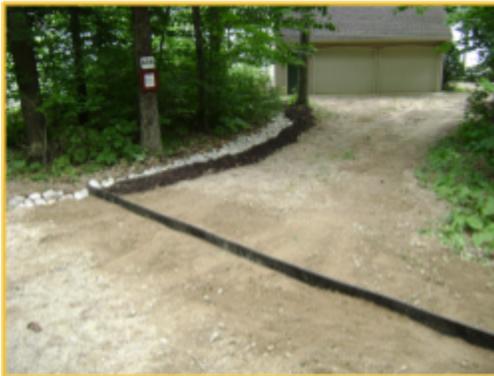
Rubber Razor - strips of hard rubber are partially buried in the driveway, placed on an angle to divert stormwater into an adjacent trench or natural area.

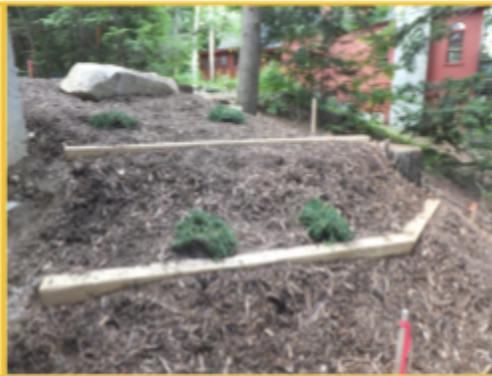
Water Bars - 6"x6" lumber is installed on a slope with crushed stone on the uphill side to trap and divert stormwater. Water bars are left slightly raised to slow water down and can be used as seen above, or placed in a pathway in shorter lengths to function as steps.

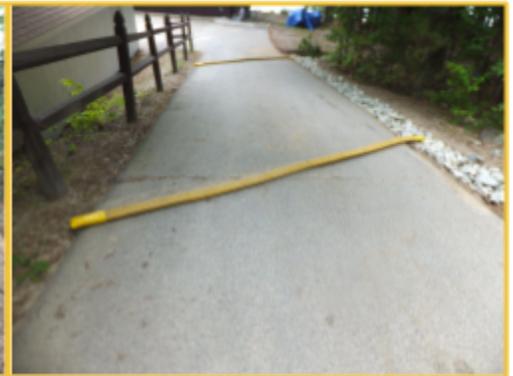
Firehose Diverter - In paved driveways, burying rubber and wood are not an option. Old firehose, or other durable material, can be filled with sand or stone and placed on an angle to divert stormwater. These have the added benefit of being movable.

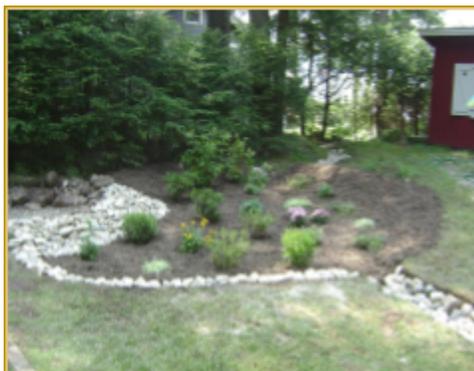
Rain Garden - pervious detention basin designed to store stormwater during a rain event and allow it to infiltrate. Typically a trench directs water into the rain garden. Water tolerant plants are put in to uptake additional water and absorb excess nutrients.

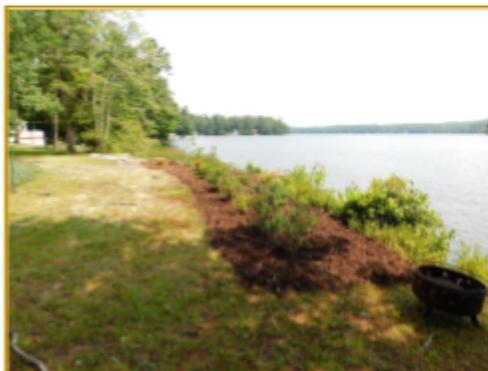
Vegetated Buffer - The shoreline is the last line of defense from stormwater. Dense, woody vegetation slows down stormwater and the root system binds sediment together and keeps it from eroding.

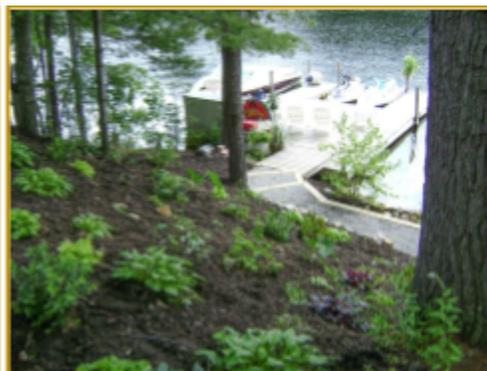
Erosion Control Mulch - This chunky mulch is made of tree and stump grindings of various sizes, this allows it to bind together and trap stormwater without washing away. This is the simplest way to protect bare soil and will last for many years before breaking down.

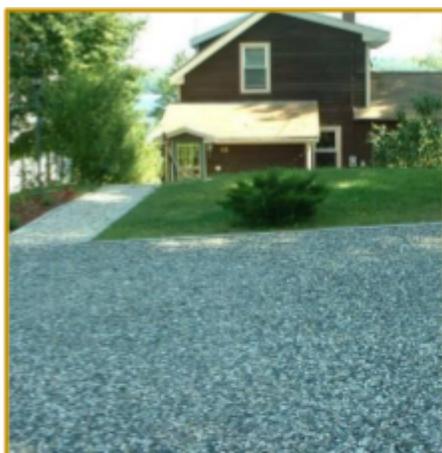
Hard Pack - This is an aggregate stone material that does not wash away as easily as sand and gravel. The lack of fine materials means less sediment erosion.

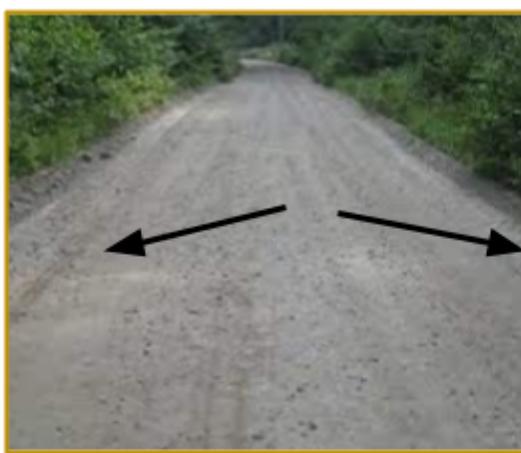
Crowning - A dirt road must be slightly pitched so water will run off of it instead of forming potholes and gullies. The high point can be in the middle to direct water in both directions, or on a far side to direct all water in one direction.

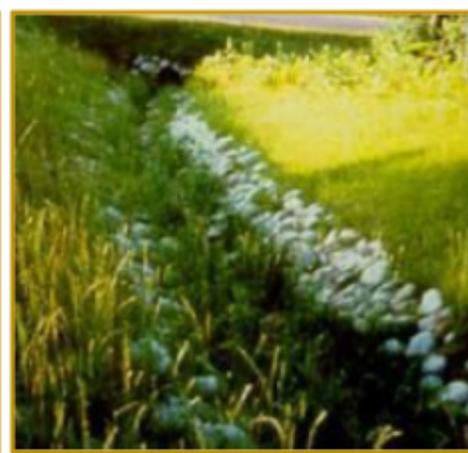
Ditching - Once water is directed off the road, it should flow into a pervious ditch to allow it to infiltrate. There are various methods such as vegetation and check dams which can be used to slow stormwater down in a ditch.
