# Eelgrass Distribution in Casco Bay

2013

Final Project and Data Report  
for the Casco Bay Estuary Partnership and  
the Maine Department of Environmental Protection

December 18, 2013

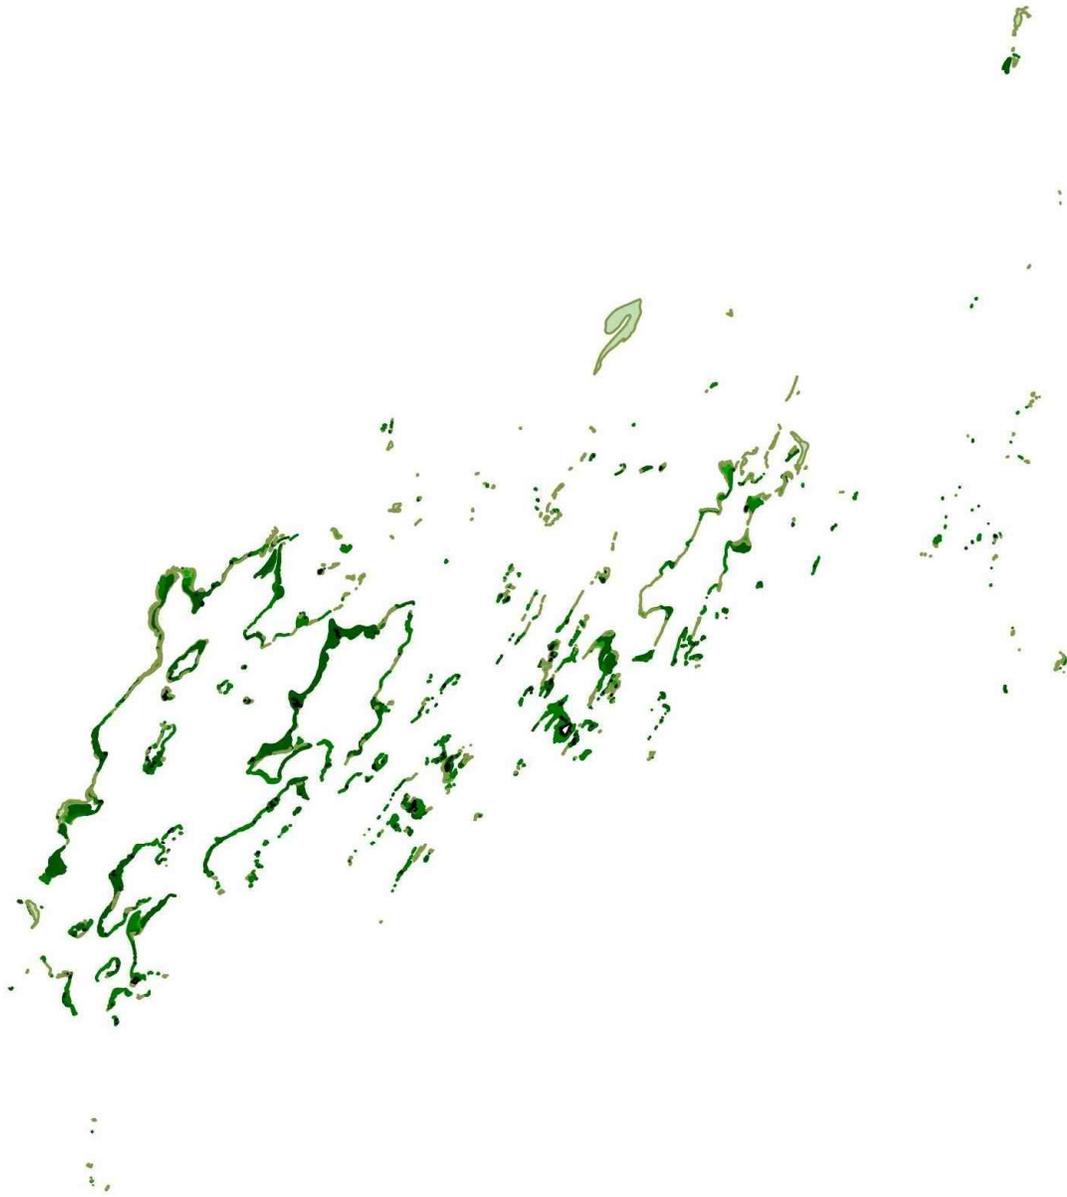
Vignette: Casco Bay Eelgrass Beds, 2013, (colored coded for cover class).

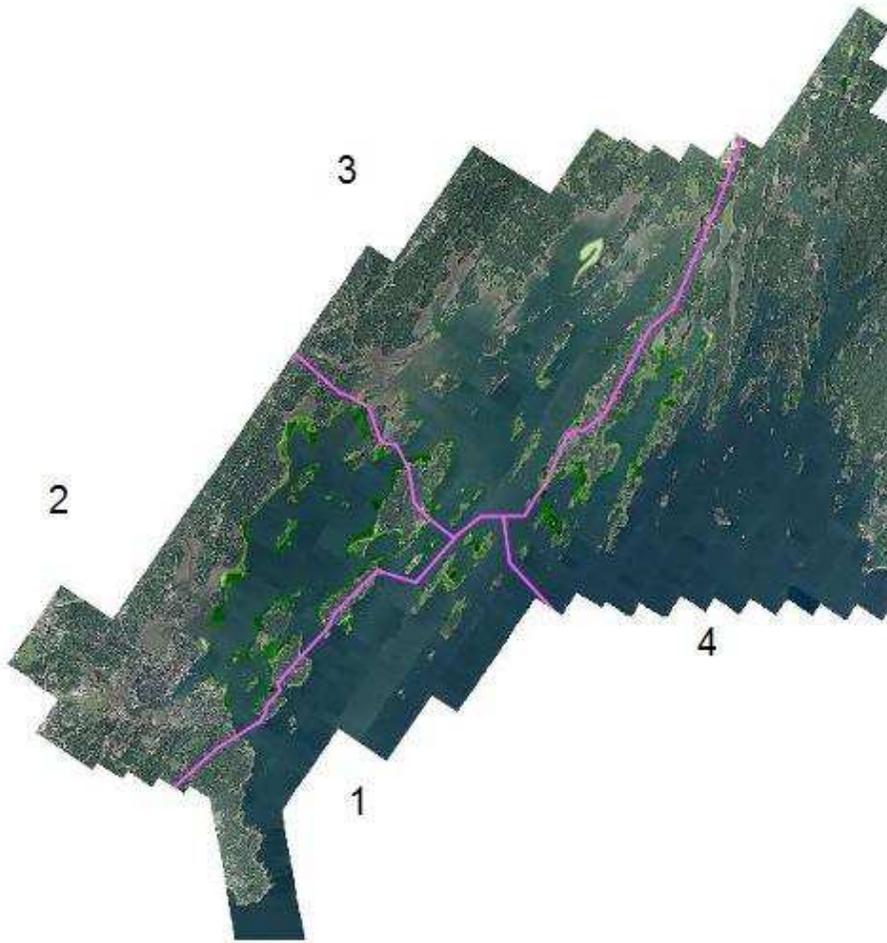
Figure 3. Location of quadrants used to compare area of Casco Bay eelgrass beds in 2013 with that of 2001/02.

divided into four quadrants (Figure 3) and the years 2001/02 and 2013 compared. Quadrants were numbered 1 through 4. Quadrants 2-4 were similar in area but generally were different types of environments. Quadrant 1 constituted outer islands in the south western portion of the bay, had the least amount of habitat, and as would be expected, the least amount of eelgrass. Quadrant 2 extended from Portland Harbor to the Cousins Island Bridge and out past Great Chebeague. Quadrant 3 included the area from the Cousins Island bridge around to the western shore of Harpswell Neck. Quadrant 4 included the eastern shore of Harpswell Neck to Small Point.
