## TMDL Assessment Summary

# Red Brook

This **TMDL** assessment summary applies to a 5.4-mile section of Red Brook, located in the Town of Scarborough and the City of South Portland, Maine. Red Brook, a tributary to Clarks Pond in South Portland, begins in a wetland area north of County Road (Route 22) in Scarborough. The stream flows through a large wetland area as it travels south along Gorham Road in Scarborough. It then crosses under the Maine Turnpike (I95) next to Exit 44 in Scarborough. The brook follows I-295 and passes under it several times on its way into Clarks Pond, an impoundment draining into the Fore River and then Casco Bay. There are several large ground water fed ponds in the Red Brook watershed with outlets running into the brook. The Red Brook watershed covers 2,048 acres in the town of Scarborough and the cities of South Portland and Westbrook.

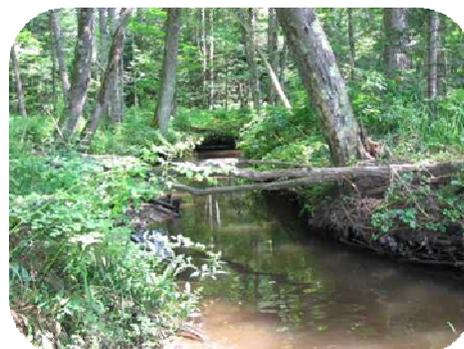
*Red Brook downstream of Station 219.  
(Photo: Maine DEP Biomonitoring Program)*

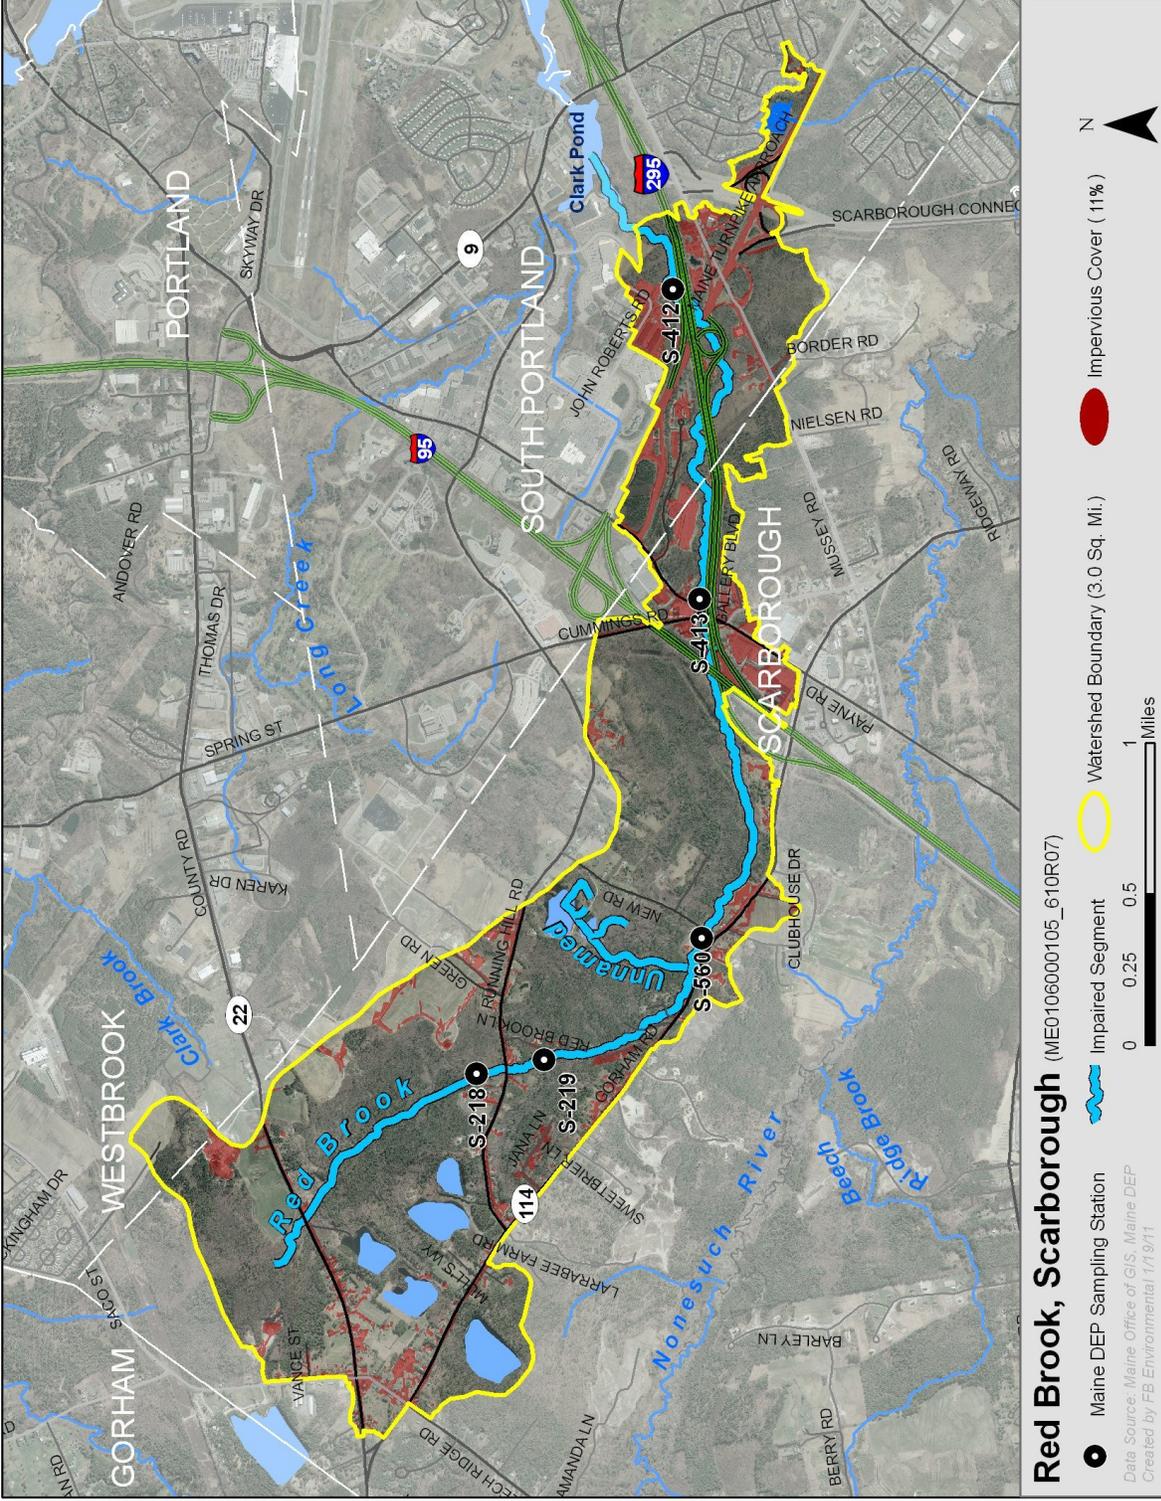
**Figure 1: Map of Red Brook watershed impervious cover.** 4

The development is concentrated in the most downstream portion of the watershed (Figure 1) and exerts a disproportionate effect on the lower impaired stream segment. This segment does exhibit characteristics associated with impairment due to stormwater runoff, therefore a target was chosen to reduce the impact of IC and achieve water quality classification. The relative contribution of this development needs to be evaluated during the development of a Watershed Specific Plan, as recommended in the IC TMDL.

*The Impervious Cover Calculations are based on analysis of GIS coverage's presented in Figure 1. The impervious area is derived from 2007 1 meter satellite imagery and the watershed boundary is an estimation based on contours and digital elevation models.*

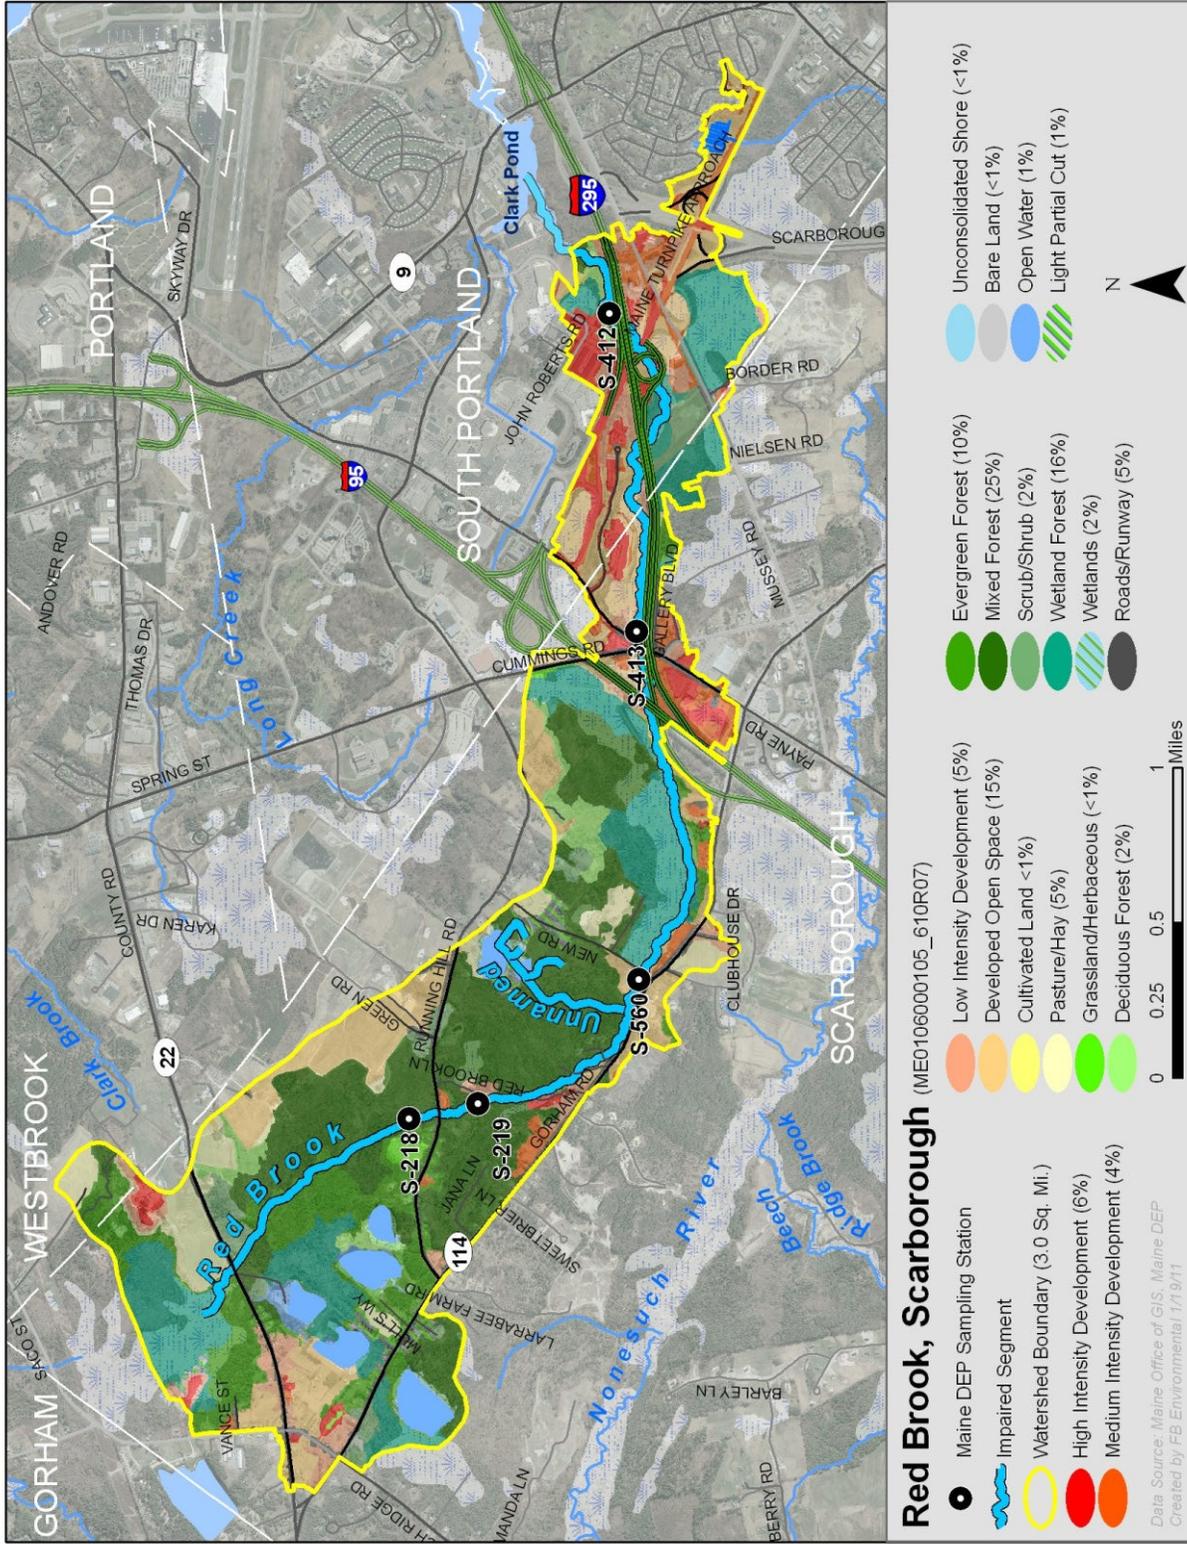
Figure 2: Map of Red Brook watershed land cover.
