A-25-1

Stacy Creek
Eliot, ME

Strategy Purpose Exclude oil from Stacy Creek

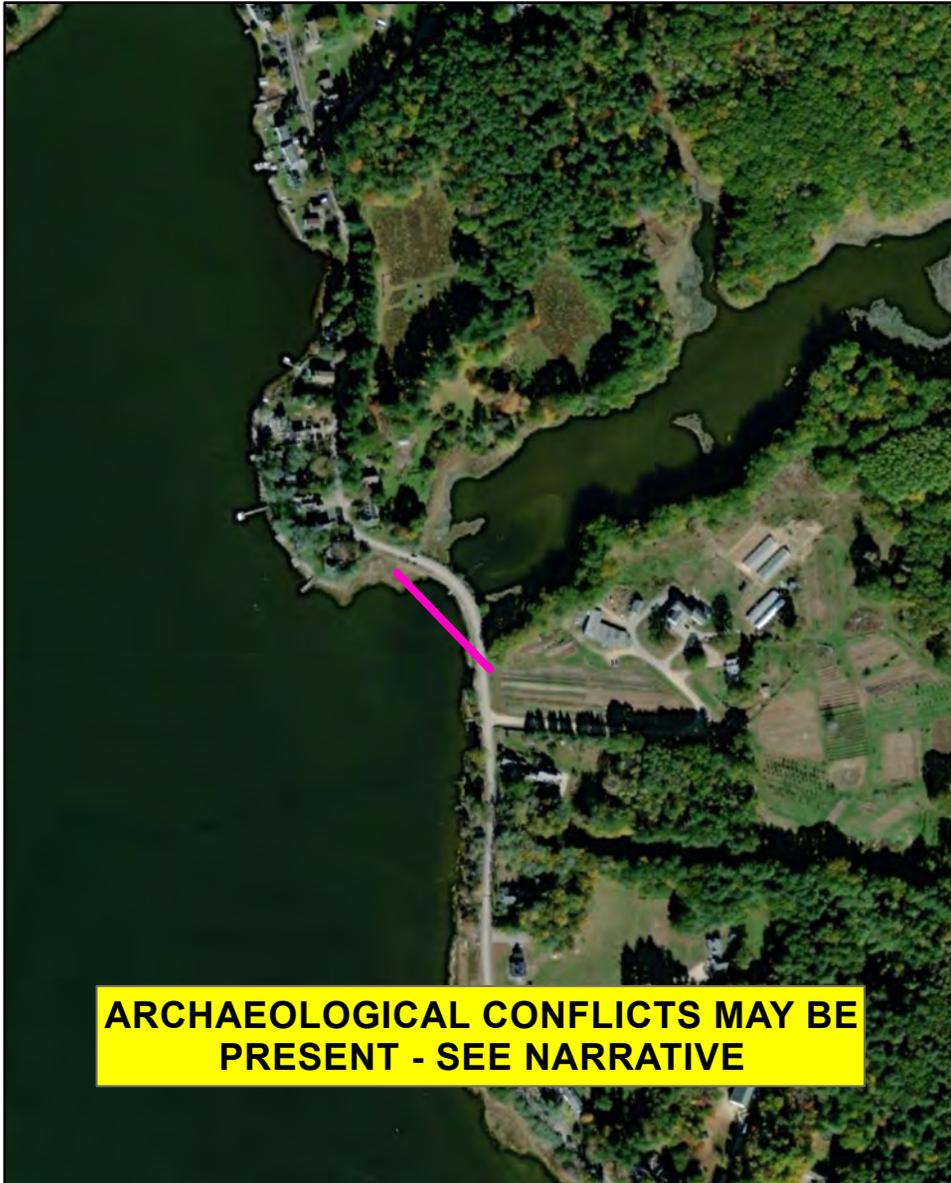
ARCHAEOLOGICAL CONFLICTS MAY BE PRESENT - SEE NARRATIVE

Work Assignment Deploy 400 feet of containment boom across culvert. Deploy from shore - no boat access. Ample anchor points north and south of creek mouth.

Archaeological Conflicts ME: Old mill location underwater in mouth of Stacy Creek, likely beyond where boom in in map. Deviations from GRS design will require MHPC review. Contact MHPC at (207) 287-2132.

Special Instructions Traffic control needed during deployment. Consider deploying debris trap on upstream end side of River Road culvert to protect downstream boom.
