# B-11-2

## Harraseeket River: Staples Cove Freeport, ME

# B-11-2 Harraseeket River: Staples Cove

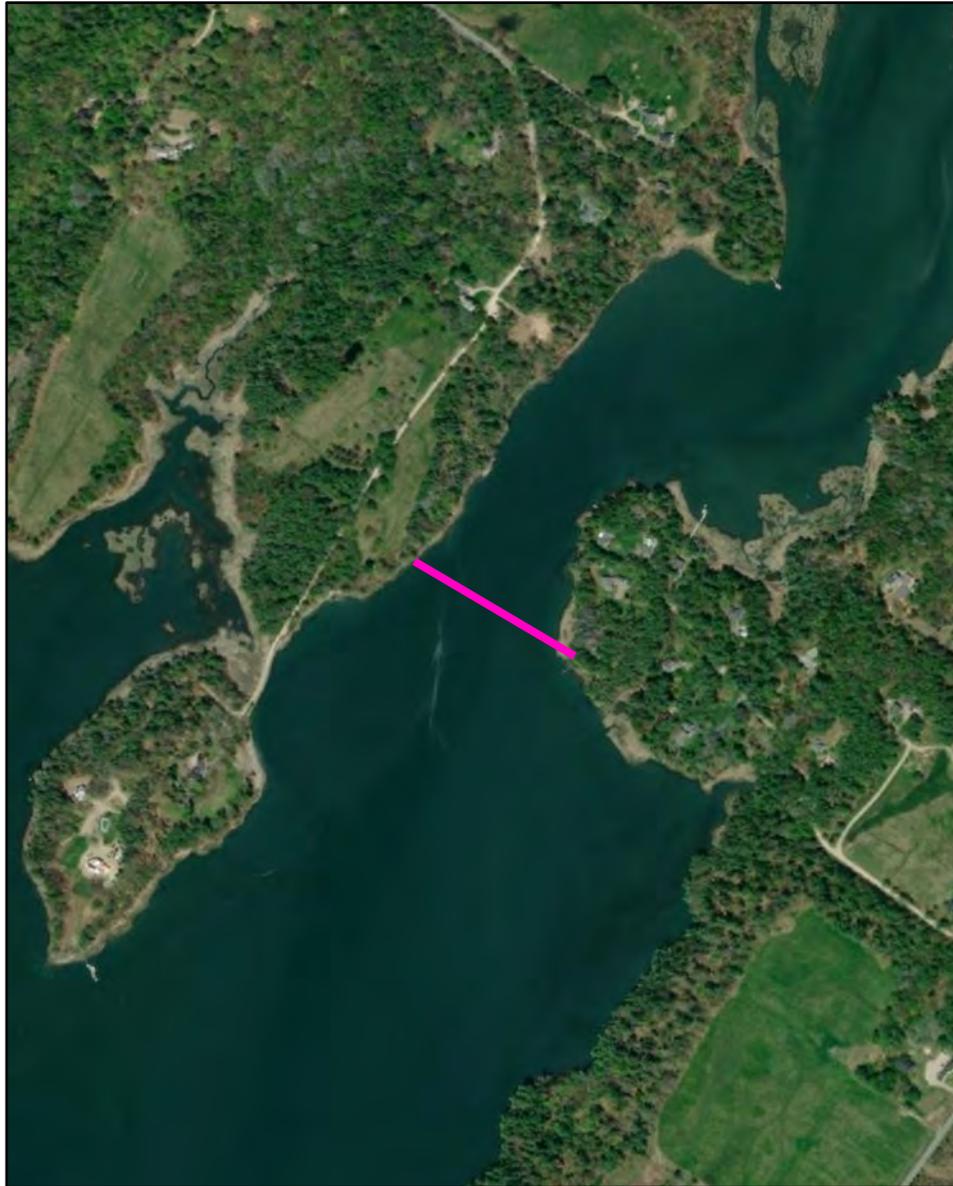
**Strategy Purpose** To exclude oil from salt marshes in upper reaches of river.

**Work Assignment** Deploy a 700' section of boom across inlet northeast of Bartol Island at high tide.

**Length of Boom (feet)** 700

**Type of Boom** 12" - 18" containment boom / sorbent
